# Technical Service Bulletin

| <b>Technical Service Bulletin:</b><br>TSB170085 | <b>Released Date:</b> 31-Oct-2018 |

## Fault Code 5867: PACCAR™ Chassis with Battery Disconnect Switch

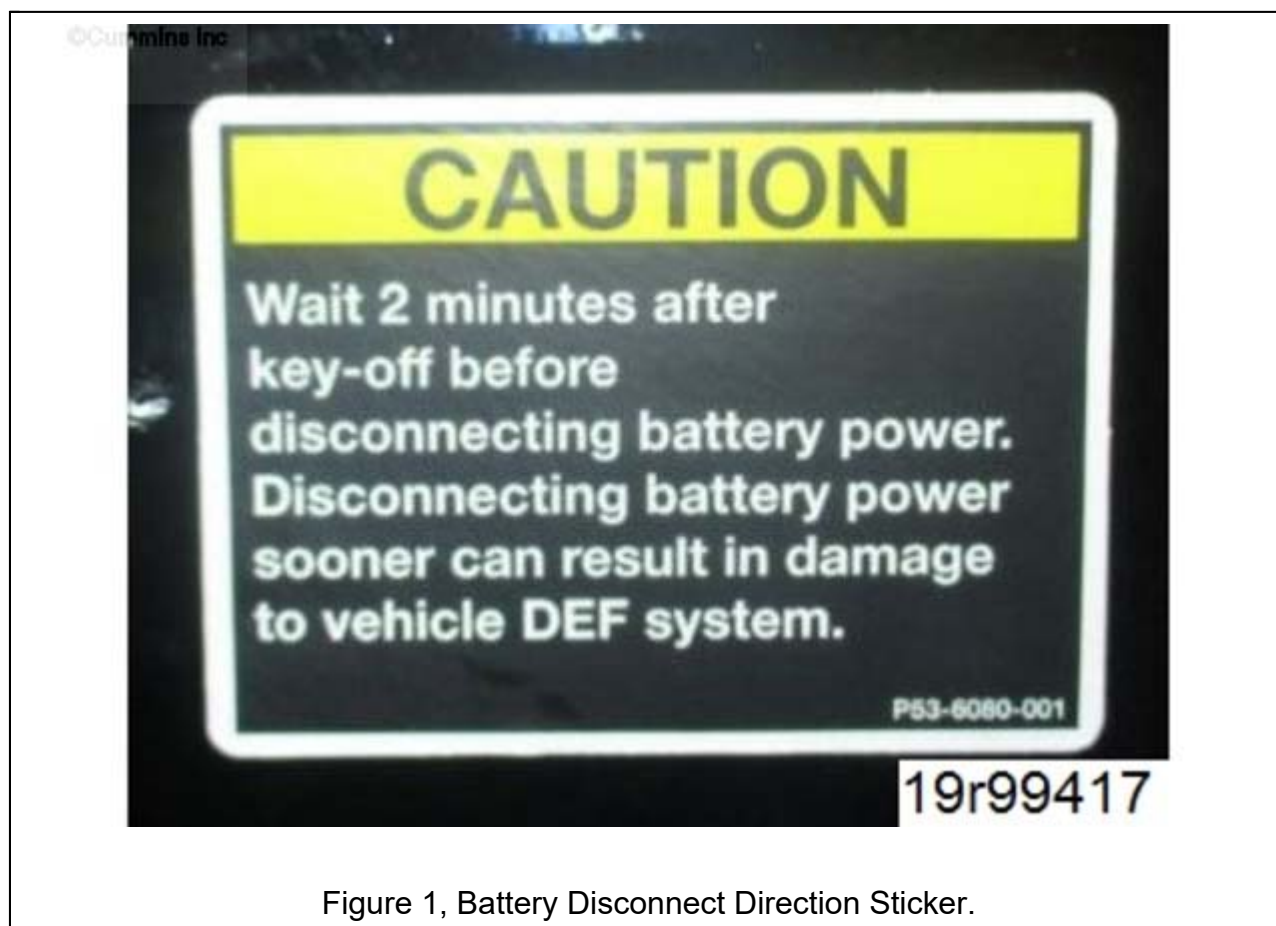
- PACCAR™ chassis do **not** provide a dedicated power source to the aftertreatment DEF dosing unit. Units equipped with battery disconnect switches can interrupt the DEF system power down and purge sequence, logging Fault Code 5867.

- Verify notification sticker directing proper power down procedures is affixed to chassis near battery disconnect switch. Contact local PACCAR™ support location for battery disconnect power notification sticker See Figure 1 below.
- Inform operator of proper power down procedure which requires two minutes before disconnecting power using battery disconnect switch.
