# Service Update

## 18259 Gen 1 Wireless Charging Modules Installed Instead of Gen 2

Reference Number: N182180150

<b>Condition</b>	Certain 2019 GMC Acadia vehicles have been built with a Gen 1 wireless charging module that will not charge some of the latest iPhone and Samsung smart phones.
<b>Correction</b>	Replace the Gen 1 module with the Gen 2 module kit.

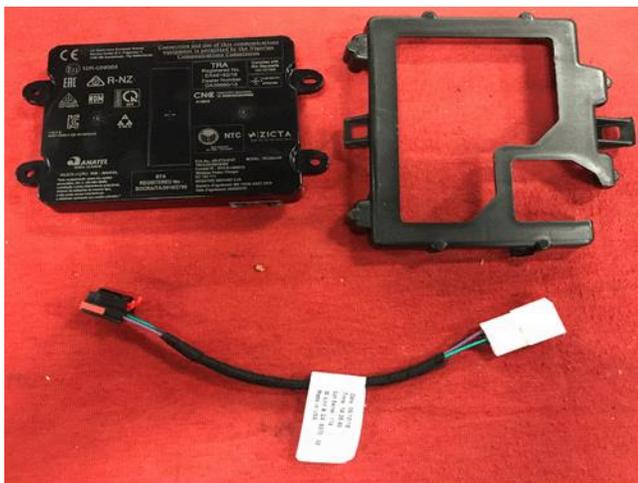
5135197

**Note:** Only the parts shown below will be used from the kit ordered for converting from GEN 1 wireless charging to GEN 2 wireless charging.
