### PIC6285B Diagnostic Aid for DTCs P1AEE and P1AEF, Control Module Hybrid/EV Battery System Voltage High Voltage (Over-Voltage)

Brand:	Model:	Model Years:	VIN:		Engine:	Transmissions:
			from	to		
Chevrolet	Volt	2016 - 2019	All	All	All	All

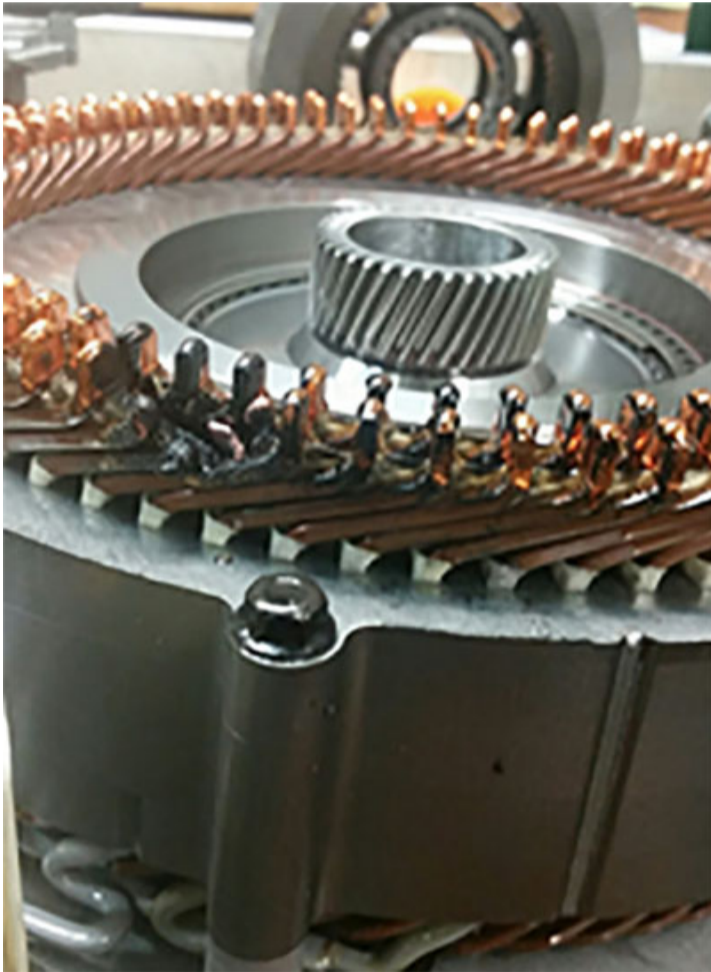
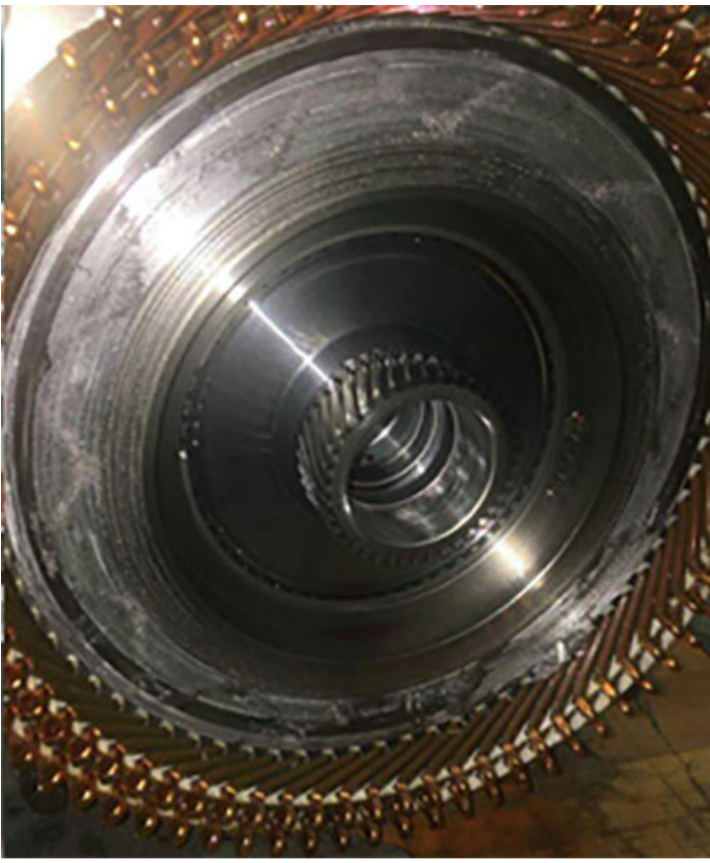
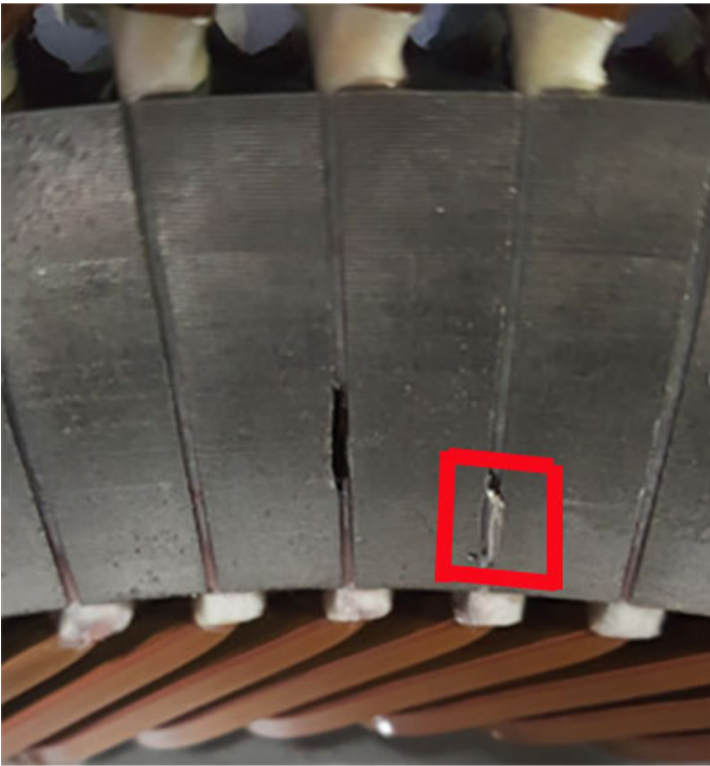
If one of these parameters is 0 volts in the freeze frame, then it is likely the vehicle has a loss of isolation condition.

If accompanied by DTCs P1AF0/P1AF2/P1E22 or P0C01/P0C04, then the loss of isolation will be located within the transmission, usually due to debris in the motor stators from a failed internal component.

Examples of debris causing stator problems:

Use the *Loss of Isolation on the High Voltage Main Bus* procedure in SI to help pinpoint which subsystem is causing the loss of isolation.

**Note: Any loss of isolation will not self-heal and needs to be repaired for vehicle safety. Clearing codes without repair is not an acceptable remedy of this category due to the vehicle hazards created by P1AEE and P1AEF.**

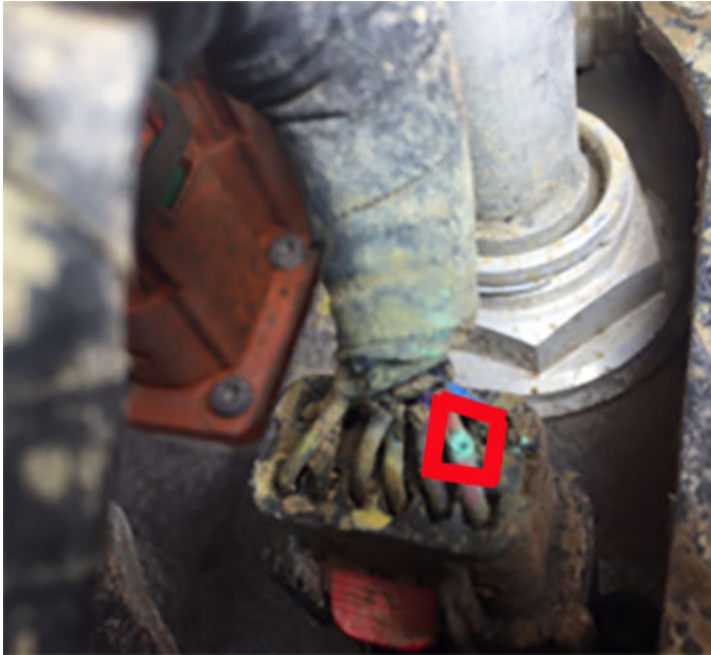
**Any compromise in these circuits may cause the contactors to open unexpectedly.**

Example of connector X357 with stone impingement and corrosion on wiring:

**Inspect circuits 3961 and 3959 for contactor control as well as B+ 5240 and ground circuit 2050 (G302).**

If no trouble is found, replace the K114B HPCM2 module for a possible internal fault with contactor control.

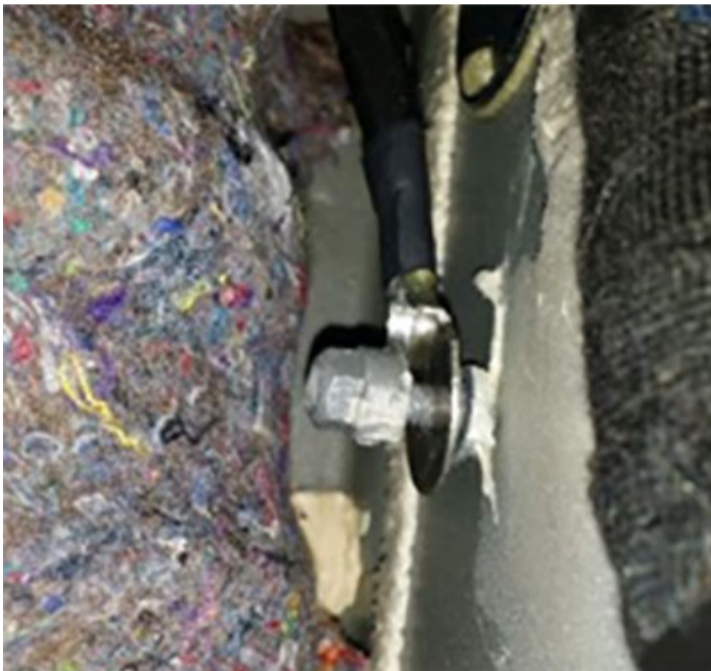
Example of loose ground G302:

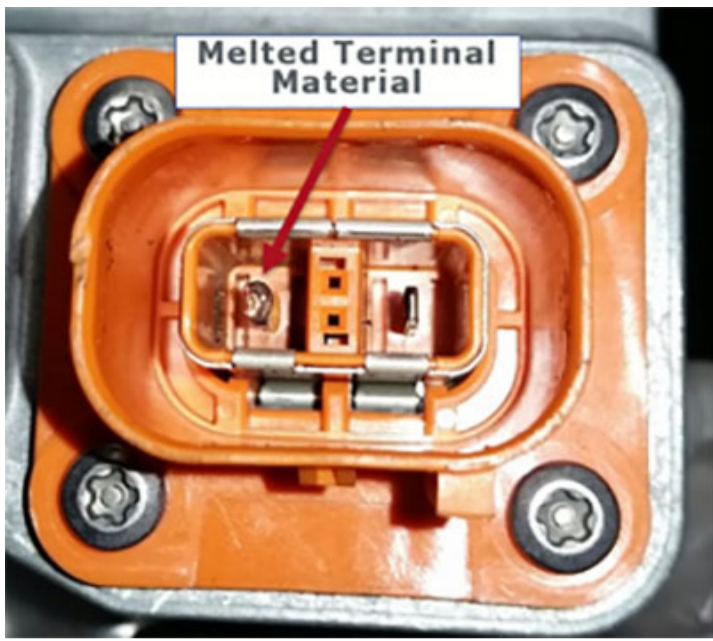
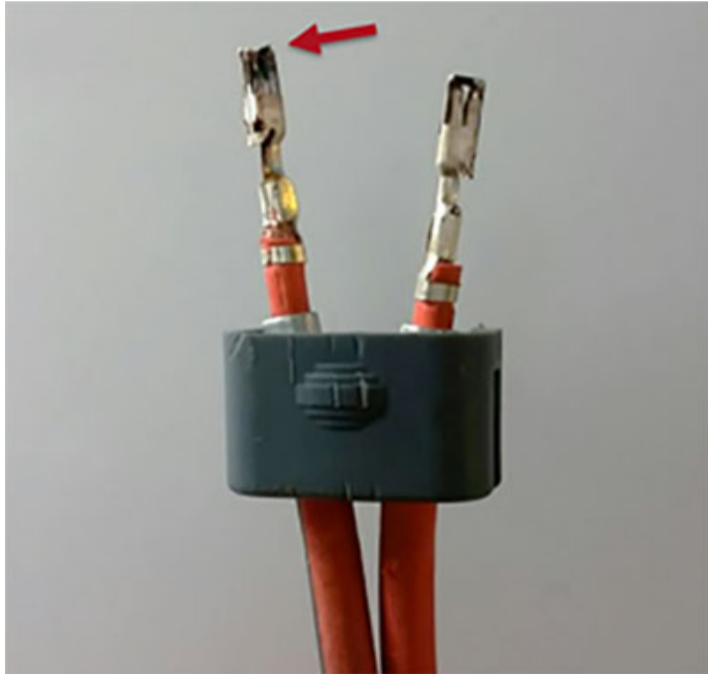
This is expected to be a less common category for P1AEE and P1AEF. If one of the parameters is near but not equal to zero, properly inspect each of the orange high voltage connectors on the vehicle for a loose connection on the high voltage bus.

Example of a loose connector X2 at the K10 Coolant Heater Control Module:
