Preliminary Information

PIP5241B Appearance Of Cracks In Engine Block Deck Surface

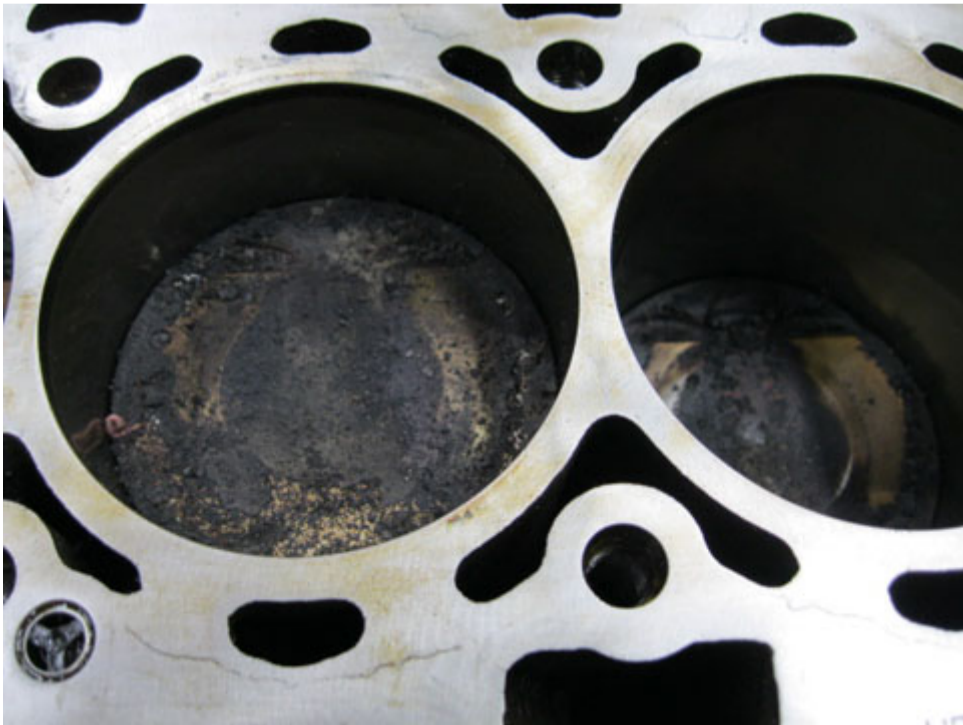
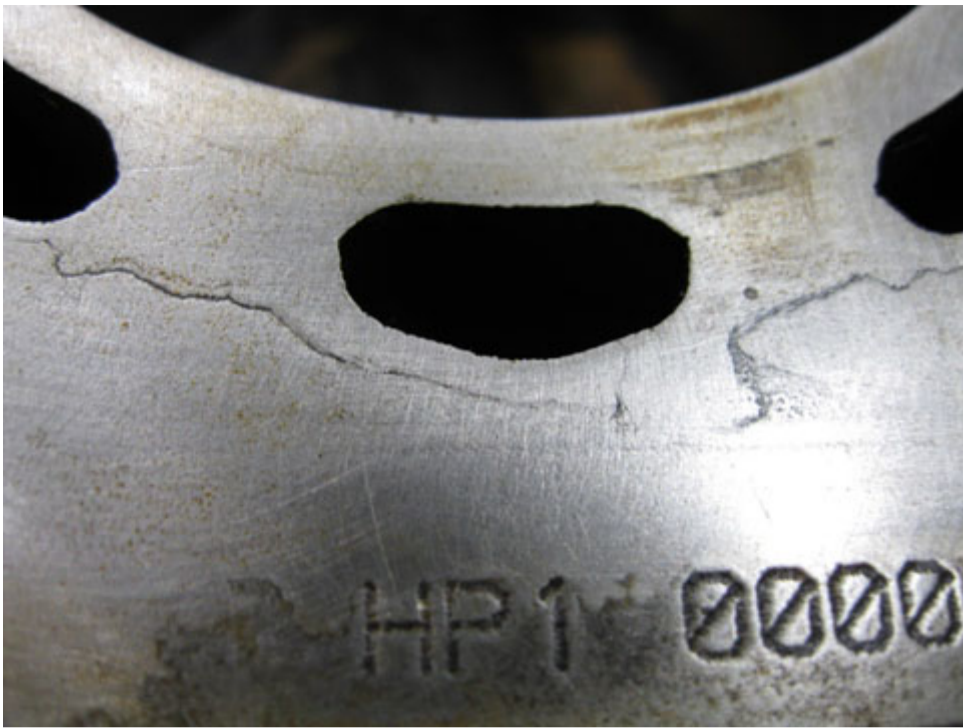
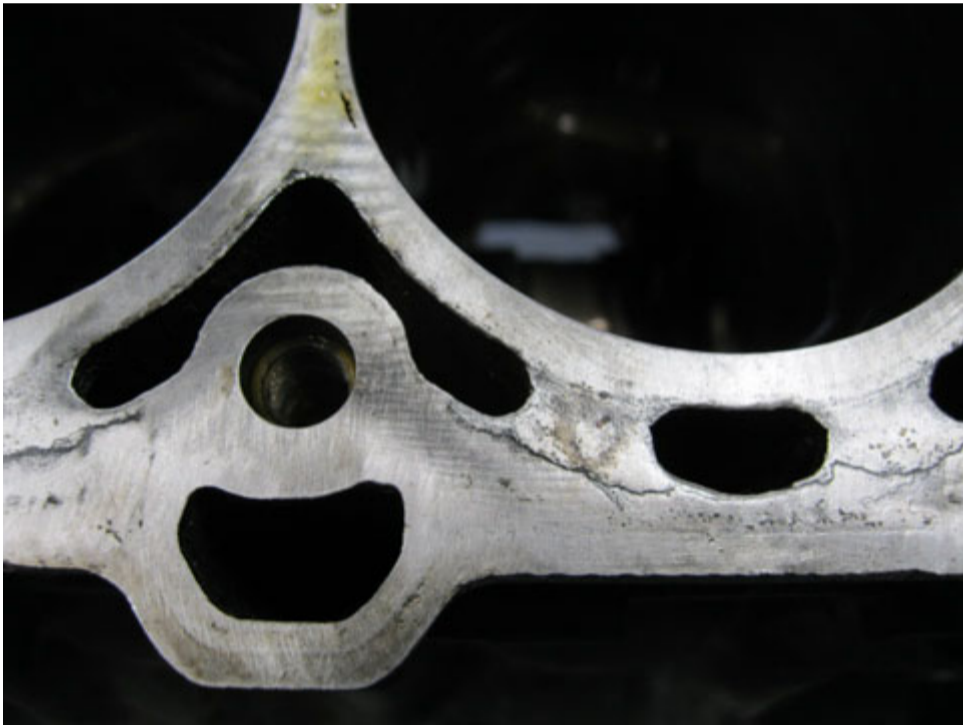
During engine block service, a technician using improper block deck cleaning methods may see lines in the block deck surface. (See photos below).

These lines may be mistaken for cracks.

These lines are the result of using abrasive pad / bristle devices to clean the gasket surface of the engine components. See the latest version of bulletin 00-06-01-012 for complete details on the use of these devices.

If improper cleaning methods are used it cannot be determined by GM if the integrity of the sealing surface has been compromised.

It takes about 15 seconds to remove 0.203 mm (0.008 in) of metal with an abrasive pad.

If slight traces of these lines are seen after using the proper gasket surface cleaning methods, they will not affect cylinder head gasket sealing.
