Preliminary Information

PIP5595 Shifter click noise, shifter boot appears tight or bulge in the shifter boot

Brand:	Model:	Model Years:	VIN:		Engine:	Transmissions:
			from	to		
Chevrolet	Colorado	2018 - 2019	All	All	All	N8D
GMC	Canyon	2018 - 2019	All	All	All	N8D

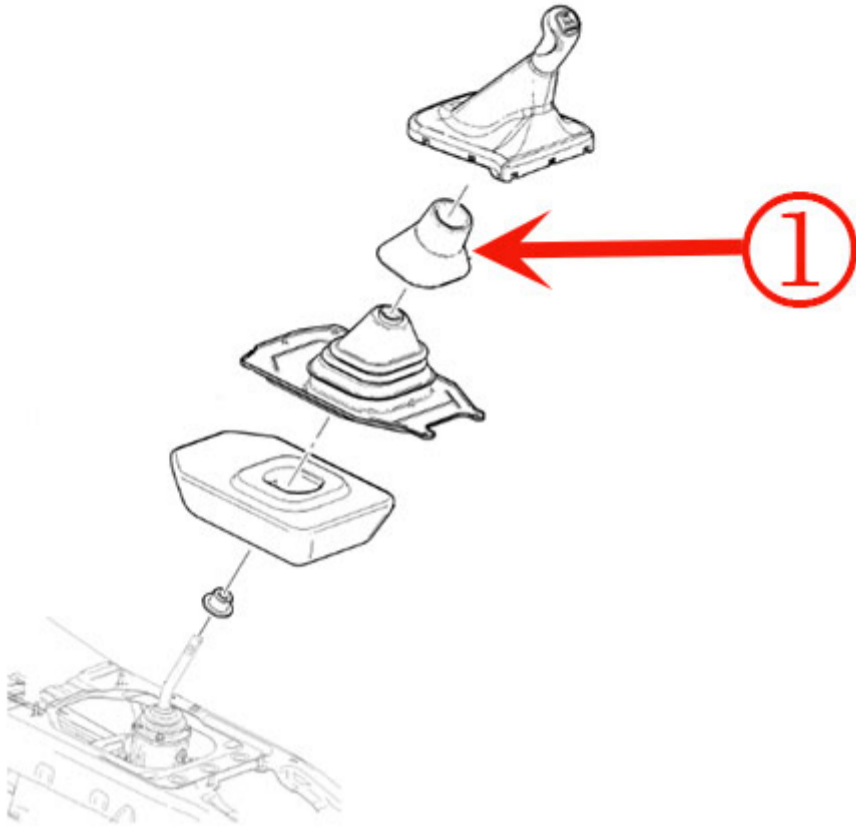
Involved Region or Country	North America
Condition	Click noise from the shifter area or customer complaints of the shifter boot is tight or has a bulge in it.
Cause	Transmission isolator boot is not fully seated

Some customers have commented on a click noise when shifting or that the leather boot covering the shifter assembly is pulled tight in some gears and or may be bulging out near the bottom of the knob. If the isolator (1) below is not in the correct orientation or fully pushed down and seated in the correct position any one of the before mentioned complaints could be noted.

Remove the shifter boot and push the isolator down into the correct position and reinstall the boot. There is no reason to replace the boot.
