Preliminary Information

PIP5421F Malfunction Indicator Lamp Illuminated With DTC P0300 Models

Brand:	Model:	Model Years:	VIN:		Engine:	Transmissions:
			from	to		
Chevrolet	Malibu	2016	All	All	1.5L LFV	All
Chevrolet	Malibu	2017	Start of Production	1G1ZE5ST6HF214701	1.5L LFV	All

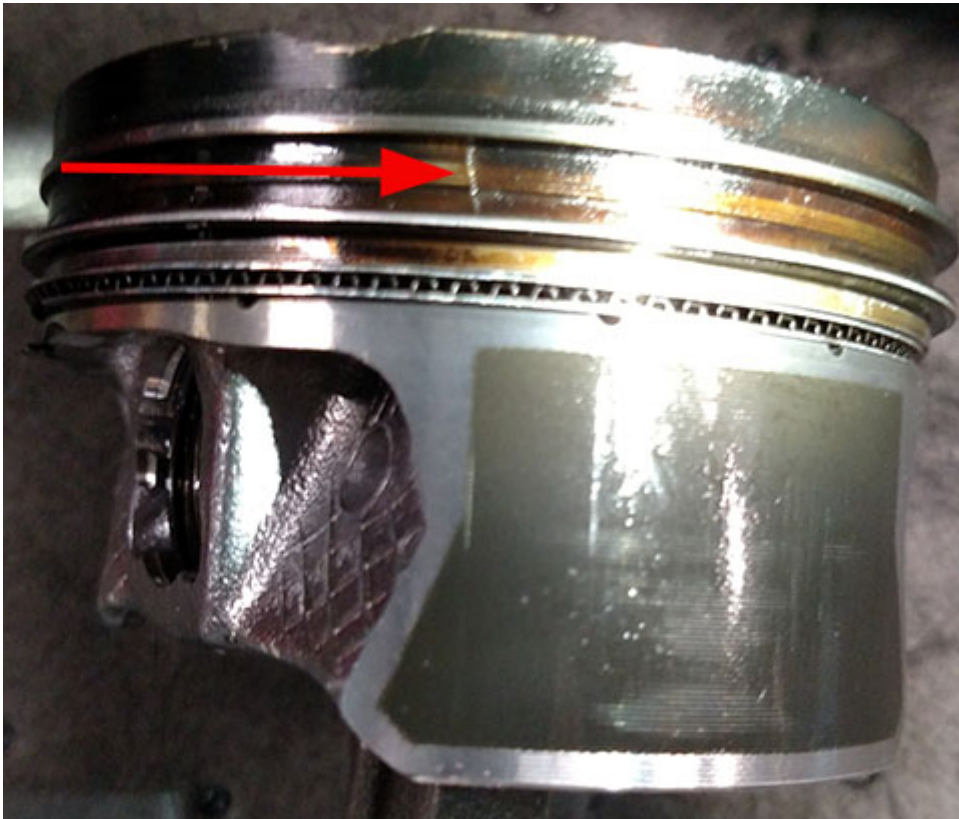
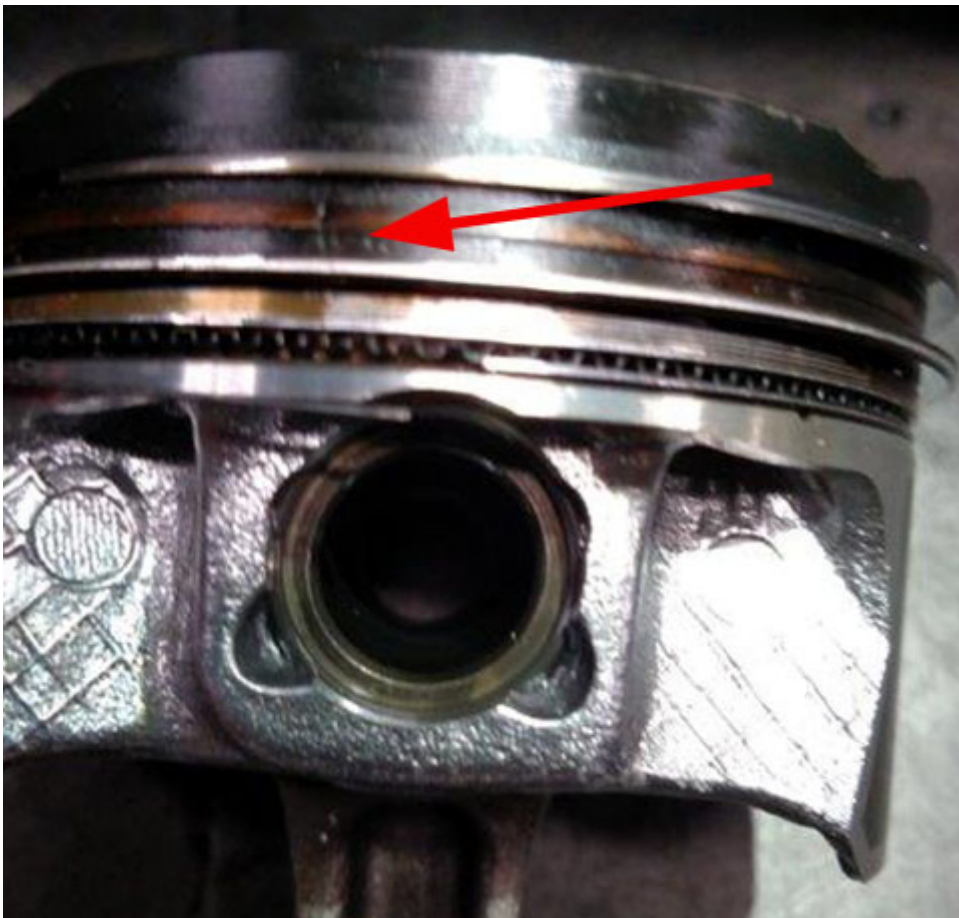
Involved Region or Country	China, Europe, International Operations (GMIO), Korea and North America.
Condition	Some customers may comment on a rough running engine with the Malfunction Indicator Lamp on. Upon inspection, a technician may find DTC P0300 set along with a misfire and low compression in one or more cylinders.
Cause	This condition may be caused by a damaged piston requiring replacement of all four piston and rod assemblies with an updated part number.

Shown below are examples of pistons with varying levels of damage.

If the cylinder wall surface has not been compromised, replace all four piston and rod assemblies.
