Preliminary Information

PIP5491A Intermittent service 4wd messages displayed in the DIC Models

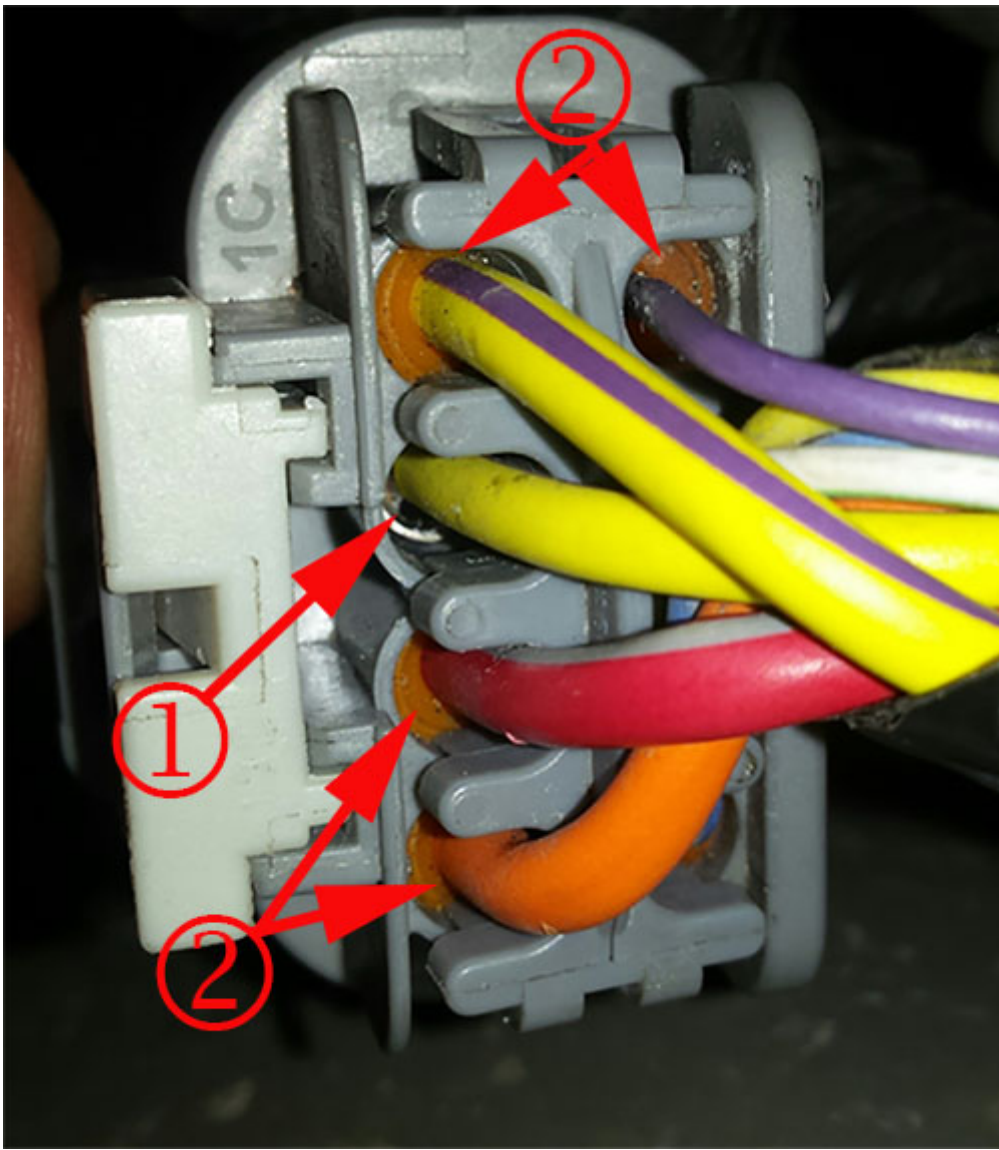
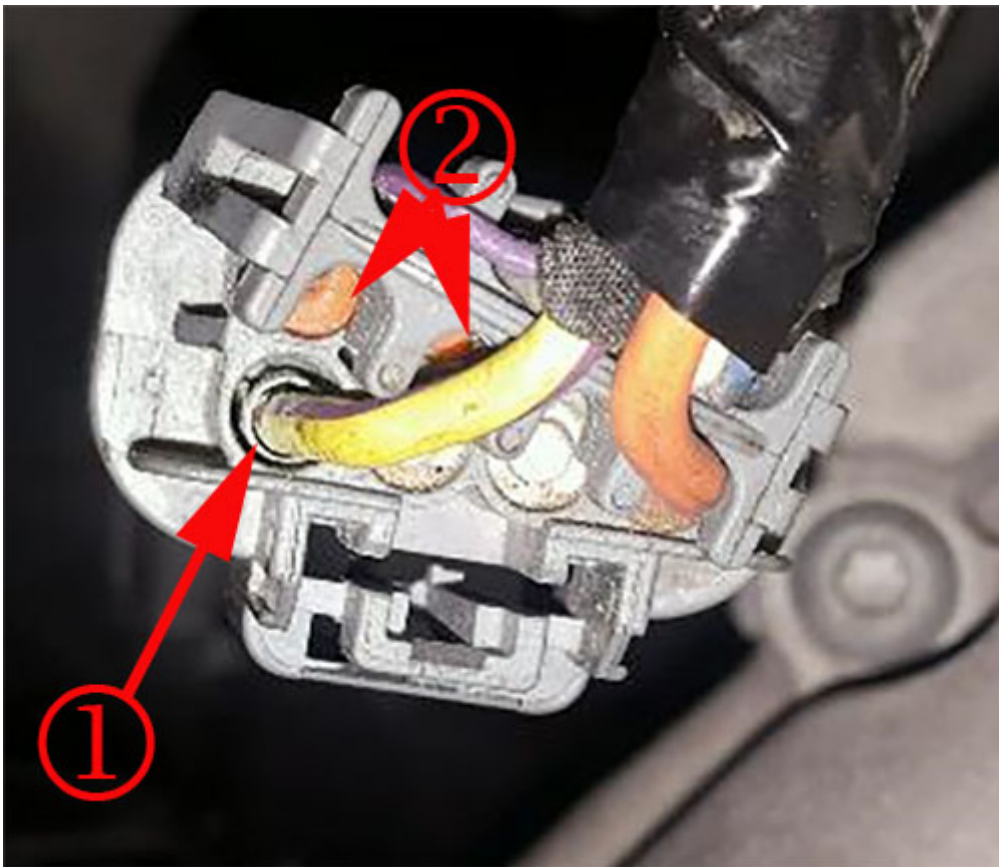
Involved Region or Country	North America
Additional Options (RPO)	NQF NQH NQ6 NPO NG7
Condition	Intermittent Service 4 Wheel Drive message in the DIC
Cause	Wiring terminal issues that could be caused by missing seal around the wire.

When diagnosing intermittent transfer case control module DTCs related to signal or circuit integrity including C0321, C0392, C0396, C0398, C0306, C039E, C038D inspect the related connectors and ensure that the seals are properly installed in the connectors. Missing seals allow moisture inside the connector and will cause repeat conditions and or different intermittent conditions. Items number 1 below show missing seals where items 2 show the proper seals.

Some connectors are serviced as a connector, some have terminated leads and some are available as harness only. If there is corrosion in the connector and has to be replaced, the mating side of the connector should also be replaced whether it is another connector or electrical component. Example if the connector at the transfer case actuator is replaced due to a missing seal and corrosion is present the transfer case actuator should also be replaced. In this instance use the appropriate labor operation for the wiring repair performed and if component replacement is required submit that as net amount.
