# Preliminary Information

## PIP5486F Ticking, Tap, or Rattle Noise From Engine With Possible Misfire DTCs.

### Models

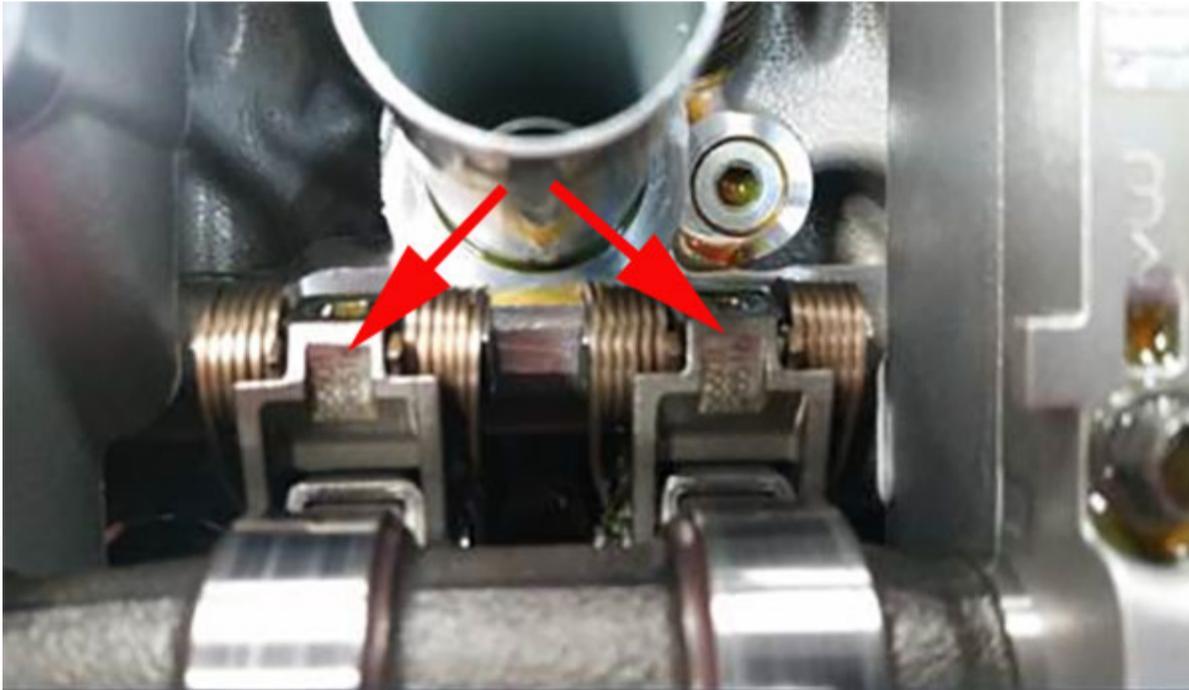
- a) Push down on the rocker end at the SHLA to test for soft or spongy feel. (See below)

c) If soft , spongy, or damaged SHLAs or rockers are found on either the intake or exhaust side of any cylinder it will be necessary to replace all the affected cylinder SHLAs or rockers and retest.

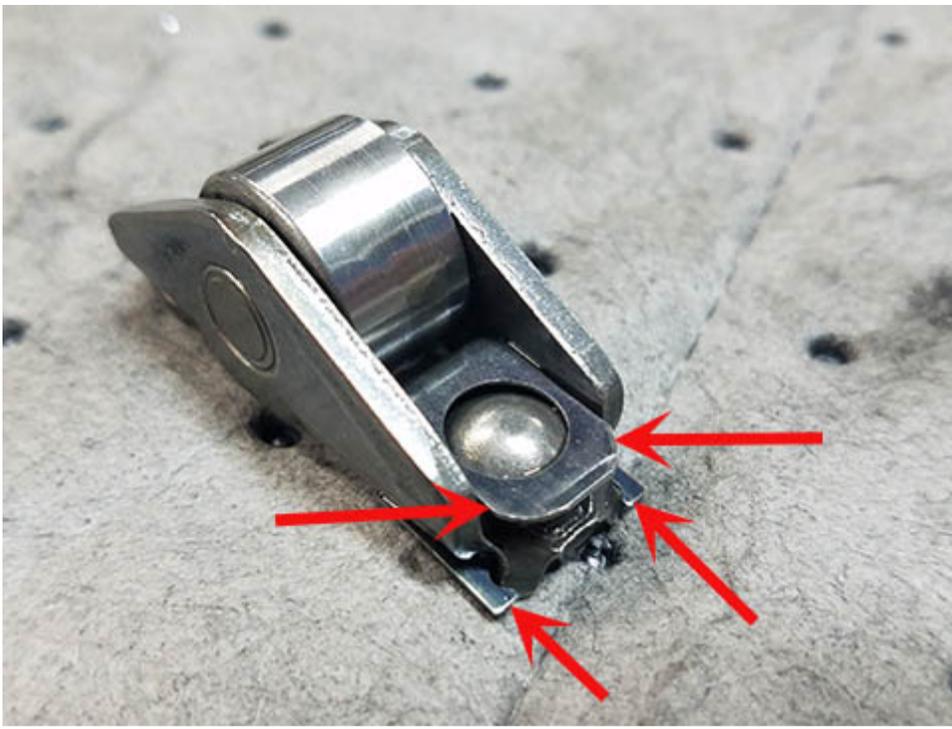
- b) Check for any visible damage to non-AFM rocker clips. (See Below)

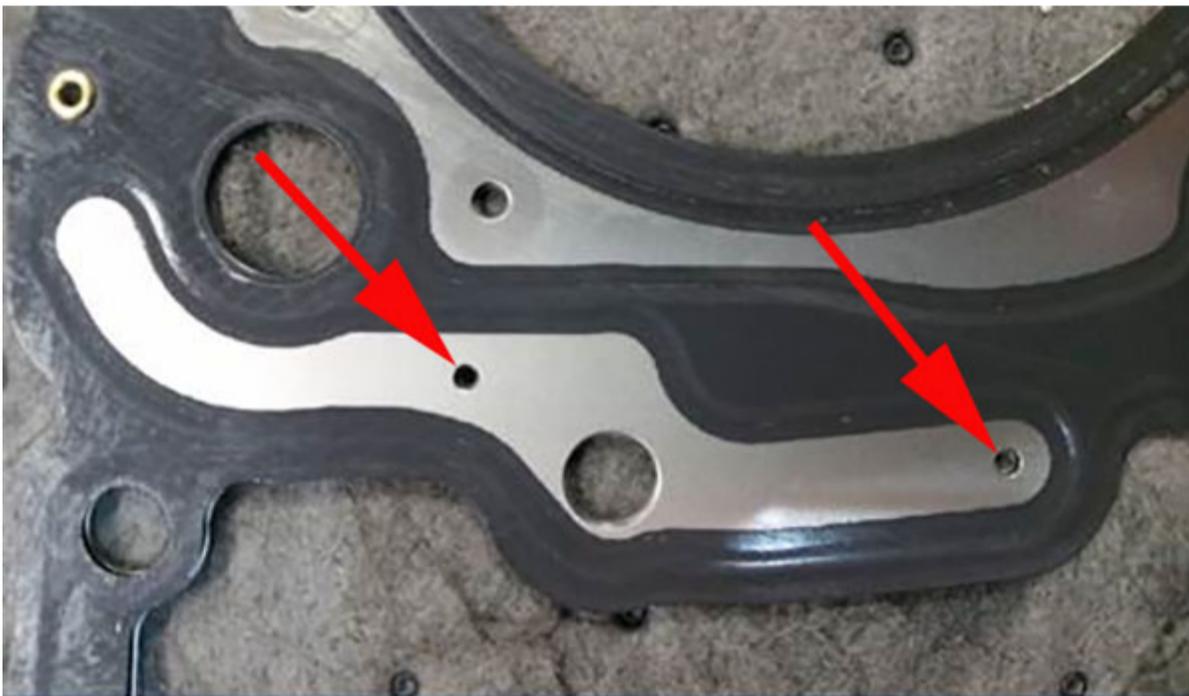
5) If the replacement SHLAs are still spongy it will be necessary to remove the affected head and inspect the head gasket for debris in the oil passages noted below.

a) If debris is found, inspect the camshaft caps for wear or discoloration due to lack of oil.

b) If wear or discoloration is found then replace the cylinder head assembly with camshafts.

c) If there is no wear or discoloration, clean the oil passages and replace the head gasket.

d) Change the oil and filter

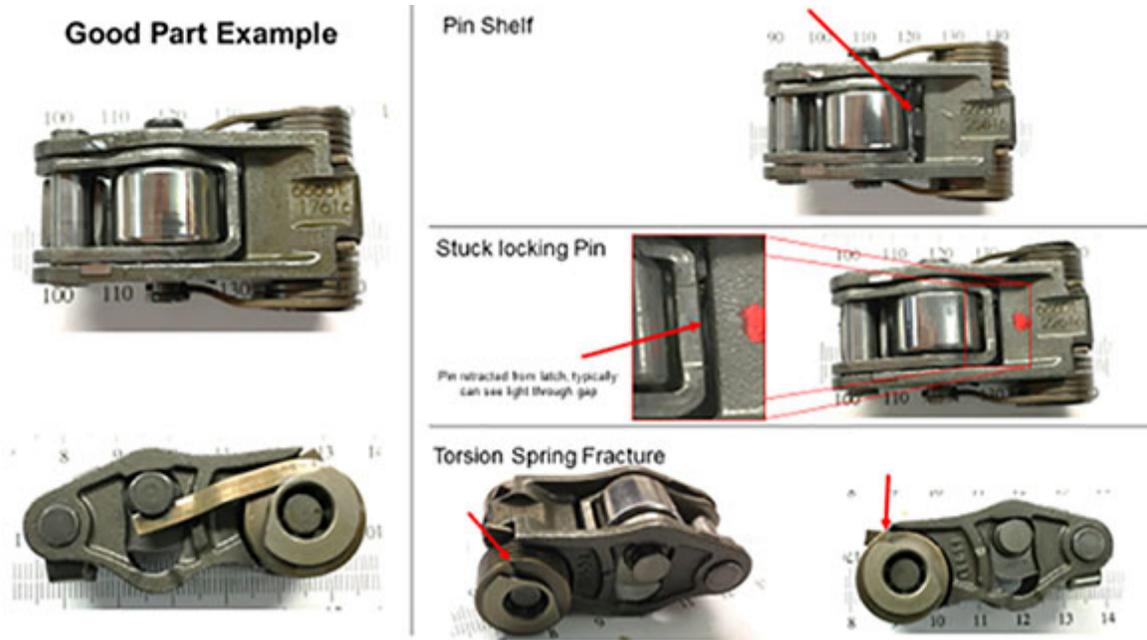
7) Inspect the SRFF' and rocker assemblies for any damage or dislodge.

Below are pictures of possible SRFF failures.

If any one of the SRFF's are damaged it will be necessary to replace all four on the affected cylinder.

For the above conditions engine replacement is not necessary.  
Please perform the repairs for these conditions.

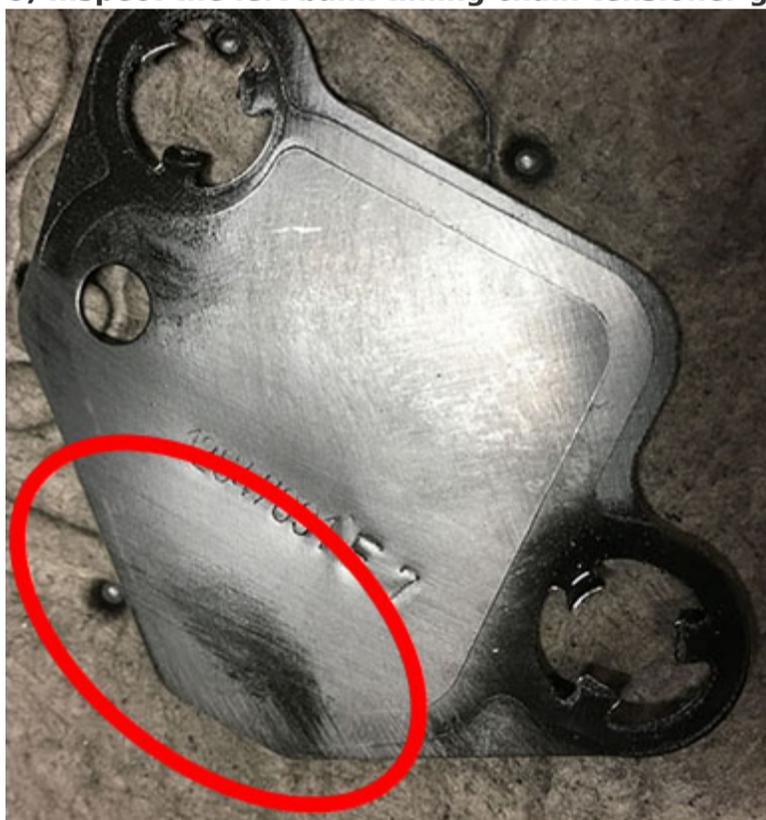
8) Inspect the left bank timing chain tensioner gasket for not sealing correctly. (see below)

Replace the tensioner and gasket if this condition is found.
