PIP5255A P16D0 P0300 Oil Leak Random Misfire Inspect Oil Galley Plugs In Head

Brand:	Model:	Model Years:	VIN:		Engine:	Transmissions:
			from	to		
Chevrolet	Impala	2014 - 2015	All	All	2.5 LKW	All
Chevrolet	Malibu	2014 - 2015	All	All	2.5 LKW	All

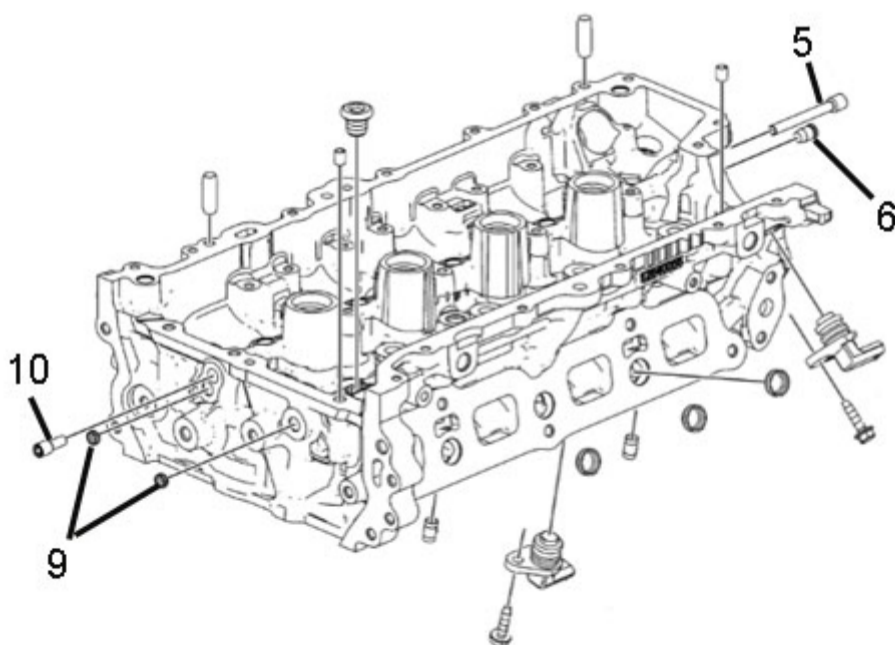
After cylinder head replacement, the head may have an external oil leak, random misfires on all cylinders when camshaft is on low lift with light throttle and/or sets P16D0 P0300.

If code P16D0 and/or P0300 sets, random cylinder misfire on all cylinders only when on camshaft lobe low lift, verify oil galley plug #10 (see illustration below) has been installed. This oil galley plug is located in the head, behind the timing cover and would have an engine oil leak that is internal of the engine.

If the head has an external oil leak, verify oil galley plugs #5 and #6 (see illustration below) have been installed.

Oil galley plugs #9 (see illustration below) should already come installed in the new head.
