### PIP5495G Check Engine Light On With P0299 Or P0234

#### Models

Involved Region or Country:	North America
Condition:	All turbochargers that are returned to the Warranty Parts Center (WPC) are inspected by Engineering for root cause failure. The purpose of this information is to reduce the number of no trouble found (NTF) turbochargers being returned to the WPC by informing the Service Department personnel of what inspections and/or diagnosis to perform, prior to replacing and returning a turbocharger to the WPC. Read the entire bulletin prior to beginning any work.
Cause:	Misdiagnosis Leading to Returned Turbochargers with NTF

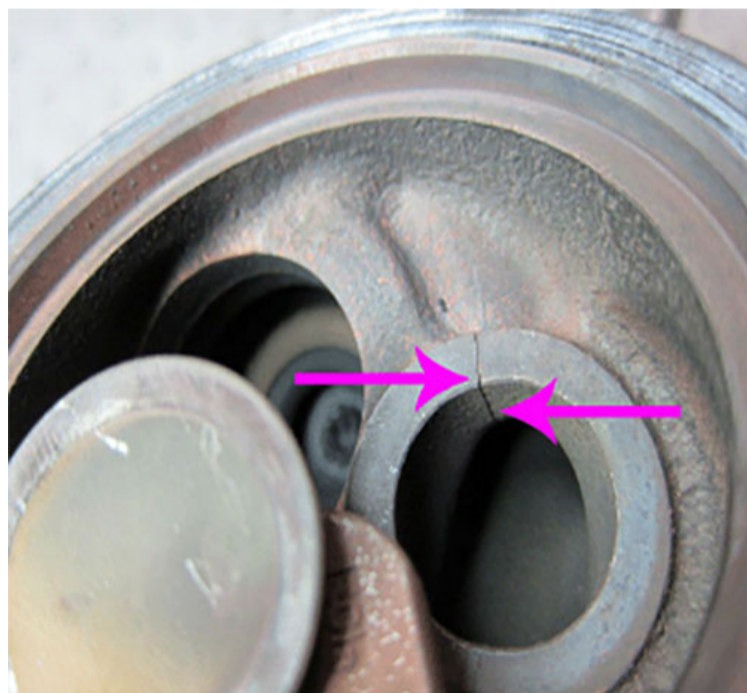
Crack(s) at the wastegate valve port (this is normal and does not affect performance)

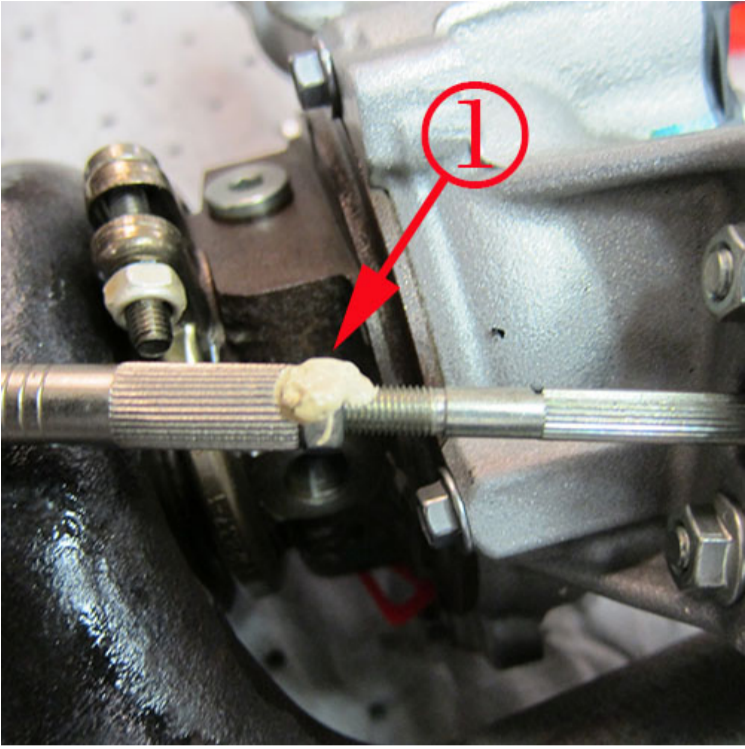
If the tamper paint seal is broken or missing, check the vehicle for any additional sign of modification to the induction, exhaust, or engine calibrations as this may indicate an attempt to adjust the wastegate arm to modify the powertrain operation.

If found, review the powertrain warranty status with your service manager prior to performing repairs

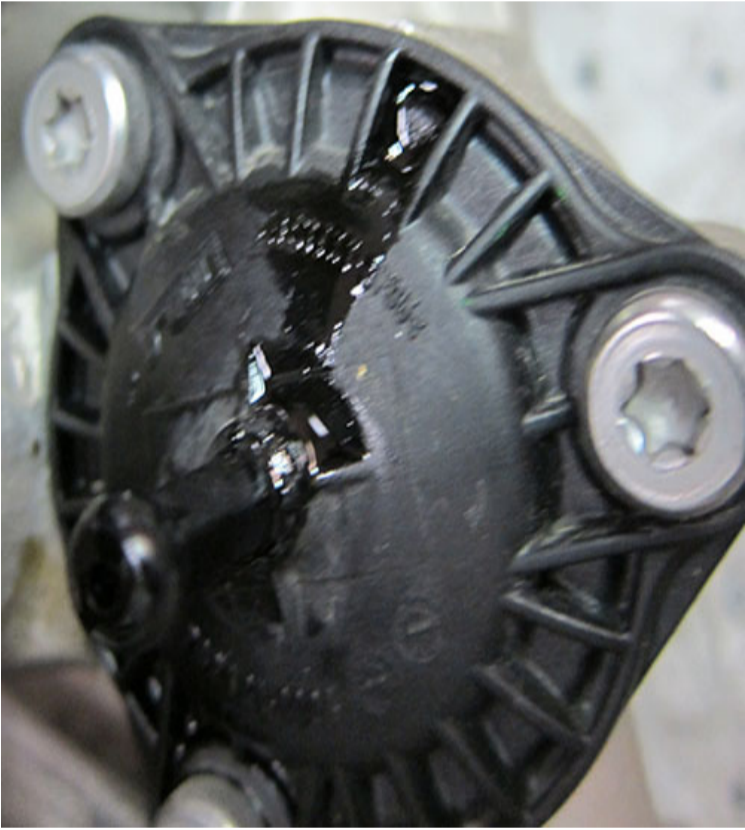
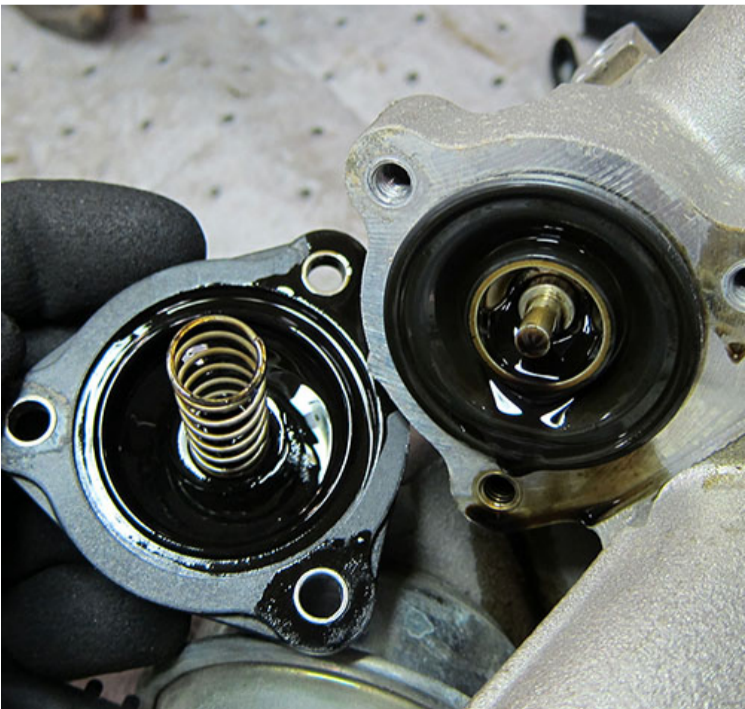
Bypass (recirculation) valve cover port broken or water/oil found inside the valve (clean the components, if necessary replace bypass (recirculation) valve assembly - released for service)

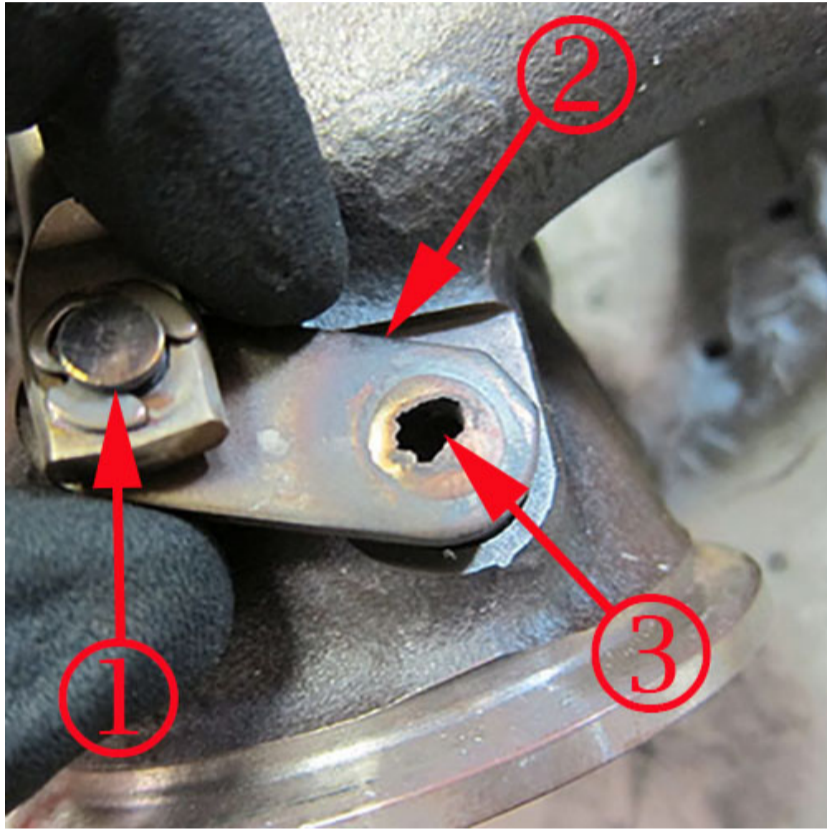
Disconnected wastegate lever arm (crank) (2) from the shaft (3).

Disconnected wastegate lever arm pin (1) from the lever arm (crank) (2).

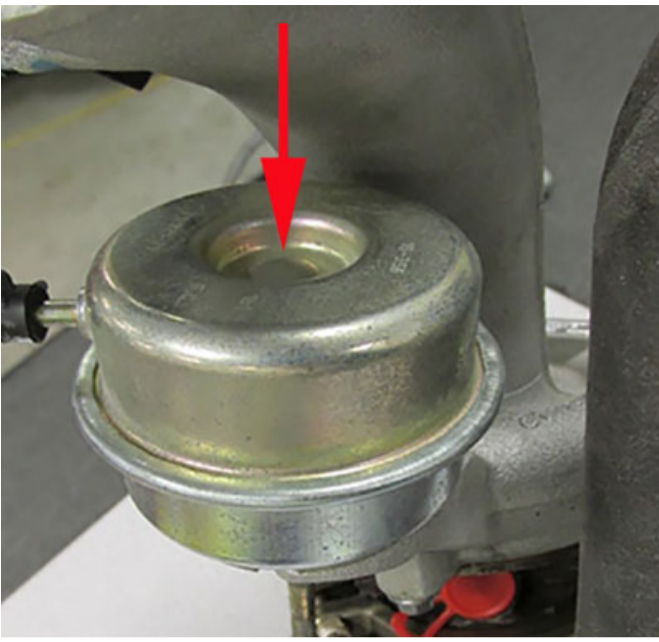
The original equipment wastegate actuator found on 2011 and 2012 model years shown below, has a recessed stop at the head of the actuator.

Original equipment actuator is found on 2011 and 2012 model years.

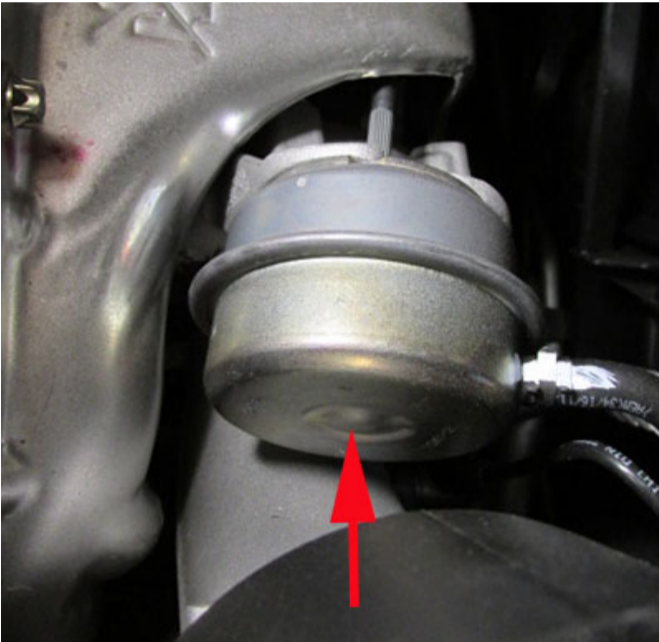
The updated design actuator shown below has a stop that is not recessed and allows 5mm more travel in the closed direction.

With this updated design, it is very unlikely that an insufficient preload issue exists.

Updated design.

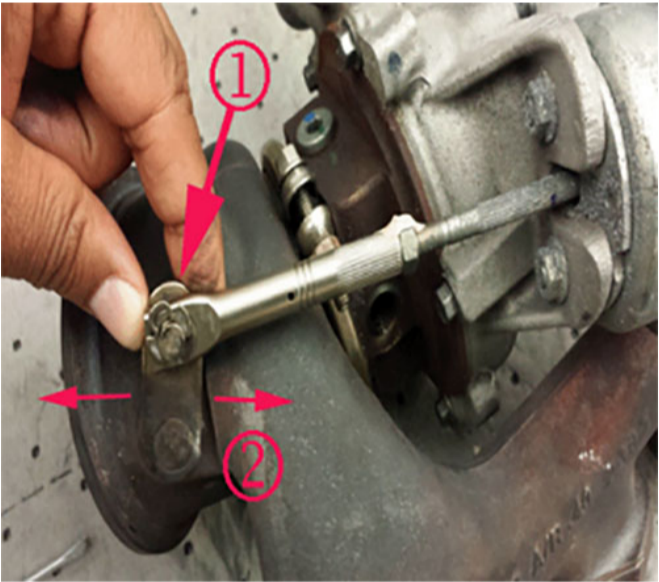
Wastegate Preload Inspection.

Wastegate lever arm (1) moves with little effort in the direction as shown (2) while the actuator rod remains static, see picture below "Wastegate Preload Inspection".

If the lever wiggles with little effort while the actuator rod remains static, the pre-load is insufficient and the turbocharger must be replaced.

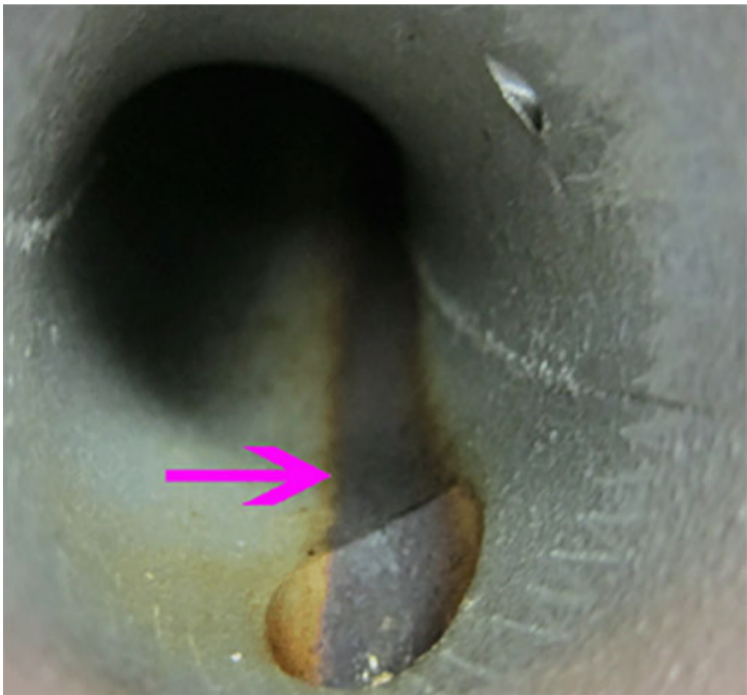
Notice: The view shown below indicates NORMAL oil staining in the turbocharger outside air inlet. This dry stain does not represent an oil leak.

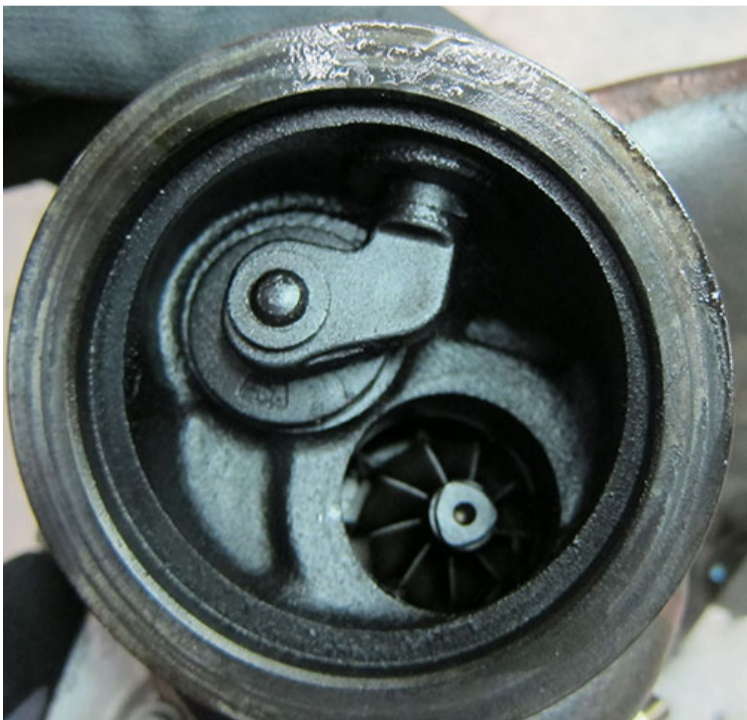
Inspect for the presence of oil in the exhaust system.

If oil is present in the exhaust system, then inspect the turbocharger turbine and compressor wheels to be sure that they are not broken off.

It is very unlikely that the turbocharger will leak oil internally if the turbine and compressor wheel shaft is not broken.

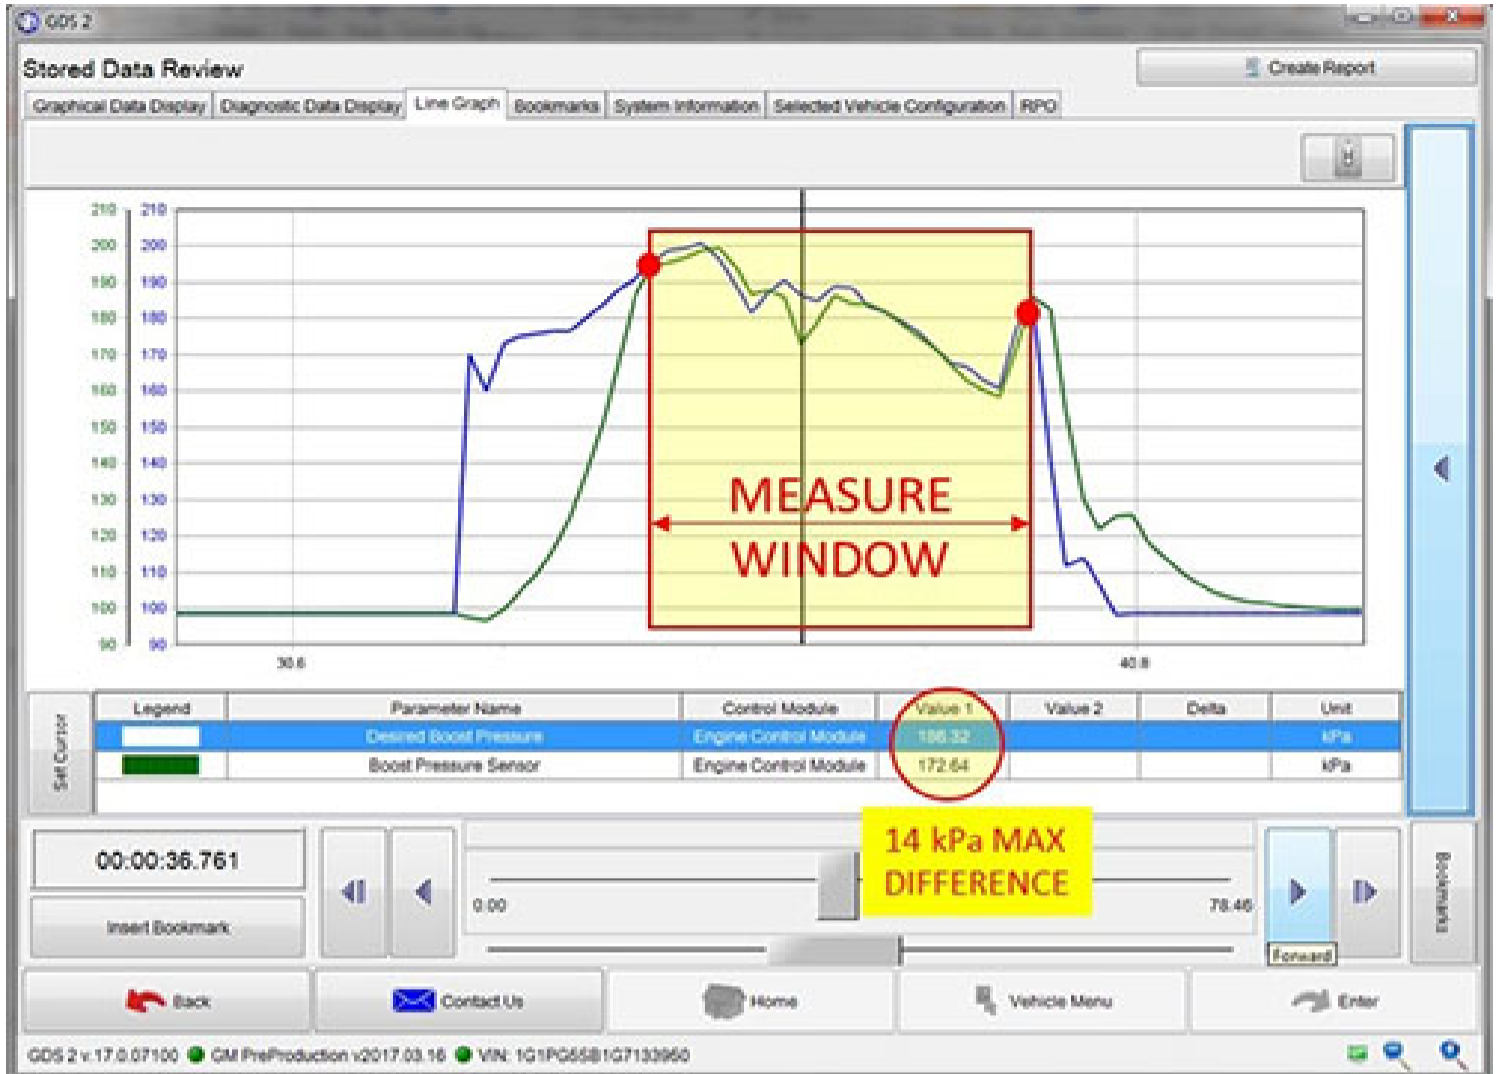
Example of normal turbocharger wastegate operation:

In this example, notice that the measure window begins once the Boost Pressure Sensor reading (Green) meets the Desired Boost Pressure reading (Blue) and ends when the APP is released per the testing instructions.

The Boost Pressure Sensor reading (Green) closely tracks the Desired Boost Pressure reading (Blue) indicating normal Turbocharger
