### PIP5416C Instrument Panel Cluster (IPC) Warning Lamps And / Or MIL Are Illuminated Diesel Exhaust Fluid (DEF) Message Displayed Various DTCs Set (Inspect Wiring Harnesses for Chafing).

Brand:	Model:	Model Years:	VIN:		Engine:	Transmissions:
			from	to		
Chevrolet	Colorado	2016 - 2018	All	All	2.8 LWN	All
GMC	Canyon	2016 - 2018	All	All	2.8 LWN	All

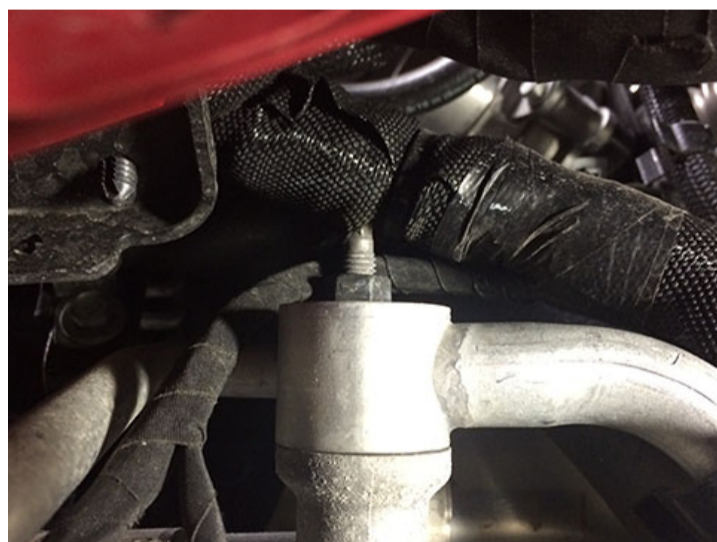
Air Conditioning (AC) compressor, AC compressor suction and discharge line manifold, AC line and AC compressor clutch.

Concerns in the area of the AC compressor, lines or suction / discharge pipes may cause:

The Check Engine Light to illuminate.

The Driver Information Center (DIC) may display a reduced power message or service power steering message.

The engine to run rough.

The Service Four Wheel Drive (4WD) Light or Stabilitrak light may illuminate.

A possible extended crank or a crank no start.

The oil pressure gauge may read erratically or read no oil pressure.

The Air Conditioning (AC) may not cool or blow hot air.

An open fuse in the Underhood Bussed Electrical Center (UBEC)

DTCs associated with chaffing in this area include:

B127E, C0306, C0321, C0398, C0800, P0071, P0072, P0117, P0119, P0340, P0341, P0406, P0483, P0522, P0628, P0641, P06A3, P0700, P20BB, P20BF, P227E, P24B1, U0073, U0077, U0121, U0131, U0140, U0151, U0415, U2099, U0401, U0415 and U0420.

If you encounter these scenarios, inspect, repair (as necessary) and route the wiring harness away from these possible chafe points.

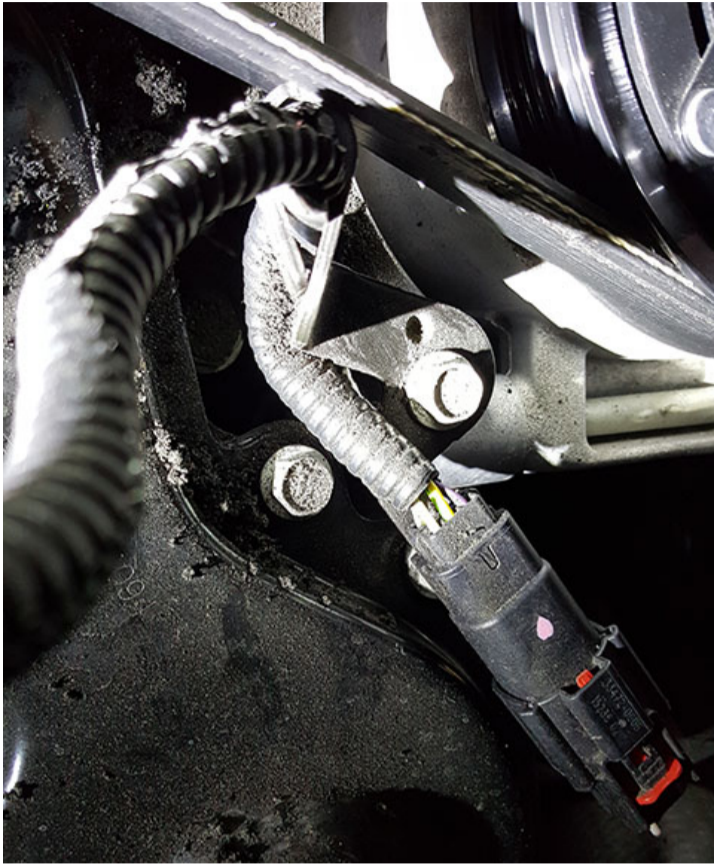
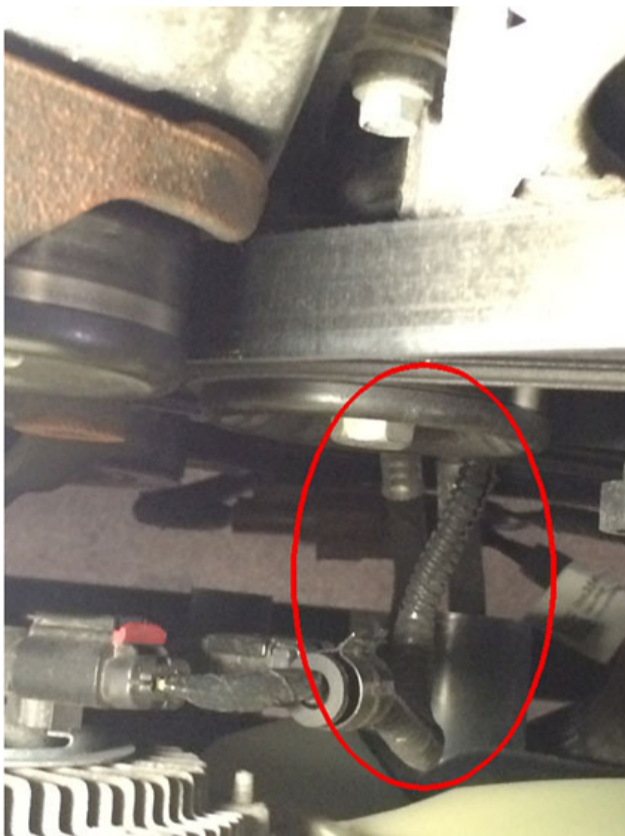
Serpentine Belt. The fan clutch wiring harness support bracket may be out of position allowing the harness to rub on the belt.

Concerns in the area of the serpentine belt may cause:

Various IPC warning lights to illuminate.

A crank no start concern.

The check engine light to illuminate.

The engine may run rough or misfire.

The Service Four Wheel Drive (4WD) light may illuminate.

The Stabilitrak light may illuminate.

The Air Conditioning (AC) may not cool or may blow hot air.

DTCs associated with chafing in this area may include:

C0273, P0526, P0480, P0336, P0526, P0641 and P0651.

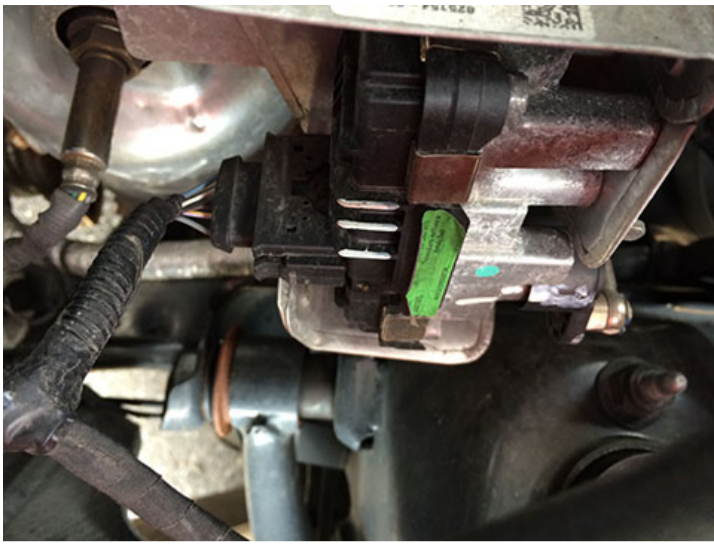
Turbocharger Vane Position Actuator Connector

Concerns with loose terminals or connector not fully seated at the Turbocharger Vane Position Actuator may cause:

The Check Engine Light to illuminate.

The Driver Information Center (DIC) may display a reduced power message.

The vehicle may have a low power concern.

DTCs associated with a loose connector or terminals include:

P0045 or P2599.
