Preliminary Information

PIP5390F Malibu 5ET50 (MKE) Hybrid Transmission Restriction Program

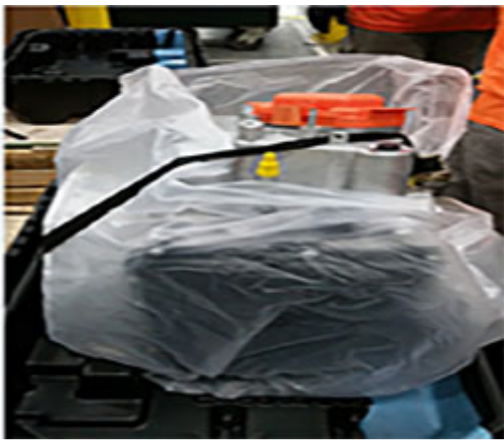
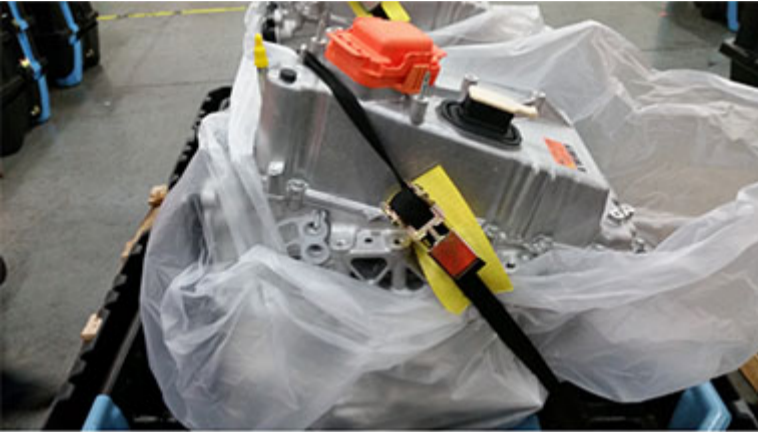
Please make sure that you are strapping the transmission down. Most of the transmissions are being returned have sustained damage from shipping.

Position the strap as shown in the pictures below and tighten with the ratchet.
