Technical Service Bulletin

GROUP CAMPAIGN	NUMBER 18-01-032
DATE OCTOBER 2018	MODEL(S) SONATA (LF)

SUBJECT: SONATA ENGINE DTC P1326 - WIRING INSPECTION /
INSTALLATION AND ENGINE REPLACEMENT
(SERVICE CAMPAIGN T3G)

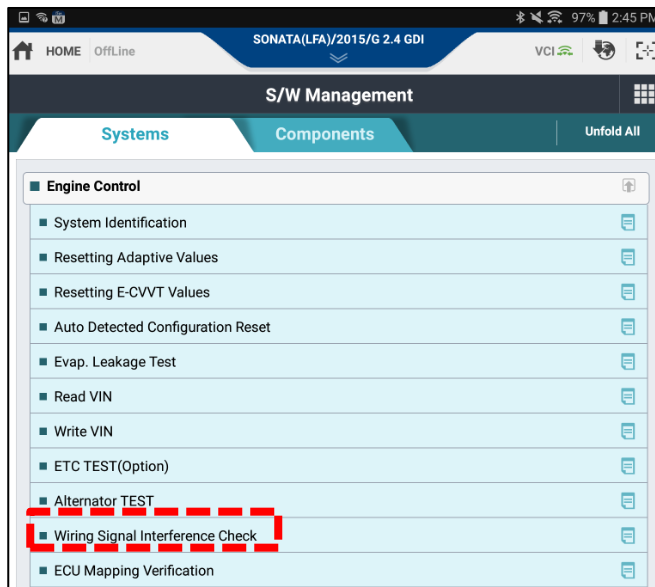
2. From the GDS main screen, navigate to **S/W Management > Engine Control** and select **Wiring Signal Interference Check**.

If the engine is seized or knocking and the wiring signal interference inspection cannot be completed:

- Submit a PA request for engine replacement with a GDS screenshot showing the VIN # and DTC P1326. When approved, replace the engine with service kits.
- Perform the wiring inspection after engine replacement.

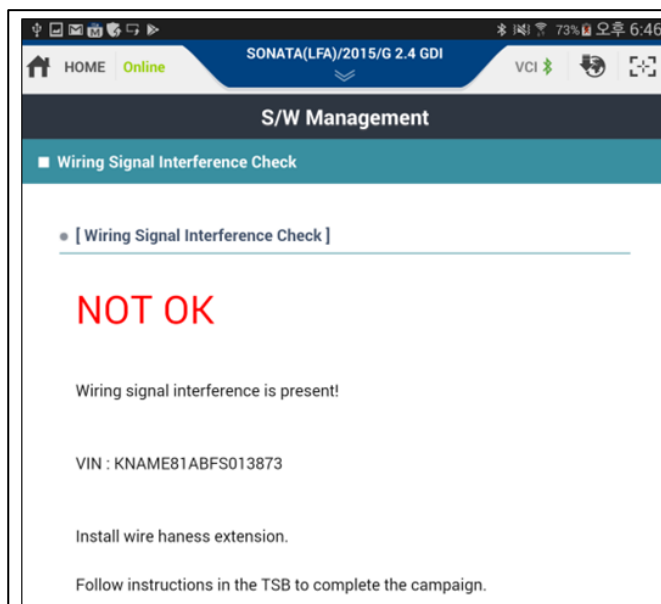
3. Follow the prompts on the GDS to complete the inspection. At the conclusion of the inspection, take a screenshot of the results screen.

If the inspection result is NOT OK:

- Submit a PA request for engine replacement with attachments of:
 - 1) Inspection results screen
 - 2) GDS screenshot showing the VIN # and DTC P1326
- When approved, replace the engine with service kits.

- Install the new wire harness extension kit.

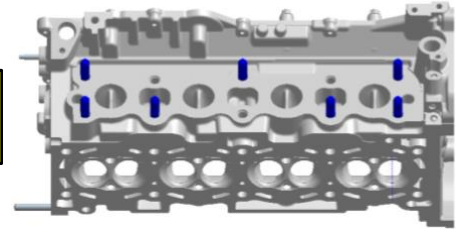
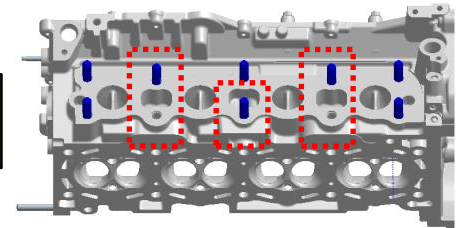
4. **For 2.4L with ULEV / FED emissions only**
2.4L replacement engines are produced with the exhaust manifold studs configured for SULEV / CAL emissions package.

Two exhaust studs must be relocated on the new engine and 1 exhaust stud must be transferred from the old engine.

- Use a commercially available stud removal tool or use the double-nut technique to complete this step.
