GROUP Product Improvement	MODEL 2015MY Sorento (XMa) Optima (QF) 2014-2015MY Optima (TF) Sportage (SL)
	NUMBER PI1802W/X	DATE October 2018
PRODUCT IMPROVEMENT CAMPAIGN		
SUBJECT: ENGINE REPLACEMENT INSTRUCTIONS FOR DTC P1326 (PI1802W/X)

This bulletin provides information related to the Technical Service Bulletin previously published in July 2018 ([PI1802](#), Rev 2, 09/24/2018) titled "Knock Sensor Detection System - ECU Logic Improvement". Specifically, this bulletin provides instructions on which procedures to follow if, after installation of the KSDS, any one of the subject vehicles below returns to the dealer with Diagnostic Trouble Code ("DTC"), P1326.

If DTC P1326 is present, first check for any wiring signal interference following the procedure set forth below before determining whether an engine replacement is necessary. Based on the results of the Wiring Signal Interference Check, dealers are to perform either the Knock Sensor Wiring Repair or the Engine Long-Block Replacement according to the procedures in this TSB.

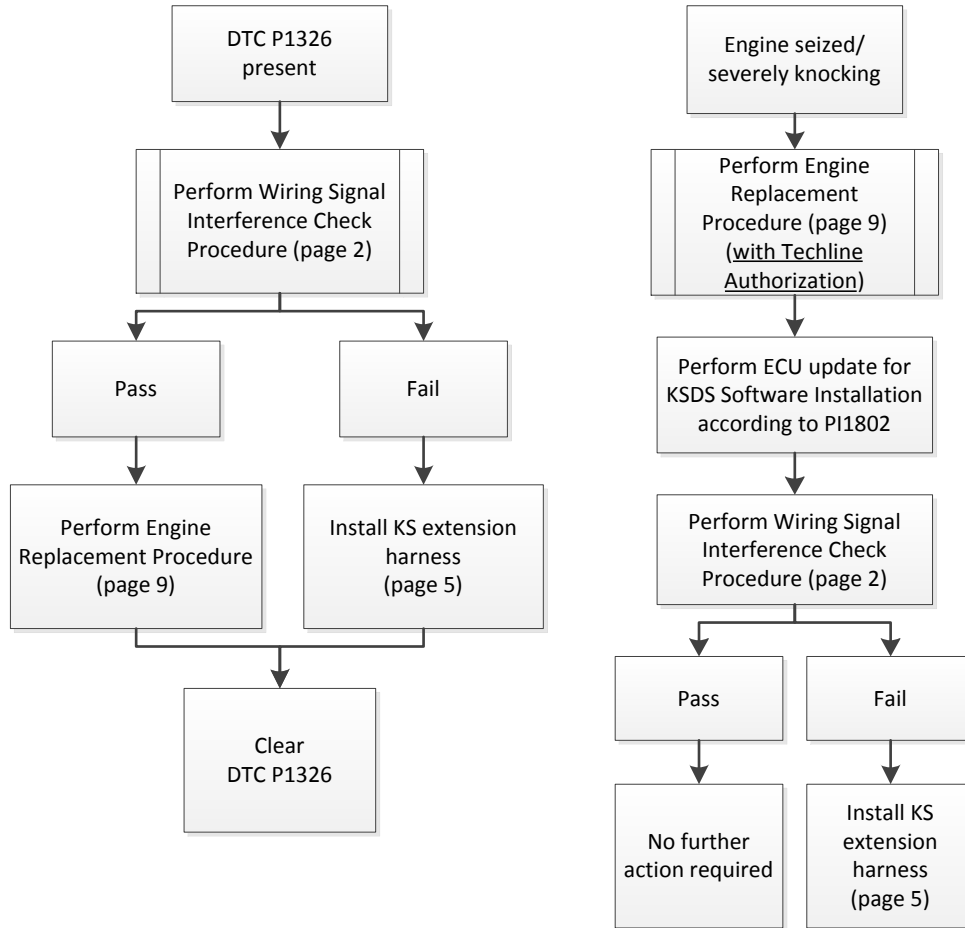
Flow Chart:

If the vehicle's engine is already seized or severely knocking, dealers are to perform the Engine Long-Block Replacement **and** the Wiring Signal Interference Check according to the procedures in this TSB.

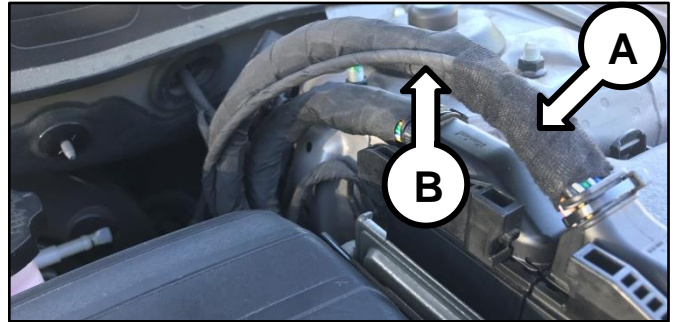
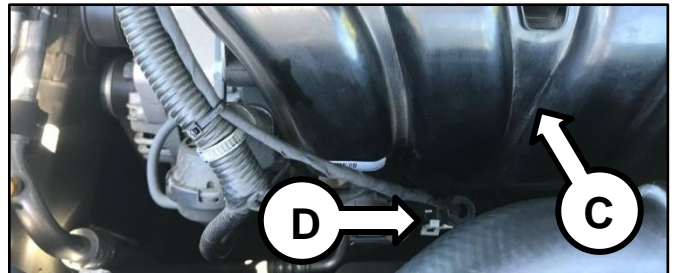
1. Inspect the ECU harness (A) and verify if the Knock Sensor wiring extension harness (B) has previously been installed.

NOTE: To identify the extension harness (B), look for an external harness (B) which should be cable-tied to the existing wiring harness (A) leading by the intake manifold (C) to the knock sensor (D), as shown.

- If the extension harness (B) has been installed, no further action is required.
- If the extension harness (B) has not been installed, proceed to the next step.

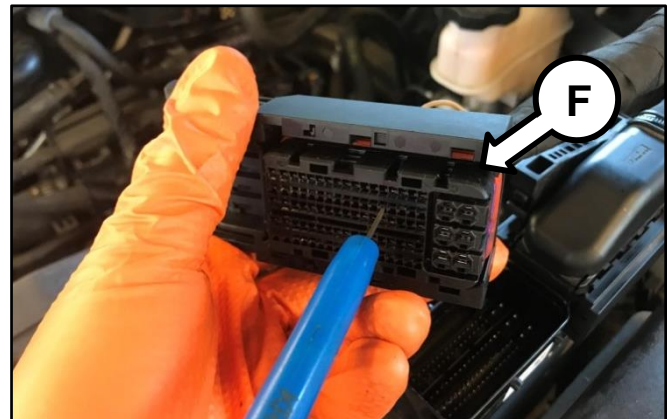
9. Remove the three (3) terminals **one at a time** and insert the new terminals of the extension harness into the ECU connector (F). Reinstall pin retainer (K) and reassemble the connector (F).

Be sure to note the rotational position of the terminals during removal. They are directional and need to be reinstalled in the same “clock” position.

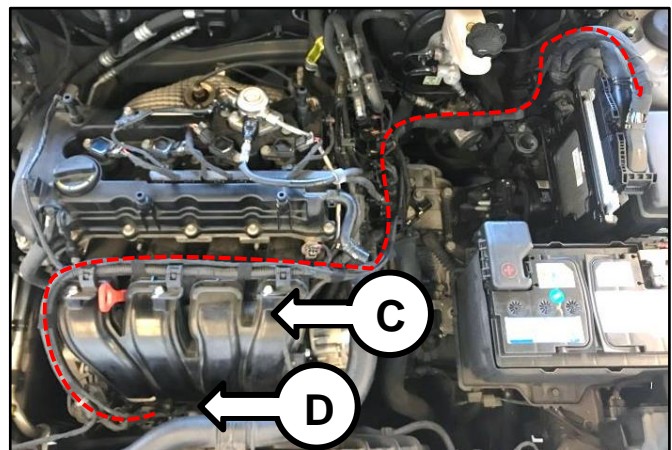
10. Route the extension harness (B) along the existing harness (A) leading by the intake manifold (C) to the knock sensor (D), as shown.

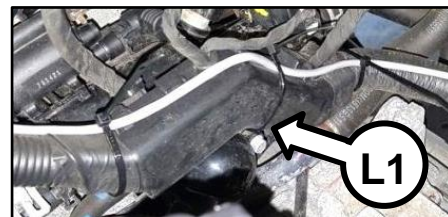
The harness (B) must be routed above and secured to the harness protector (L1) and UNDER the Breather Hose (L2) and Camshaft Position Sensor (L3).

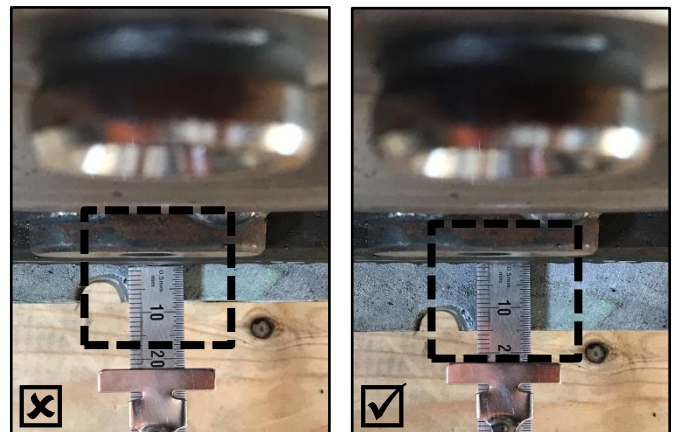
- If the torque converter has moved from the fully inserted position, carefully push inward while rotating the torque converter until it is recessed approximately 9/16 – 5/8" (14 – 16mm) (☑) into the transaxle case when reinstalling the automatic transaxle.
