**WJ54 - Checking Side Window and Replacing it if Necessary (Workshop Campaign)**

Vehicle Type: **911 Carrera (991)**

Model Year: **As of 2018 up to 2019**

Subject: **Moulding for side window**

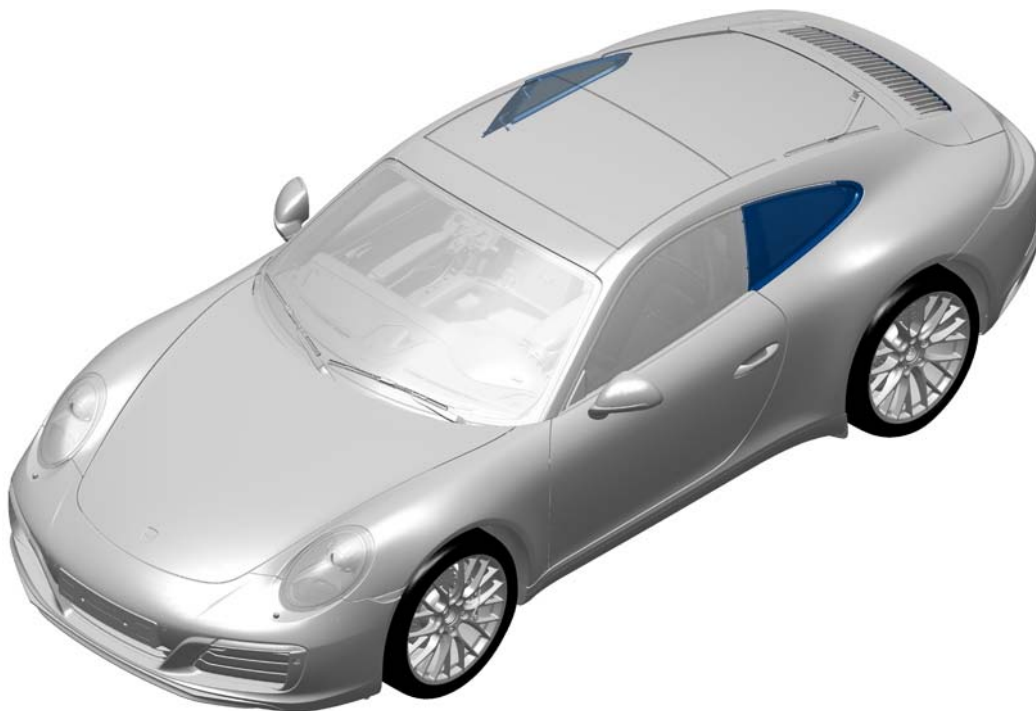
Concern: **There is a possibility that the wrong lubricant was used for fitting the side windows.**  
 If this is the case, there may be a chemical reaction and this will damage the coating on the moulding.

*Installation position of side window*

Remedial Action: Check side window in the C-pillar area and replace it if necessary.

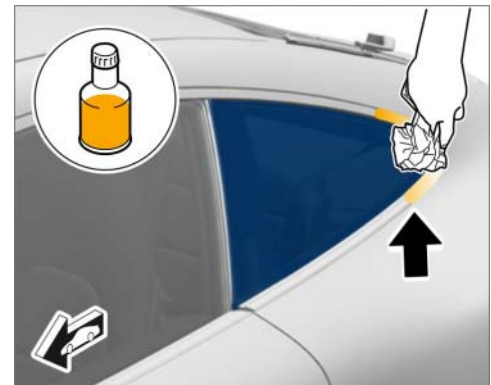
*Cleaning side window*

- Work Procedure: 1 Clean both mouldings in the marked area ⇒ *Cleaning side window -arrow-* on the side window using a clean cloth and isopropanol and leave them to dry off.
- 2 **Illuminate mouldings** in the marked area using a shop light and **check** for discolouration or signs of damage on the coating of the mouldings. Assess the surface quality in accordance with the limit sample catalog ⇒ *Checking and assessing moulding.*

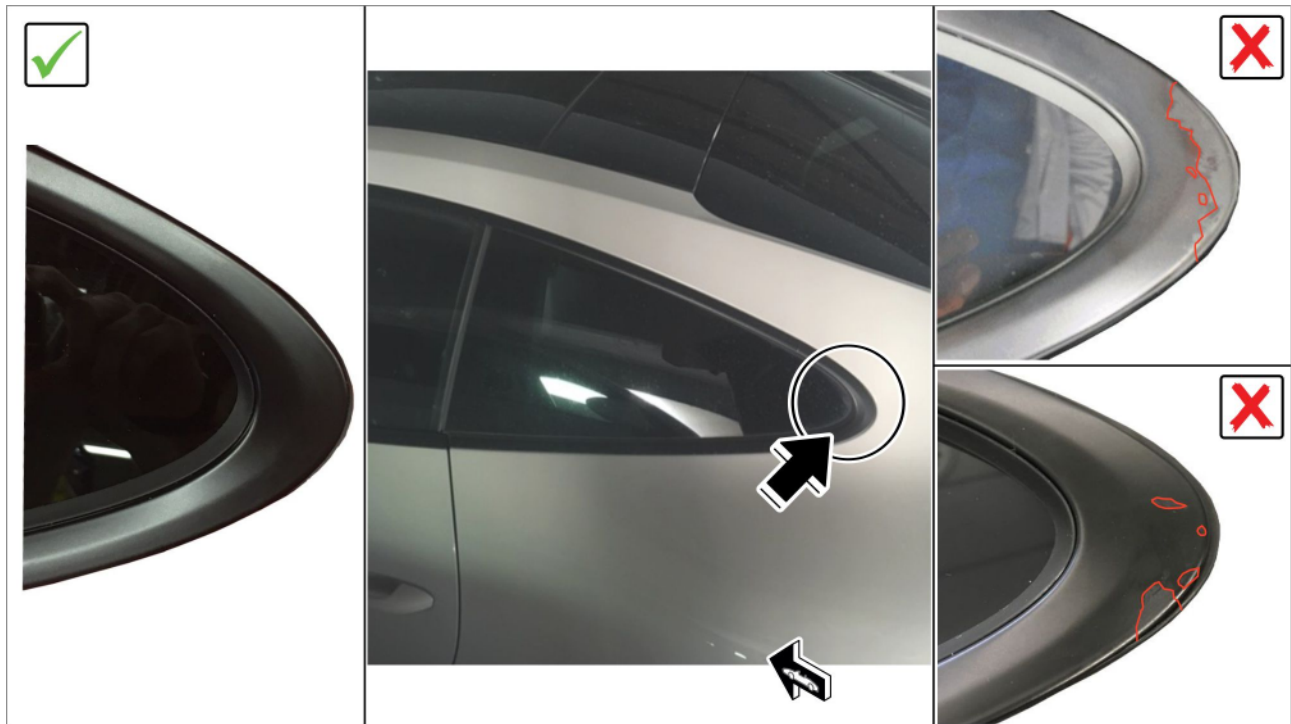
Checking and assessing moulding

Assessment		Action required
(✓)	No imperfections in the coating. <ul style="list-style-type: none"> <li>No dissolution of the coating.</li> </ul>	<b>End of action required.</b> ⇒ Continue with <b>Step 4</b> [Invoicing: <b>Scope 1</b> ]
(x)	Clear imperfections in the coating. <ul style="list-style-type: none"> <li>Clear dissolution of the coating.</li> <li>Surface faults immediately visible without illumination.</li> </ul>	Replace side window. ⇒ Continue with <b>Step 3</b> [Invoicing: <b>Scope 2-4</b> ]

3 Replace side window at the left/right in accordance with the previous check. For instructions, see: ⇒ *Workshop Manual '647519 Removing and installing rear side window (Coupé)*.
