**Small Cracks at Edge of Tail Lights**

Model	Model Year	Model Type	VIN Range	Vehicle-Specific Equipment
Cayenne	2019	9YA	N/A	N/A

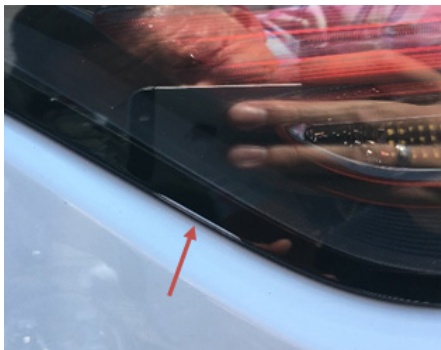
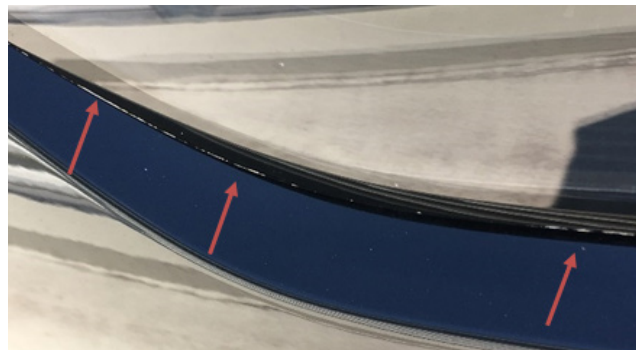
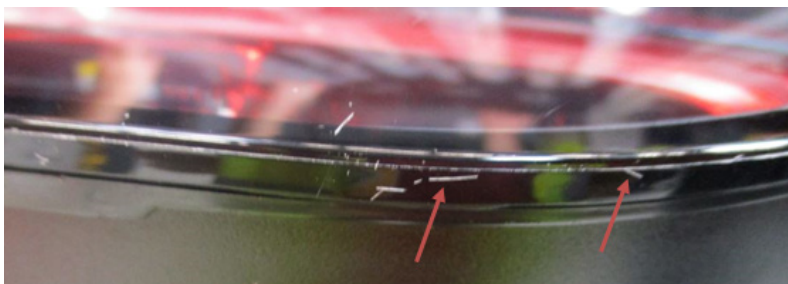
A customer may notice that the tail light (left, right or center sections) may have small cracks along the edge where it meets the body. These cracks can produce what looks like a shiny line at the edge of the tail light.

Slight variations in the molding process are causing this phenomenon. Porsche is currently working closely with the supplier to improve the processes and eliminate the possibility of these issues occurring.

The issue is cosmetic and does not affect the function of the tail light. Do not replace tail lights for this issue at this time. Improved parts are not available yet. Only replace tail lights for functional issues at this time.
