# TECHNICAL BULLETIN

03 OCT 2018

Update Prior to Sale: Hood Release Cable May Not Function Correctly

MODEL:	MODEL YEAR:	VIN:
Discovery (LR)	2017-2018	000184-077150

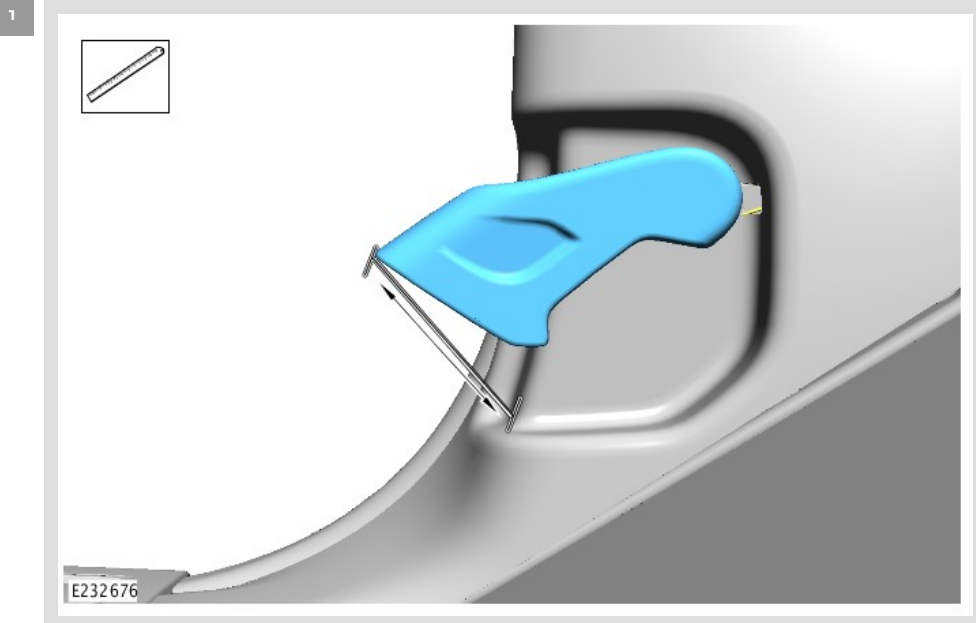
Open the hood and use a steel rule or similar engineer's scale to record the distance the interior release lever travels to operate the hood latches.

- If the hood interior release lever does operate the hood latches, the hood can be opened, and the distance is less than 120mm, release the vehicle.
  - No further action required.
- If the hood interior release lever does operate the hood latches, the hood can be opened, and the distance is more than 120mm, go to Step 5.
- If the hood interior release lever does not operate the hood latches and the hood cannot be opened, go to Step 2.
