LTB01211NAS2

TECHNICAL BULLETIN

Carbon Fiber Hood Delamination

MODEL:	MODEL YEAR:	VIN:	APPLICABILITY:
Range Rover Sport (LW)	2018 Onwards	181339 Onwards	Vehicles With: SVR

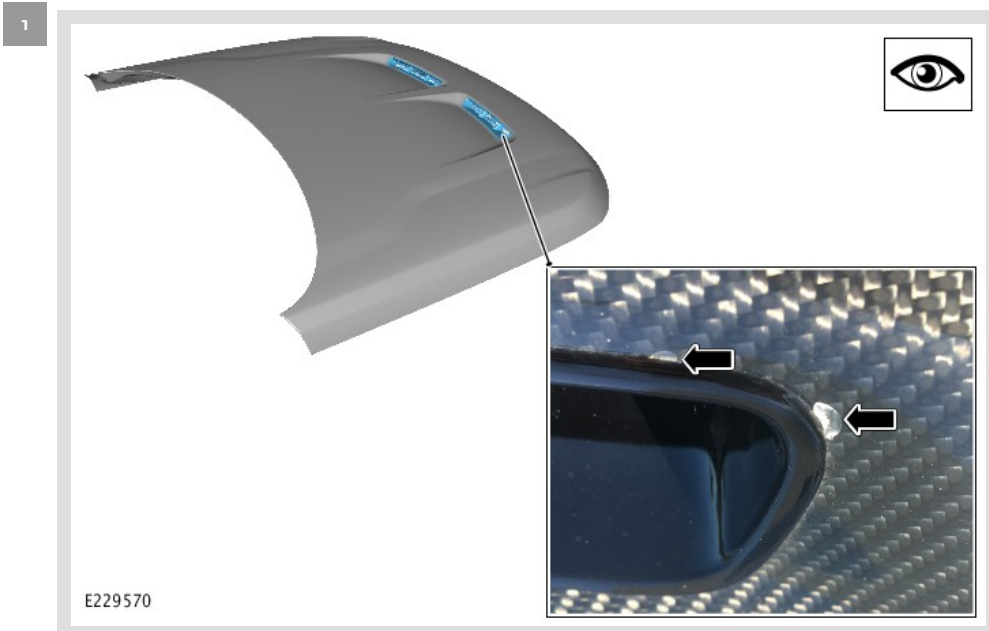
On vehicles with a carbon fiber hood, the area surrounding the hood vents on the carbon fiber hood may be delaminating.

This may be caused during hood vent installation where the hood vents lift the laminate away from the hood.

Inspect the hood for delamination in the area surrounding the hood vents.

- If similar delamination on the hood in the area surrounding the hood vents is not evident, go to the Workshop Procedure below and perform **Steps 1 and 14 only**.
- If similar delamination on the hood in the area surrounding the hood vents is evident, go to the Workshop Procedure below.
