L73X-  
A.03.18

Official After Sales Network  
Wheel badge upgrade  
March 9, 2018  
4

Wheel badge upgrade

1) Aventador Coupe and Roadster; 2) Aventador S Coupe and Roadster.

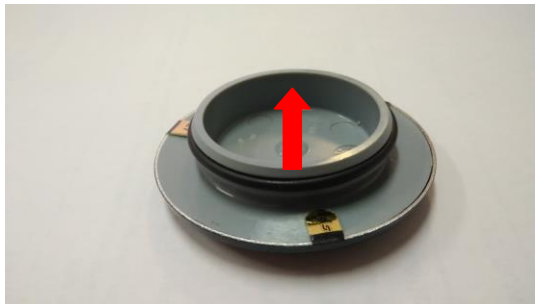
- Remove the old O-ring, pulling in the direction of the arrow.

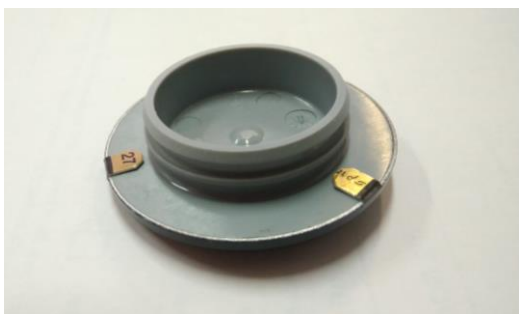
- New configuration (wheel badge without O-ring).
