L62X-A.05.18

Bracket protection upgrade

Huracan Coupè and Spyder

As a result of the continuous monitoring of the product, Automobili Lamborghini Spa found that some vehicles could have been produced without the protection of the ABS and ESP control unit mounting bracket.

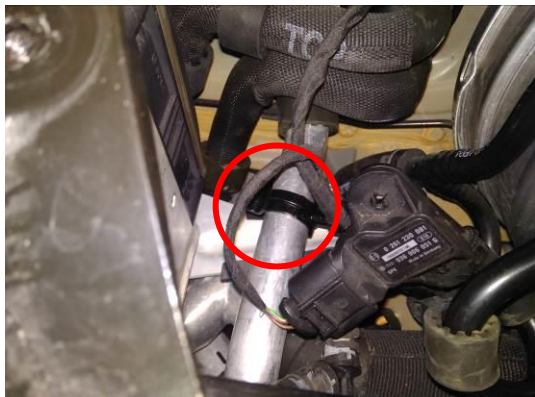
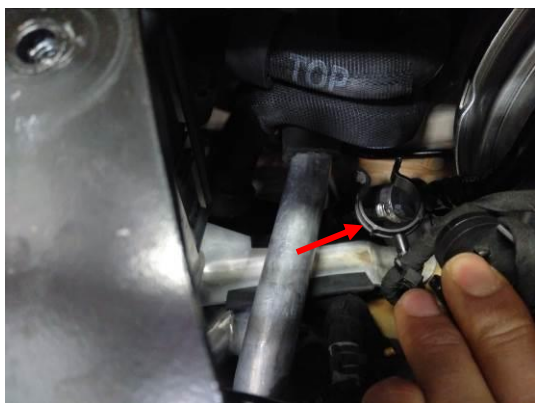
22. Disconnect the pipes from their fixing clip.

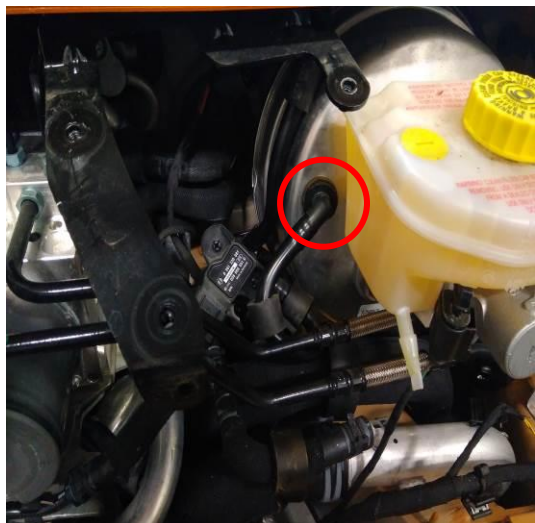
23. Disconnect the pipe.

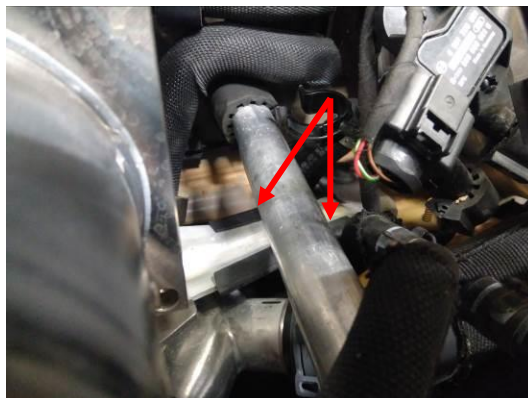
24. Remove the old protections.
