L62X-A.06.18

TSU Update

Huracán

2018

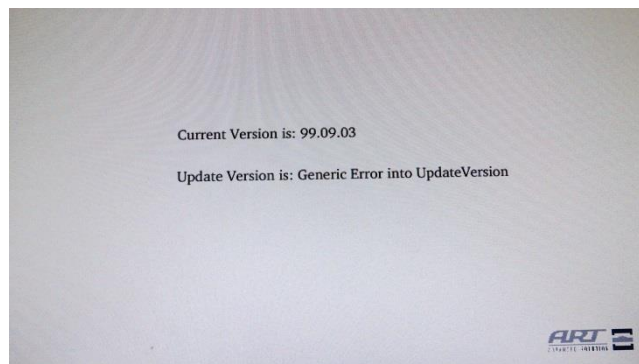
- A. During TSU update procedure, if the following page is shown in MMI display

Quit from “TSU Engineering Menu”, remove the USB memory stick from USB port and then switch ignition Off.

Then switch again ignition On, insert again USB stick into USB port and access again into TSU Engineering Menu.

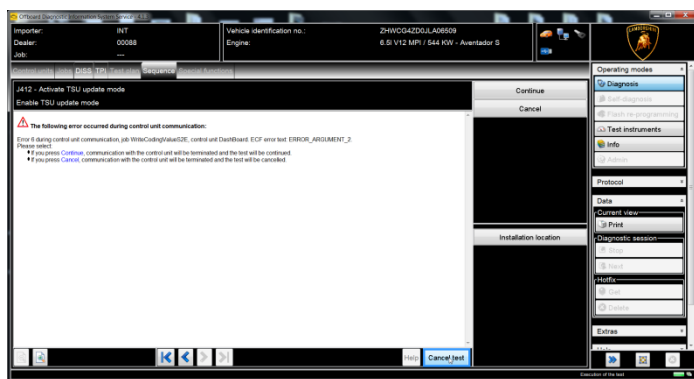
- B. If the following error page is shown, you shall abort the procedure clicking on “Cancel Test” and contact the Technical Support.

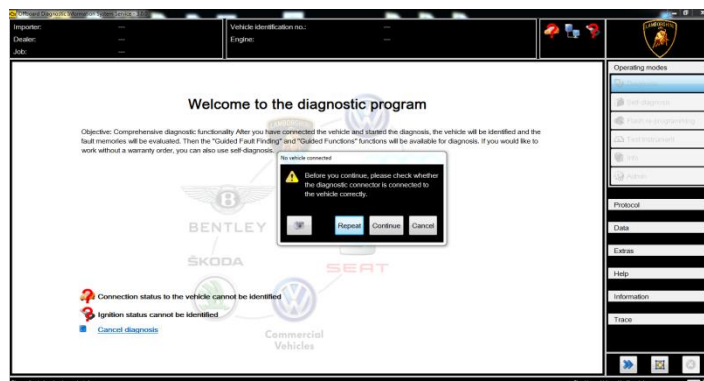
- C. If the error message regarding the VAS5054 interface and the two icons for status of on board connection and key ON are shown as in the picture below:

- Click “Cancel”;
- Repeat the VAS6154 HW interface installation following the procedure (\*) “VCI Manager v2.0”, by entering in the menu “Extras” on the right side and clicking on “Diagnostic interface”.

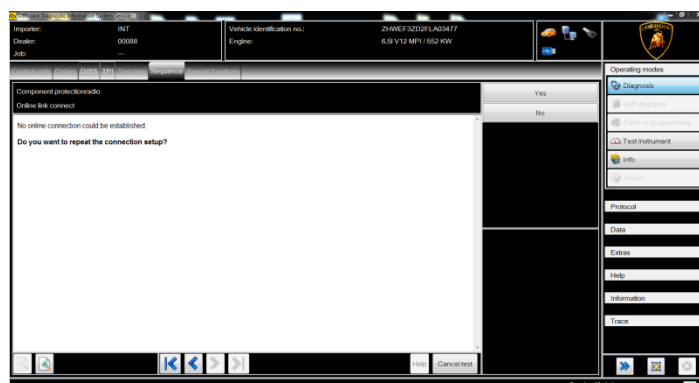
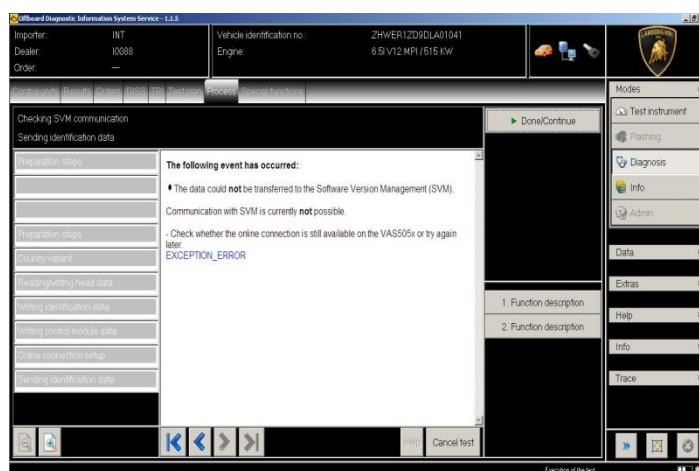
- D. If one of the connection error screens is shown as in the pictures below:

- It is not possible to establish a connection with the central server. Please check carefully that the diagnosis laptop is properly connected to the internet network and retry clicking “Yes” or “Done/Continue”.

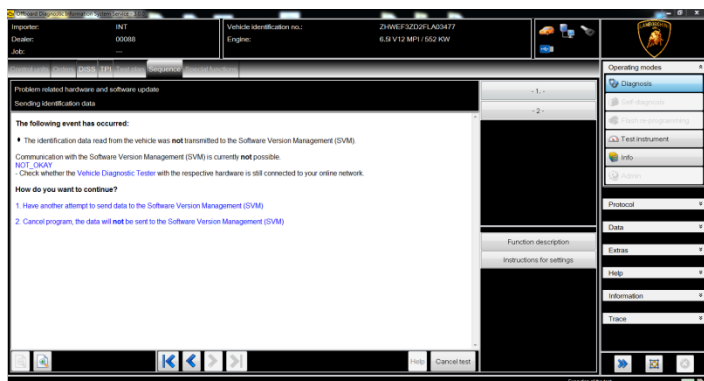
E. If the loss of connection happens during the target/actual comparison during SVM procedure:

- It is not possible to connect to central server, check the working connection of internet and retry by clicking “1”.

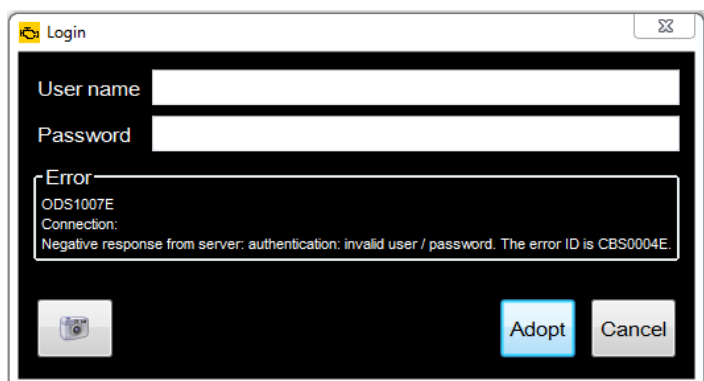
F. If the incorrect identification message is shown as in the picture below (error code: ODS1007E):

- be sure that your Geko account is valid;
- be sure that the label “Geko” is written on the token that you are using for the authentication;
- be sure the Password inserted is correct;
- click on Cancel and perform the application test (see document “ODIS\_Checking\_ConnectionServer\_SVM\_2.0” (\*)).

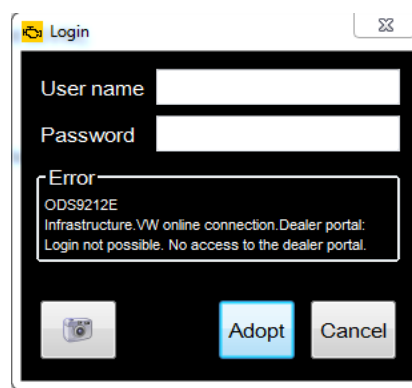
G. If the infrastructure error message is shown as in the picture below (error code: ODS9212E):

- be sure that your Geko account is valid
- be sure that the label “Geko” is written on the token that you are using for the authentication
- verify in ODIS settings you have “Internet” instead of “CPN” (see document “ODIS\_Initial\_Setup\_2.0” (\*))
- click on Cancel and perform the application test (see document “ODIS\_Checking\_ConnectionServer\_SVM\_2.0” (\*))
