L73X-A.04.18

TSU Update

Aventador S Coupè equipped with telemetry system

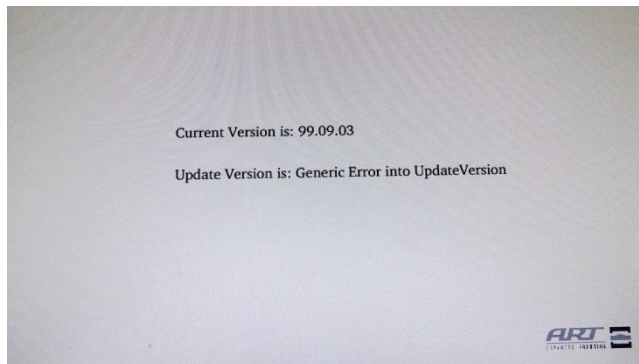
- A. During TSU update procedure, if the following page is shown in MMI display

Quit from “TSU Engineering Menu”, remove the USB memory stick from USB port and then switch ignition Off.

Then switch again ignition On, insert again USB stick into USB port and access again into TSU Engineering Menu.

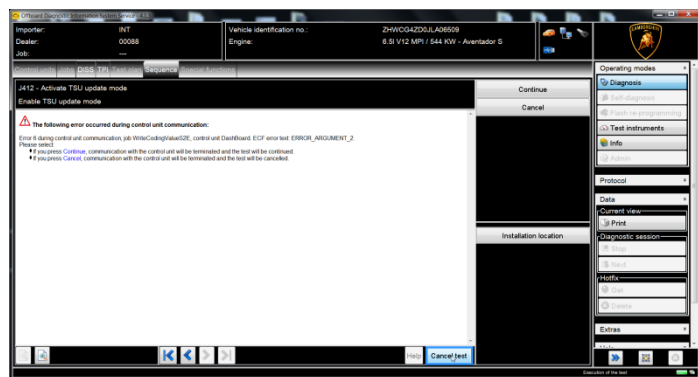
- B. If the following error page is shown, you shall abort the procedure clicking on “Cancel Test” and contact the Technical Support.

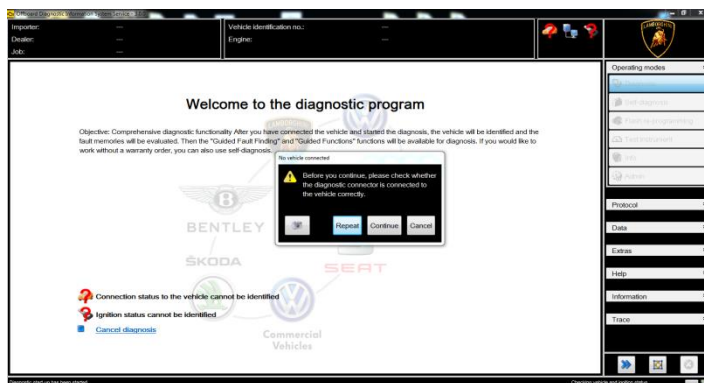
- C. If the error message regarding the VAS5054 interface and the two icons for status of on board connection and key ON are shown as in the picture below:

- Click “Cancel”;
- Repeat the VAS6154 HW interface installation following the procedure (\*) “VCI Manager v2.0”, by entering in the menu “Extras” on the right side and clicking on “Diagnostic interface”.

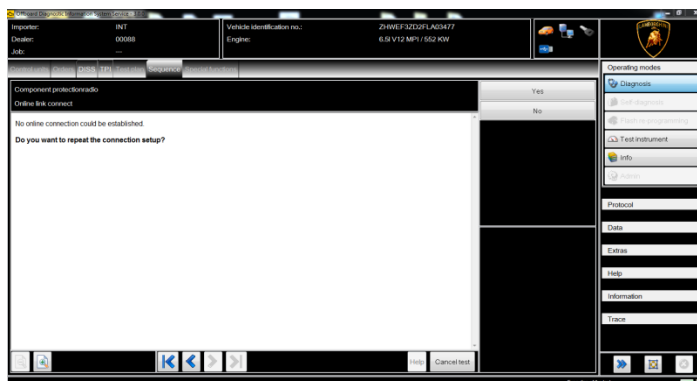
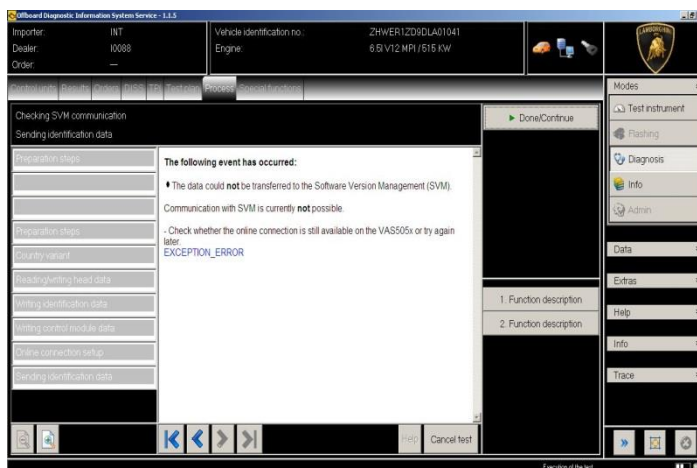
- D. If one of the connection error screens is shown as in the pictures below:

- It is not possible to establish a connection with the central server. Please check carefully that the diagnosis laptop is properly connected to the internet network and retry clicking “Yes” or “Done/Continue”.

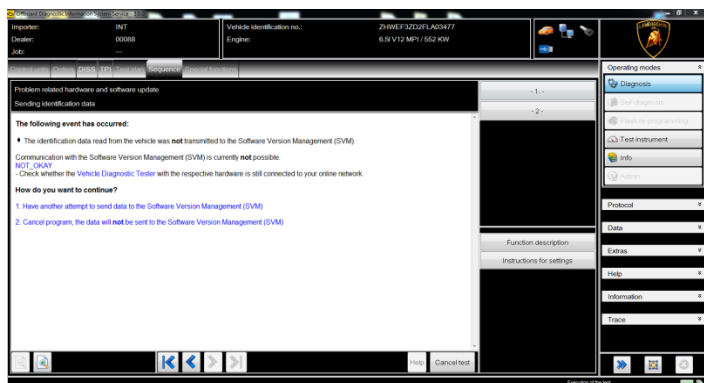
E. If the loss of connection happens during the target/actual comparison during SVM procedure:

- It is not possible to connect to central server, check the working connection of internet and retry by clicking “1”.

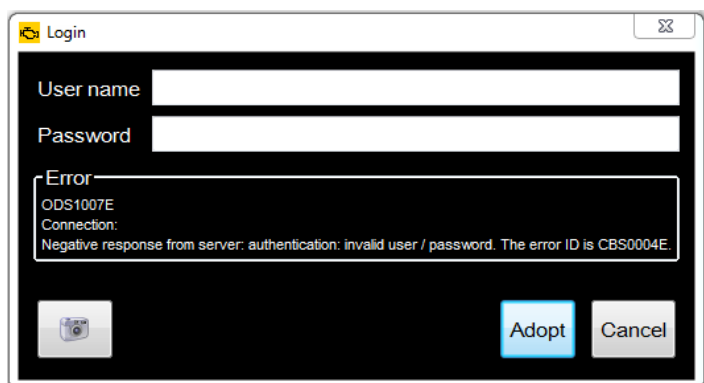
F. If the incorrect identification message is shown as in the picture below (error code: ODS1007E):

- be sure that your Geko account is valid;
- be sure that the label “Geko” is written on the token that you are using for the authentication;
- be sure the Password inserted is correct;
- click on Cancel and perform the application test (see document “ODIS\_Checking\_ConnectionServer\_SVM\_2.0” (\*)).

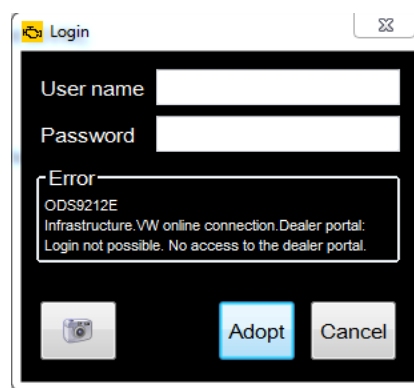
G. If the infrastructure error message is shown as in the picture below (error code: ODS9212E):

- be sure that your Geko account is valid
- be sure that the label “Geko” is written on the token that you are using for the authentication
- verify in ODIS settings you have “Internet” instead of “CPN” (see document “ODIS\_Initial\_Setup\_2.0” (\*))
- click on Cancel and perform the application test (see document “ODIS\_Checking\_ConnectionServer\_SVM\_2.0” (\*))
