**Campaign code:**  
L636-A.01.18

**Campaign description:**  
This campaign includes the MMI-Kombi-Gear Shifter Module update.

**Model:**  
Urus

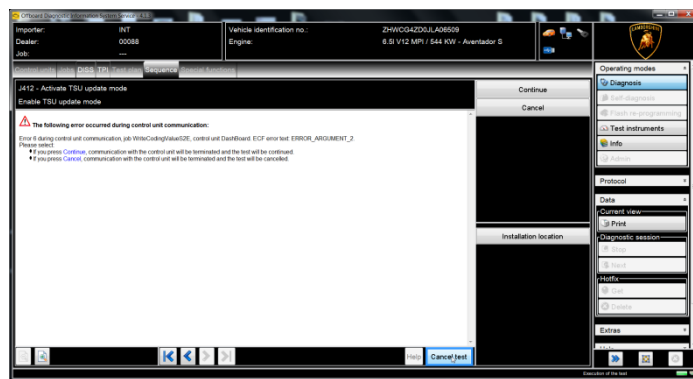
- i. If the following error page is shown, you shall abort the procedure clicking on “Cancel Test” and contact the Technical Support.

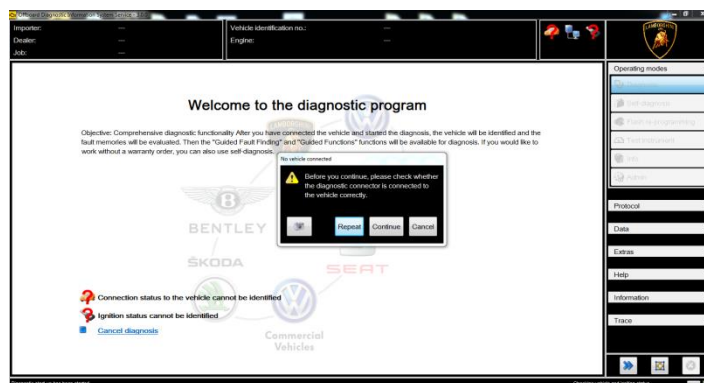
- ii. If the error message regarding the VAS5054 interface and the two icons for status of on board connection and key ON are shown as in the picture below:

- Click “Cancel”;
- Repeat the VAS6154 HW interface installation following the procedure (\*) “VCI Manager v2.0”, by entering in the menu “Extras” on the right side and clicking on “Diagnostic interface”.

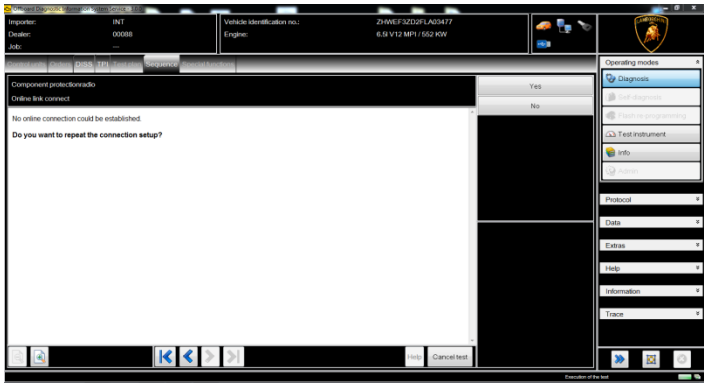
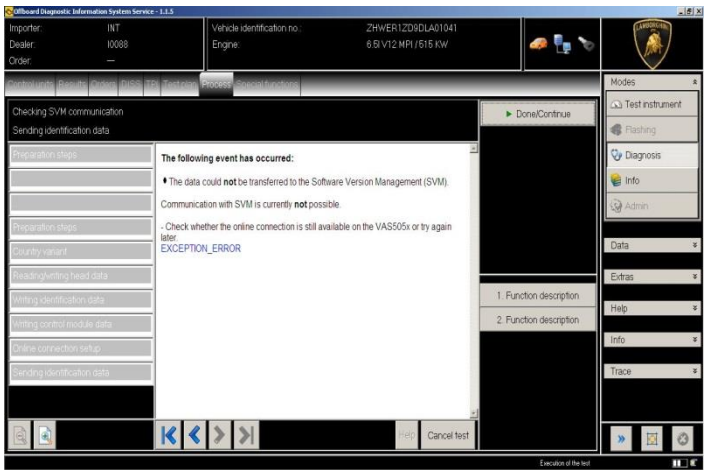
- iii. If one of the connection error screens is shown as in the pictures below:
- It is not possible to establish a connection with the central server. Please check carefully that

the diagnosis laptop is properly connected to the internet network and retry clicking “Yes” or “Done/Continue”.

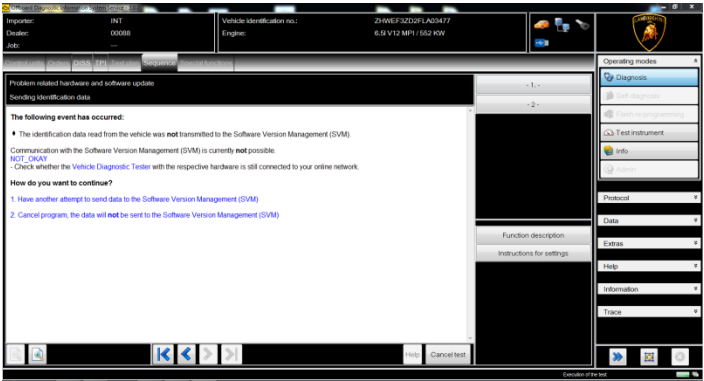
- iv. If the loss of connection happens during the target/actual comparison during SVM procedure:
  - It is not possible to connect to central server, check the working connection of internet and retry by clicking “1”.

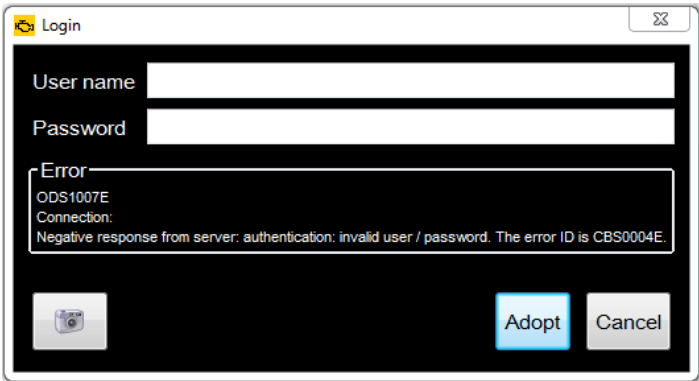
- v. If the incorrect identification message is shown as in the picture below (error code: ODS1007E):
  - be sure that your Geko account is valid;
  - be sure that the label “Geko” is written on the token that you are using for the authentication;
  - be sure the Password inserted is correct;
  - click on Cancel and perform the application test (see document “ODIS\_Checking\_ConnectionServer\_SVM\_2.0” (\*)).

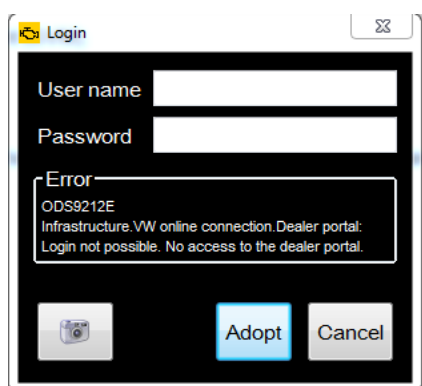
vi. If the infrastructure error message is shown as in the picture below (error code: ODS9212E):

- be sure that your Geko account is valid
- be sure that the label "Geko" is written on the token that you are using for the authentication
- verify in ODIS settings you have "Internet" instead of "CPN" (see document "ODIS\_Initial\_Setup\_2.0" (\*))
- click on Cancel and perform the application test (see document "ODIS\_Checking\_ConnectionServer\_SVM\_2.0" (\*)).
