# Technical Service Bulletin

<b>Subject:</b>  CHECK ENGINE LIGHT ON WITH DTC P0172:00	<b>Bulletin No.:</b> 01-019/18
	<b>Last Issued:</b> 10/10/2018

## APPLICABLE MODEL(S)/VINS

2013 CX-5 2.0L (M/T) with VINs lower than JM3KE\*\*\*\*\*168326 (produced before November 15, 2012)

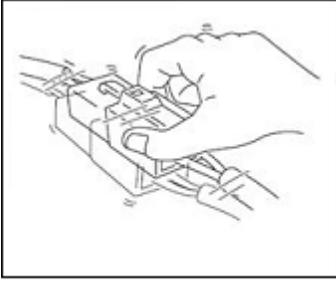
SI118152b

5. Verify the MAF voltage is approx. 0.72V and stable.

**NOTE:** While monitoring the MAF voltage, shake and twist the harness and connector for the mass air flow (MAF) sensor / intake air temperature (IAT) sensor No.1.

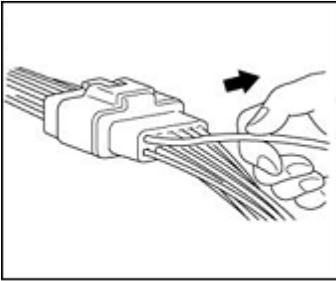
SI118152c

- If the MAF voltage changes as shown when shaking or twisting, the wiring is suspect and should be inspected/repared before continuing with TSB.
