Technical Service Bulletin

Subject: WRINKLES ON LEATHER SEAT SURFACE OF NEW VEHICLE	Bulletin No.: 09-015/18
	Last Issued: 10/10/2018

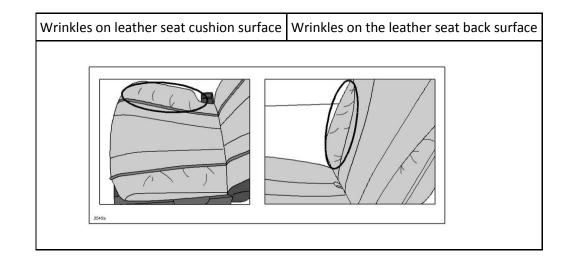
At PDI or when new vehicle is delivered, some customers may complain about wrinkles on the leather seat cushion and/or seat back surface.

Customers having this concern should have their vehicle repaired by a qualified upholstery repair specialist using the following repair procedure.

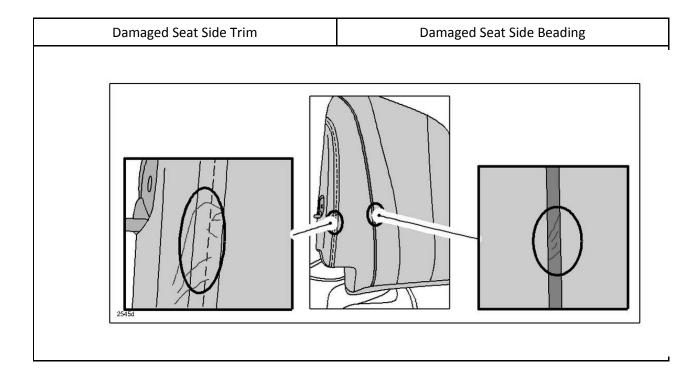
- Do NOT keep the steamer head at the same place for a long time.
- Do NOT run the steamer head without a water-soaked cloth especially over seat trim beading and seat side trim area.
- Seat damage may occur if the caution points above are nor followed as shown below.
