Technical Service Bulletin

Subject: OIL MAINTENANCE MONITOR RESET CONCERNS	Bulletin No.: 09-037/18
	Last Issued: 10/25/2018

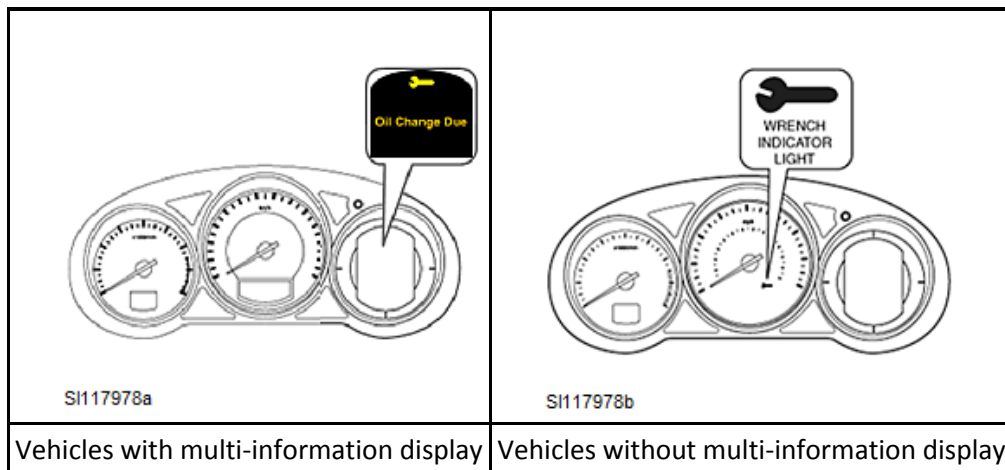
- The wrench light (Oil Change Due message) cannot be cleared using MAZDA CONNECT/Applications/Vehicle Status Monitor/Maintenance reset menu.
- The wrench light (Oil Change Due message) is displayed before the oil change is due.

This is caused by only one reset procedure being performed when the oil is changed, usually using the center display. Two reset procedures are required, one is using the trip meter switch to reset the powertrain control module (PCM) and the other is using the center display to reset the connectivity master unit (CMU).

To correct this issue, the CMU software has been modified so that the oil maintenance monitor reset operation on the center display resets both the CMU and the PCM at the same time. With this change, the reset operation using the trip meter switch is now unnecessary.

1. Verify customer concern.
2. Update the software version of the CMU to Ver. 70.00.100A or later according to MAZDA CONNECT UPDATE PROCEDURE on MGSS.
3. Verify repair.
