# Technical Service Bulletin

**RATTLE NOISE FROM FRONT DOOR GLASS**

**Bulletin No.:** 09-038/18

2013-2016 CX-5

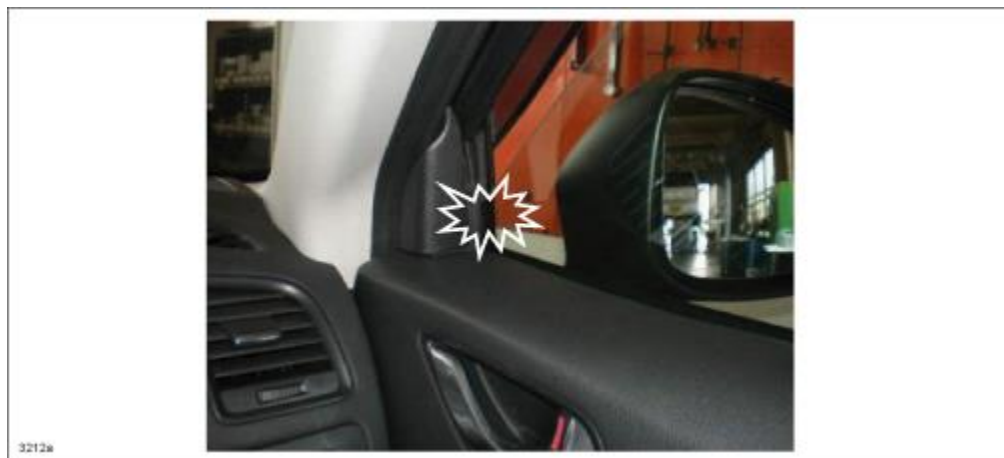
Some vehicles may experience a rattle noise from the front door glass when driving with the window open approx. 1/2 to 4 inches (1 - 10 cm).

The rattle noise may be caused by insufficient holding force of the glass run channel. To increase the holding force, the shape of glass run channel has been changed and non-woven pads have been attached to the glass run channel.
