P20EE (diagnostic troubleshooting code) SOLUTION - NOX CONVERSION EFFICIENCY

Prevost vehicles

B13R (9700 us/can)

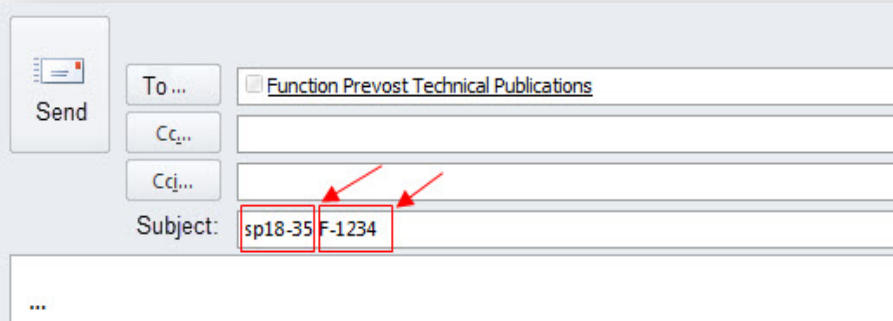
Please indicate in the "subject line": SP18-35 and the short V.I.N. as in the example below...
