JTB00458NAS3

TECHNICAL BULLETIN

'Rattle' Noise From The Front Of The Vehicle

MODEL:	MODEL YEAR:	VIN:	APPLICABILITY:
XE (X760)	2017	921222-937474	Vehicles With: 8HP45 8-Speed Automatic Transmission RWD

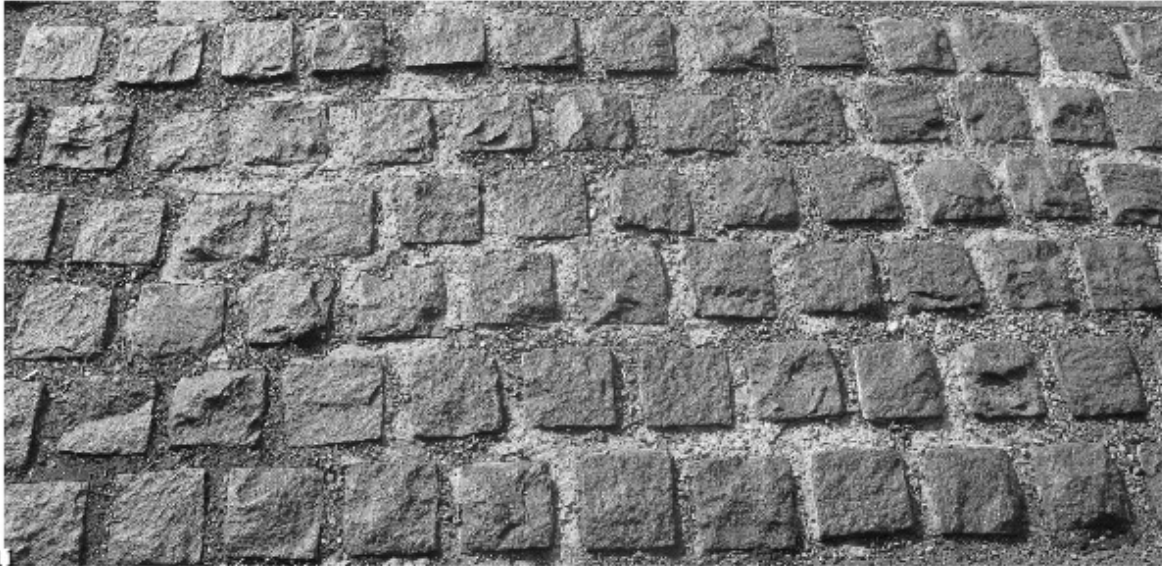
1

Typical road surface that can generate the rattle sound.

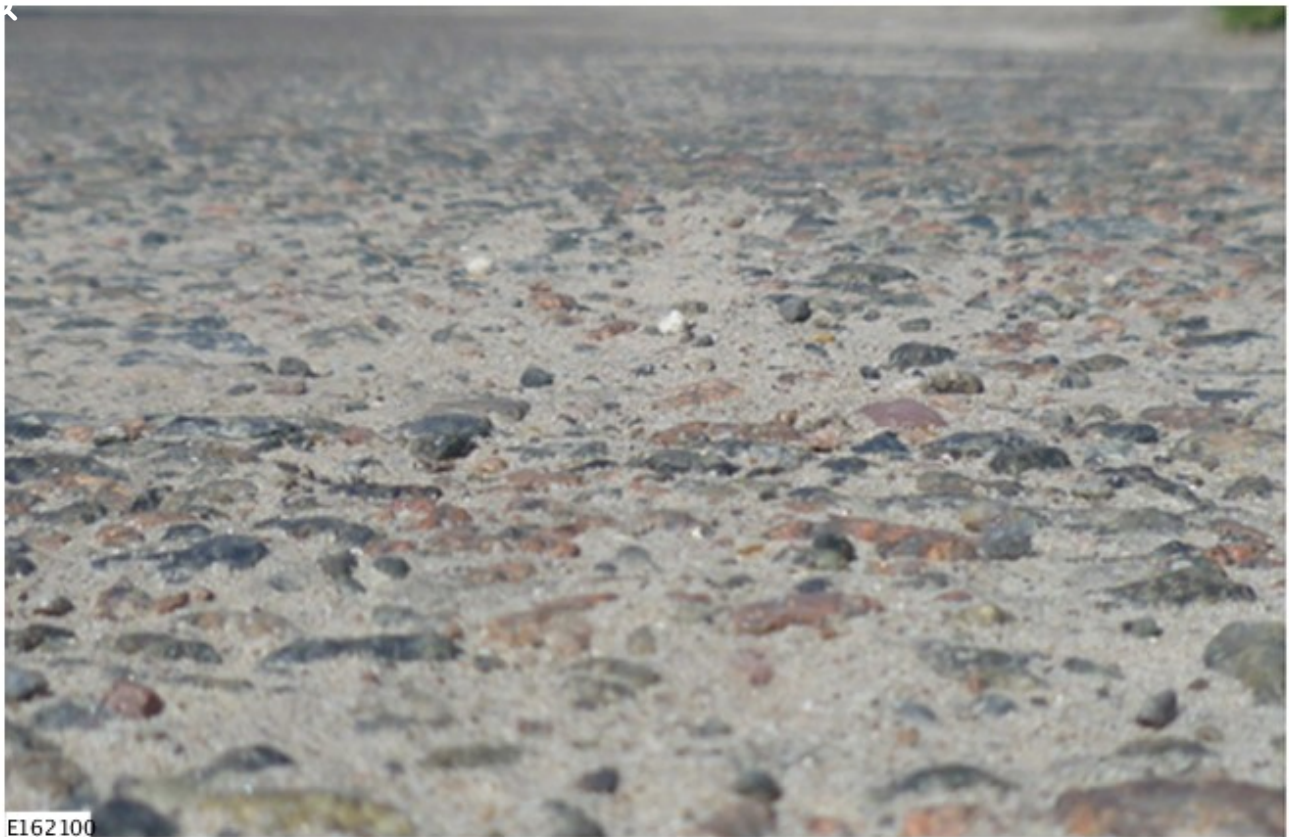
2

Typical road surface that can generate the rattle sound.
