JTB00458NAS3 TECHNICAL BULLETIN 05 SEP 2018

'Rattle' Noise From The Front Of The Vehicle

MODE	.: MODEL YEAR:	VIN:	APPLICABILITY:
XE (X760)) 2017	921222-937474	Vehicles With: 8HP45 8-Speed Automatic Transmission RWD

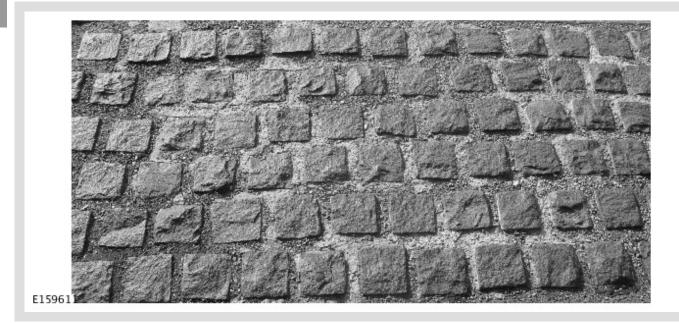
Typical road surface that can generate the rattle sound.

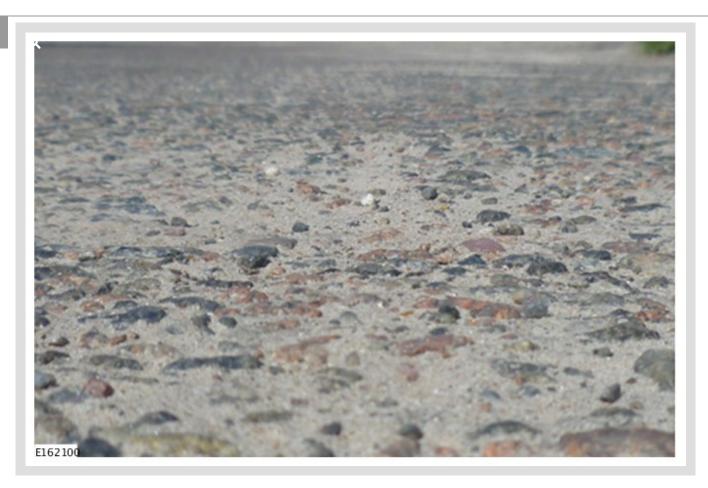
2

Typical road surface that can generate the rattle sound.
