JTB00458NAS4

TECHNICAL BULLETIN

'Rattle' Noise From The Front Of The Vehicle

MODEL:	MODEL YEAR:	VIN:	APPLICABILITY:
XE (X760)	2017	921222-937474	Vehicles With: 8HP45 8-Speed Automatic Transmission RWD

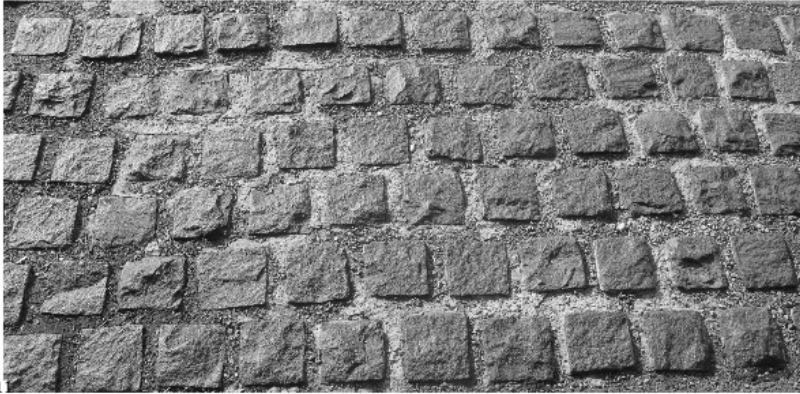
E15961

Typical road surface that can generate the rattle sound.

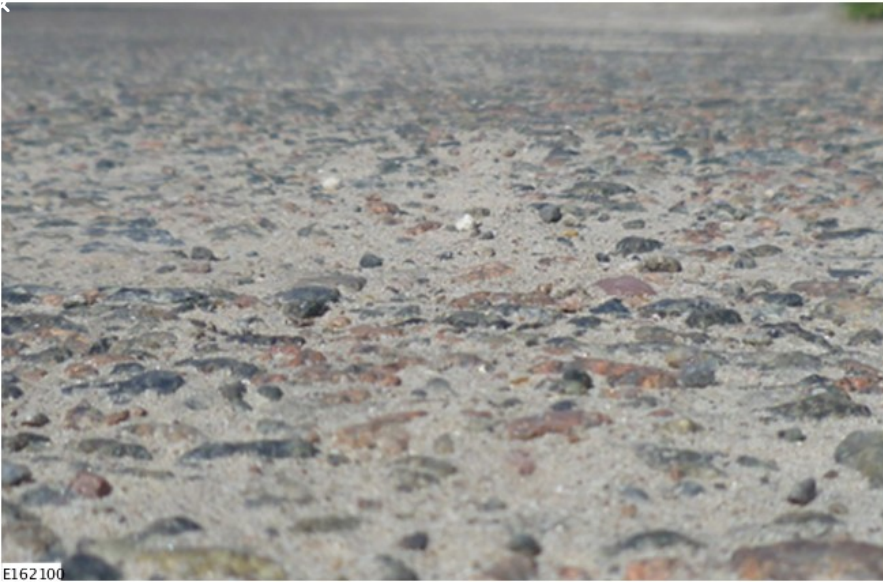
E162100

Typical road surface that can generate the rattle sound.
