TECHNICAL SERVICE BULLETIN

Glove Box Misaligned

18-2306
02 October 2018

Ford 2015-2018 F-150

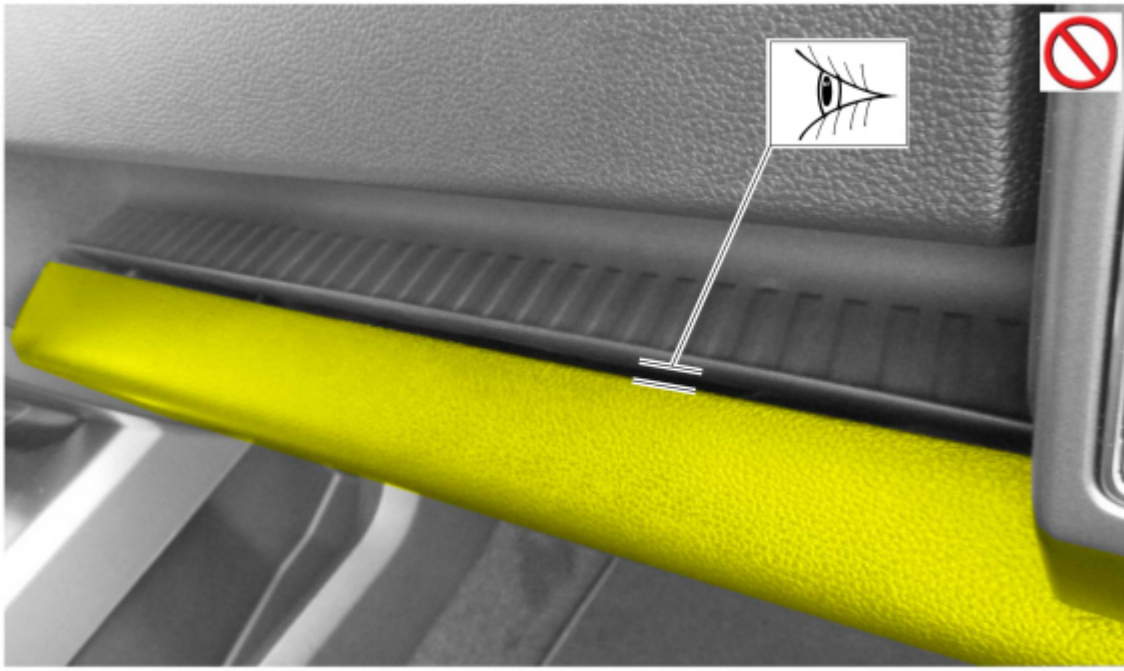
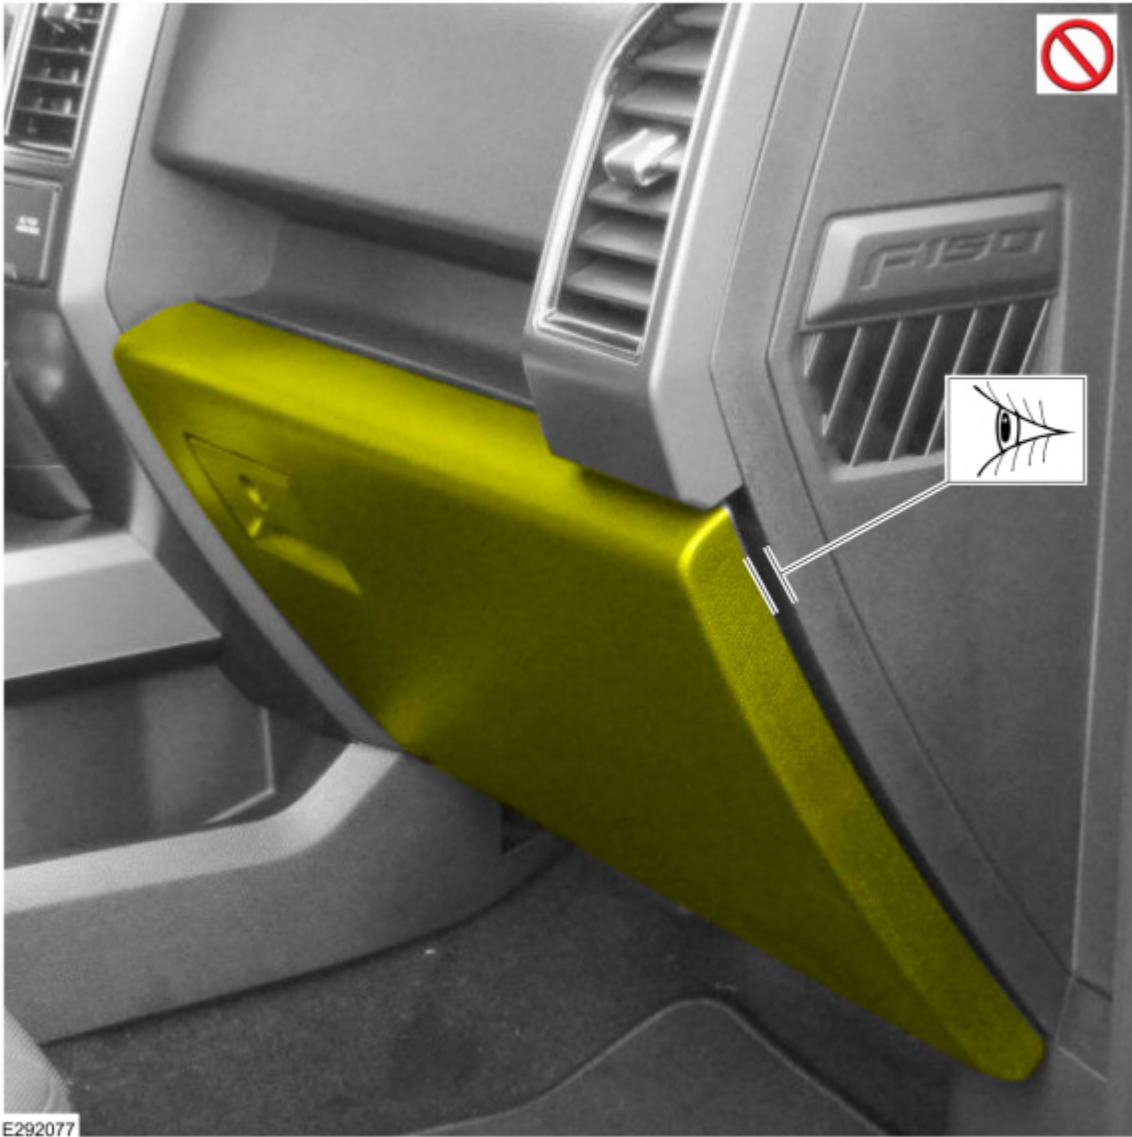
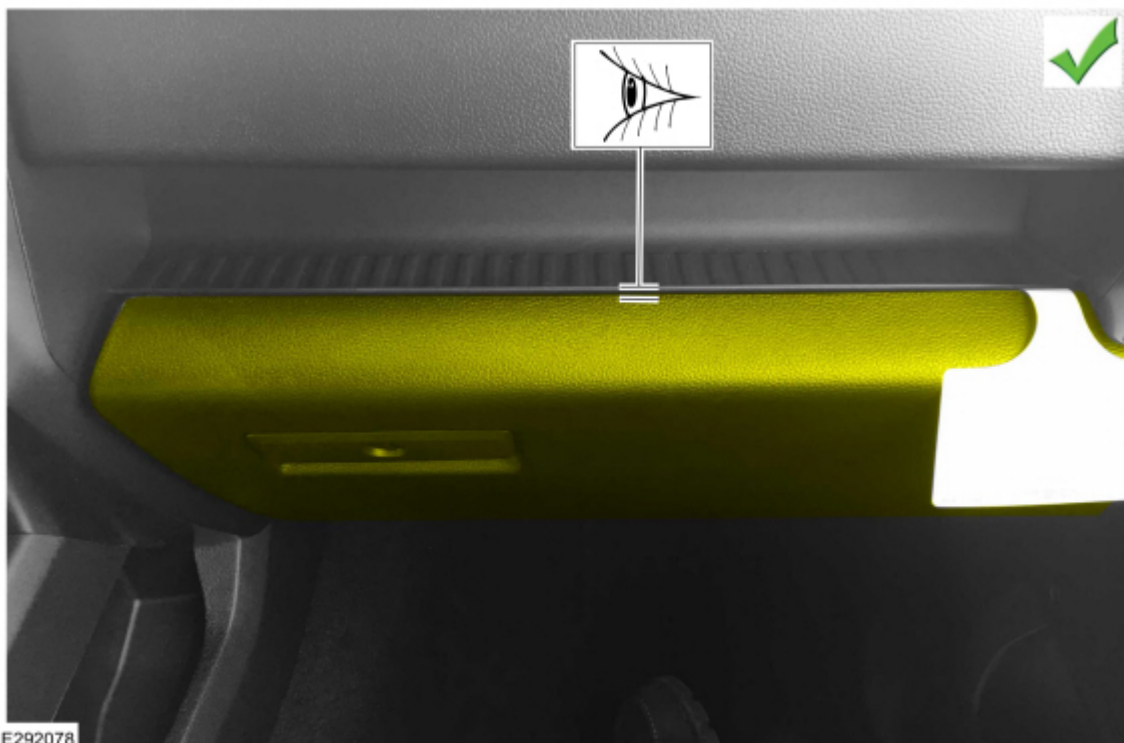
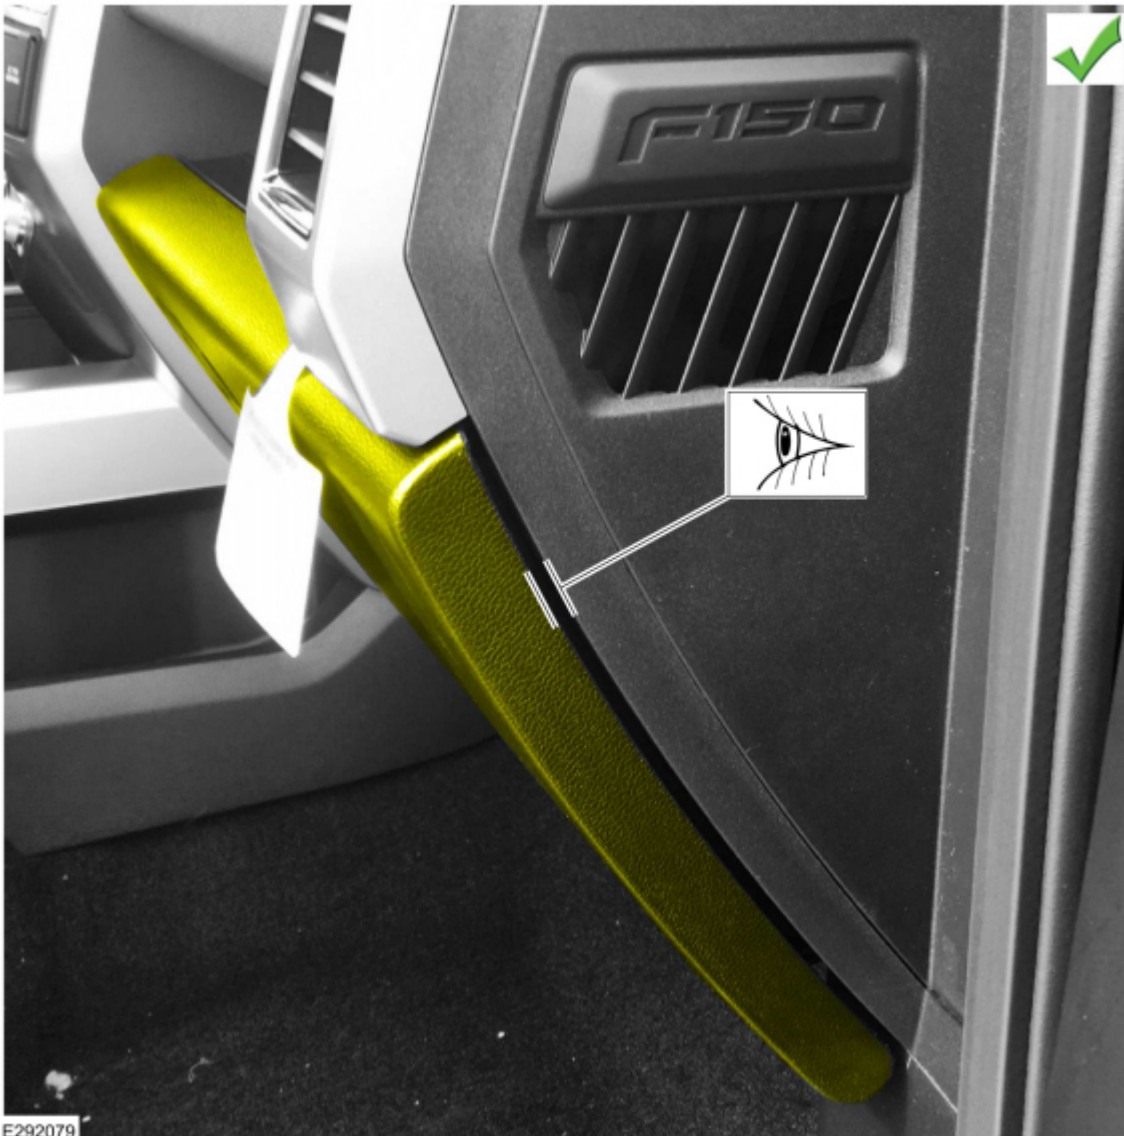
- Inspect the glove box door in the closed position. Does the glove box exhibit a misalignment at the storage tray and/or right side instrument panel with no other visible defect? (Figures 1 - 4)
 - Yes - proceed to Step 2.
 - No - this article does not apply. Refer to the Workshop Manual (WSM), Section 501-12 for normal diagnostics.

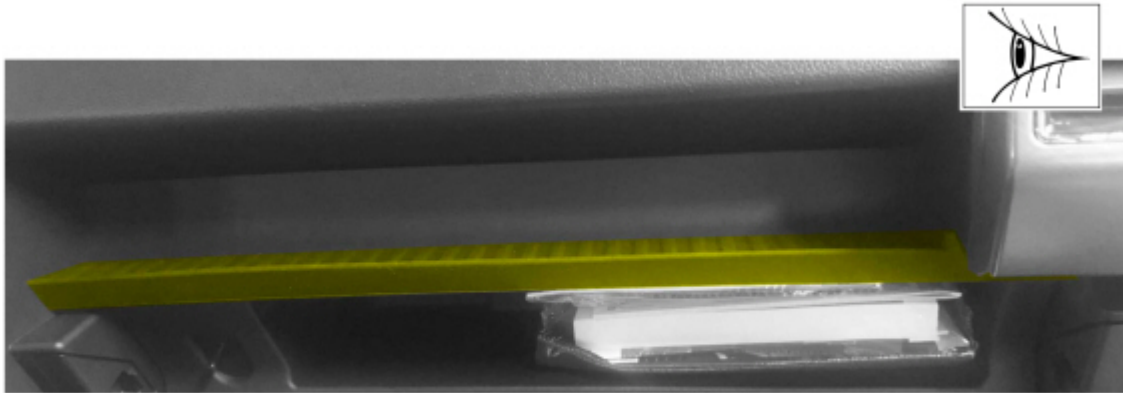
Figure 6

2. Inspect the glove box storage tray rubber mat. Is the mat properly seated and flush on both end of the instrument panel? (Figures 5 - 6)

3. Remove the rubber mat and close the glove box door. Refer to WSM, Section 501-12. Does the glove box door close properly?
 - (1). Yes - The rubber mat was installed incorrectly. Install the rubber mat making sure the right hand side is properly tucked and seated to the instrument panel. Refer to WSM, Section 501-12. Proceed to step 4.
 - (2). No - install the rubber mat and proceed to Step 4. Refer to WSM, Section 501-12.
4. Inspect the glove box door left and right hand strikers. Are the strikers fully seated? (Figures 7 - 9)
 - (1). Yes - proceed to Step 6.
 - (2). No - proceed to Step 5.

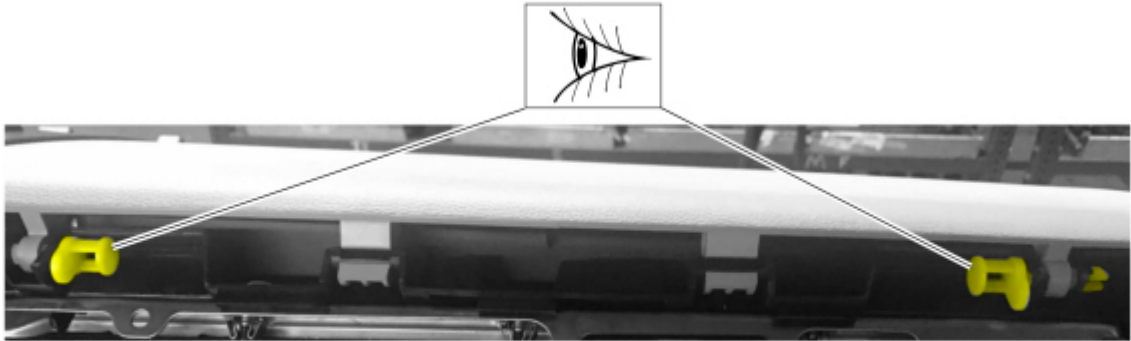
Figure 10

- 5. Remove the improperly installed striker using a non-marring pry tool and reinstall. Make sure the striker is fully seated.
- 6. Inspect the glove box door hinge pins. Are both pins fully seated? (Figure 10)
 - (1). Yes - proceed to Step 8.
 - (2). No - proceed to Step 7.

7. Remove and reseal the hinge pins.
8. Close the glove box door and inspect for proper alignment. Is the door properly aligned and latched on both sides?
 - (1). Yes - repair is complete.
 - (2). No - proceed to Step 9.
9. Remove the bumpers from the glove box door and close it. Does the glove box door latch properly? (Figure 11)
 - (1). Yes - If the glove box door closes properly with the bumpers removed, the bumpers have taken a set in the door open position which will increase closing force and inhibit proper latching. Install the bumpers and close the glove box door fully. Make sure both sides are latched. Increased closing force may be required to properly latch the glove box door. Allow the glove box door to remain in the closed position for 2 hours to allow the bumpers to take a set in this position. Repair is complete.
 - (2). No - proceed to Step 10.
