Replace Front Air Spring Modules

Classification	Repair Bulletin	Section/Group	31 - Suspension	Country/Region	All
Year	2017, 2018	Model	Model S	Version	All

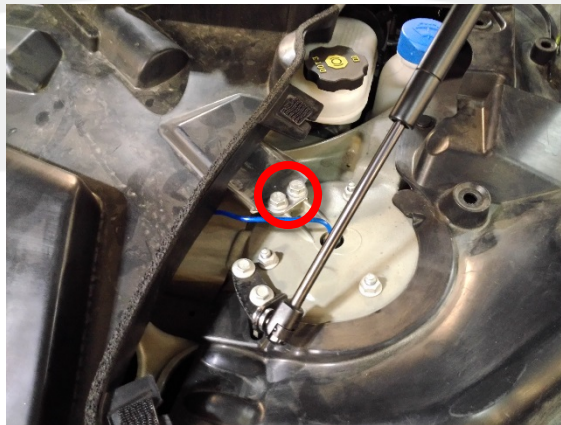
Figure 1 (LH shock tower shown)

On some Model S vehicles equipped with air suspension, a front-end rattle noise might come from behind the IP carrier when traveling over road transitions. For example, when traveling from driveway to street, or from asphalt to concrete. The noise is generated from a vibration harshness that otherwise has no detrimental effect on the vehicle.

2. Remove the LH and RH underhood aprons (refer to Service Manual procedure 12251202).
3. Bring two shop towels, a 13mm socket, and a torque wrench during the road test to perform a temporary modification as follows:
 - a. Locate a street or parking lot of good road surface, where a short road test that reproduces the noise can be safely and consistently conducted at low speeds in observance of local traffic laws.
 - b. Repeat the road test several times to establish a course, and to familiarize yourself with the front-end rattle noise.
 - c. Remove the bolts (x2) that attach the shock tower brace to the LH shock tower (Figure 1).

- g. Remove the shop towels, move the shock tower braces back to the LH and RH shock towers, and then install the bolts (x4) that attach the braces to the towers (torque 20 Nm) (Figure 1).
4. If during the road test (after removing the shock tower brace bolts):
- The front-end rattle noise was not heard, discontinue this procedure and replace the LH and RH front air spring modules (refer to Service Manual procedure 31105002).
 - The front-end rattle noise was still heard, then the noise is not resolved by this bulletin. Continue to the next step.
- NOTE:** Refer to Toolbox articles, for example #27522, #27520, and #31344, to help identify the source of the noise.
5. Install the LH and RH underhood aprons (refer to Service Manual procedure 12251202).
6. Install the rear underhood apron (refer to Service Manual procedure 12251102).
