# Reroute C-Pillar Electrical Harness

| <b>Classification</b> | Repair Bulletin | <b>Section/Group</b> | 17 - Electrical | <b>Country/Region</b> | United States, Canada |
| <b>Year</b> | 2017, 2018 | <b>Model</b> | Model 3 | <b>Version</b> | All |

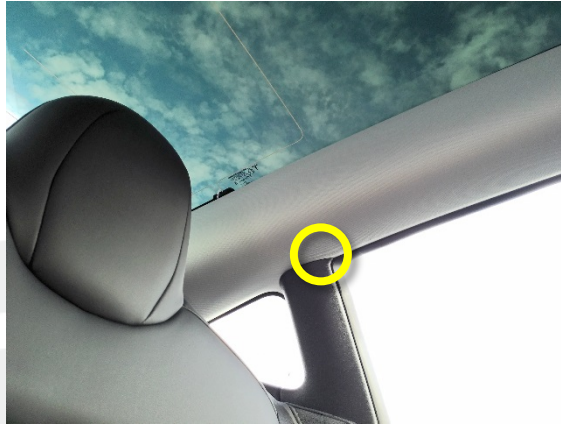
**Figure 1 (Where upper C-pillar trim meets side rail trim)**

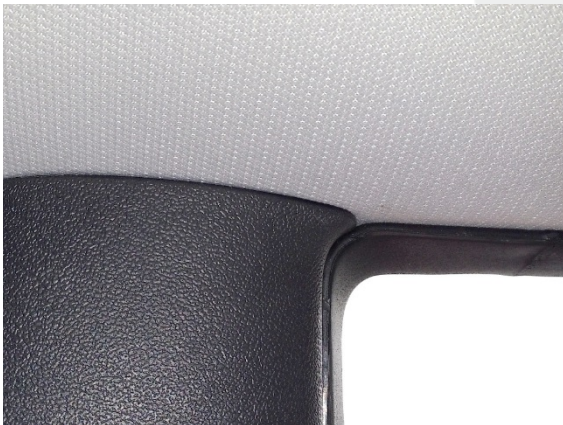
**✓ Figure 2 (Fit is tight, no gap)**

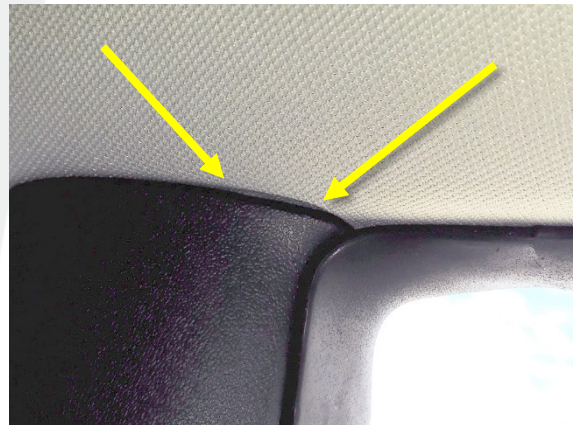
Some Model 3 vehicles might have been manufactured with the C-pillar electrical harness(es) routed incorrectly, causing a gap between the upper C-pillar trim and side rail trim.

**✗ Figure 3 (Gap between trims)**

Upon customer complaint, inspect the vehicle for symptoms related to the condition. If symptoms are present, reroute the C-pillar electrical harness to close the gap between the upper C-pillar trim and side rail trim.

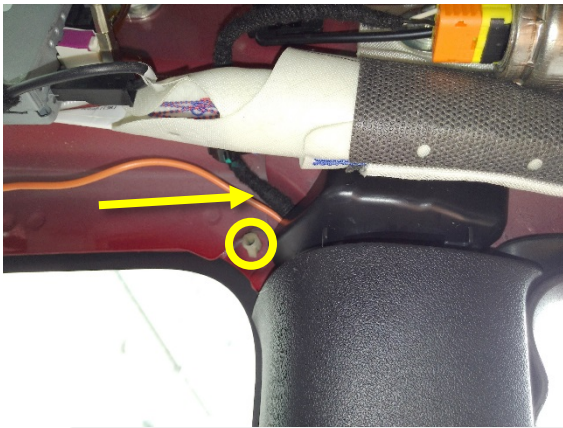
✓ **Figure 4 (Harness forward of the clip)**

4. Move the C-pillar electrical harness forward of the LH rear quarter glass push clip (Figure 4) and closer to the C-pillar.
  - If the harness can be moved forward of the clip, closer to the C-pillar, and stays, go to step 18.
  - If tension in the harness prevents this action to be completed easily, continue to the next step.
5. Carefully cut the tape and remove the C-pillar electrical harness from the upper C-pillar clip behind the LH curtain airbag (Figure 6).

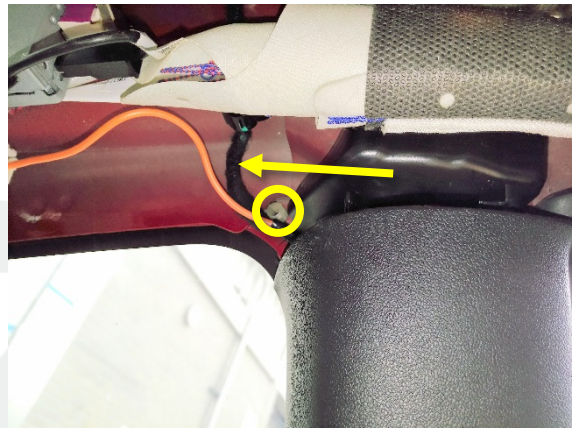
✗ **Figure 5 (Harness rearward of the clip)**

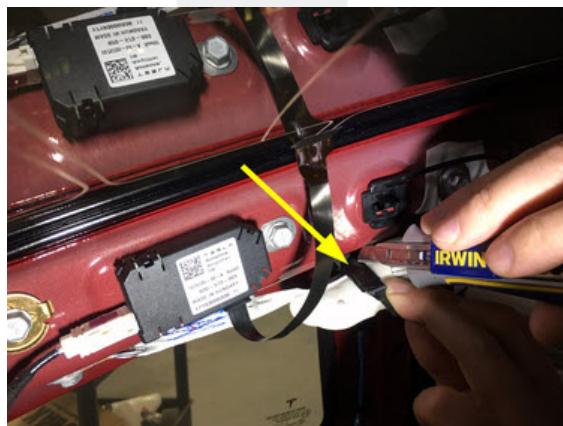
**Figure 6 (Carefully cut the tape)**

**⚠ CAUTION:** Be careful not to cut into the C-pillar electrical harness.

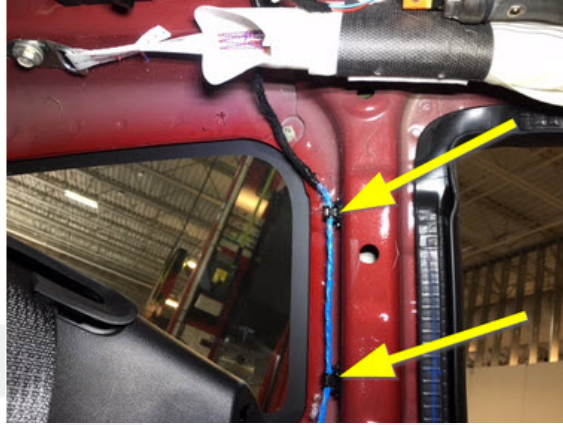
**Figure 7 (C-Pillar cable tie clips)**

8. Release the cable tie clips (x2) that attach the C-pillar electrical harness to the C-pillar (Figure 7).

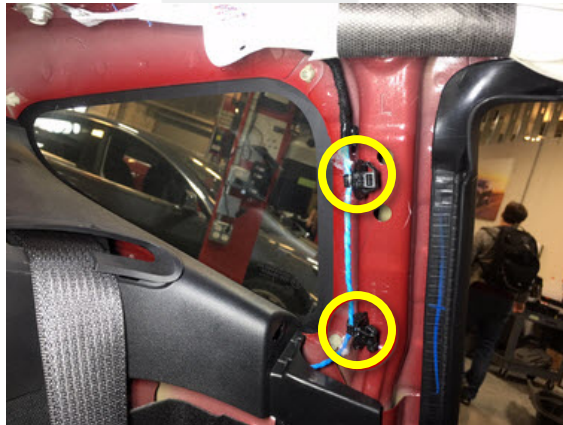
**Figure 8 (Cut clips, not electrical harness)**

**⚠ CAUTION:** Be careful not to cut into the C-pillar electrical harness.

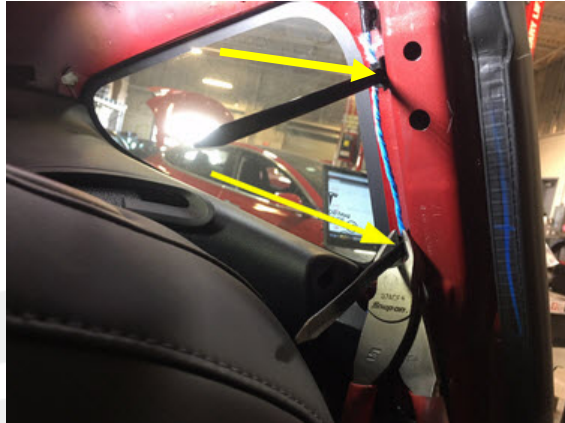
**Figure 9 (Secure the harness in position)**

11. Install new cable tie clips into the C-pillar, and while the C-pillar electrical harness is in the correct position, tighten the cable ties of the clips to secure the harness (Figure 9).

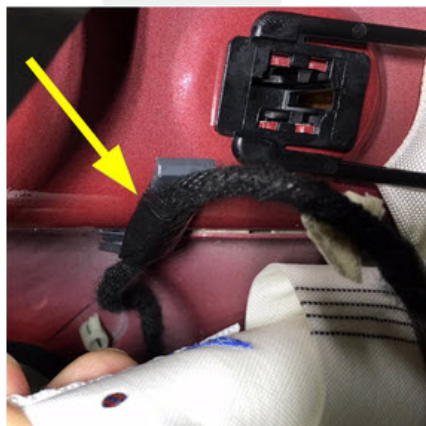
**Figure 10 (Secure clip to harness)**

12. Remove excess cable tie length from the cable tie clips.
13. Install the LH upper C-pillar trim (refer to Service Manual procedure 15186002).
14. Temporarily position the C-pillar electrical harness to the upper C-pillar clip, so that the harness can be moved forward of the LH rear quarter glass push clip (Figure 4) and closer to the C-pillar.
15. Mark where the upper C-pillar clip will attach to the C-pillar electrical harness with a piece of tape.
16. Remove the upper C-pillar clip from the upper C-pillar, and then secure the C-pillar electrical harness to the clip with several layers of tape (Figure 10).
