SERVICE BULLETIN

Classification: EC18-028a	Reference: NTB18-062a	Date: October 19, 2018
------------------------------	--------------------------	---------------------------

2018 ARMADA; MIL ON WITH DTC P0138 AND/OR P0158

APPLIED VEHICLES: 2018 Armada (Y62)

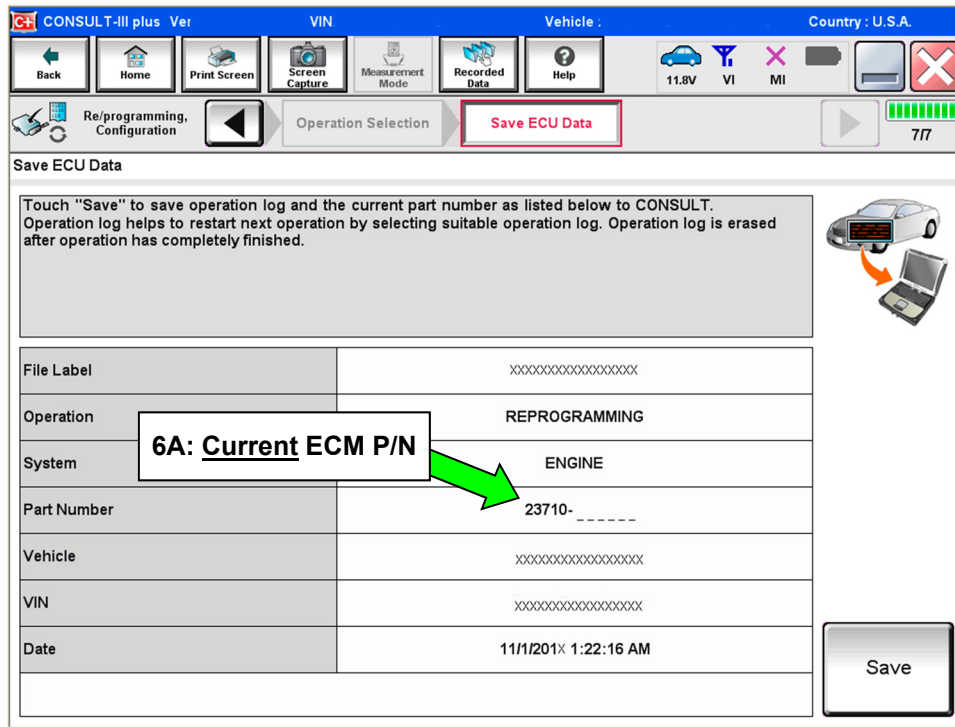
6. When the screen in Figure 2 displays, confirm this bulletin applies as follows.

A. Find the ECM **Part Number** and write it on the repair order.

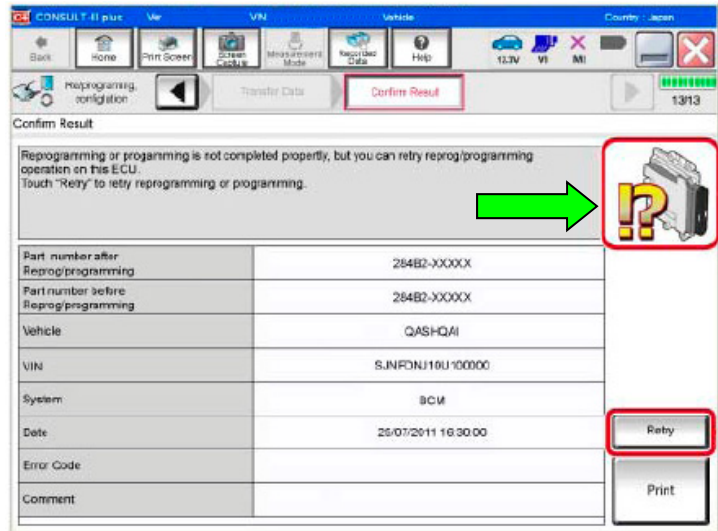
Figure 6

If reprogramming does not complete and the “!?” icon displays as shown in Figure 6:

- Check battery voltage (12.0 - 15.5 V).
- Ignition is ON, engine OFF.
- External Bluetooth® devices are OFF.
- All electrical loads are OFF.
- **Select retry and follow the on screen instructions.**
- **“Retry” may not go through on first attempt and can be selected more than once.**

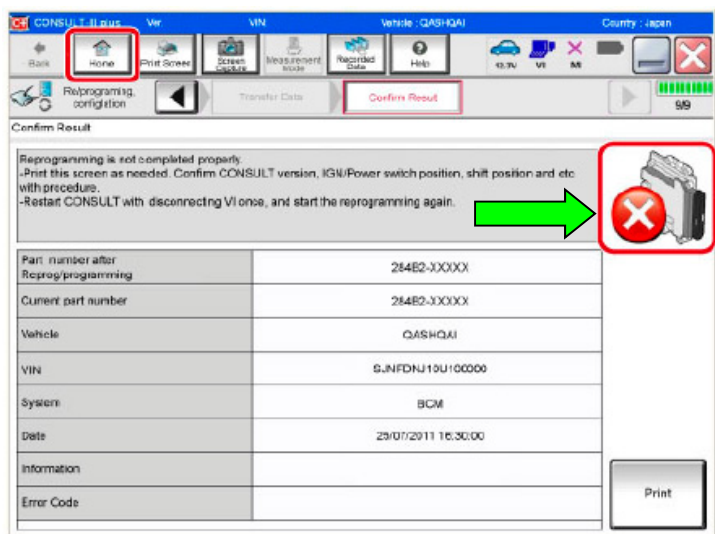
Figure 7

If reprogramming does not complete and the “X” icon displays as shown in Figure 7:

- Check battery voltage (12.0 - 15.5 V).
- CONSULT A/C adapter is plugged in.
- Ignition is ON, engine OFF.
- Transmission is in Park.
- All C-III plus / VI cables are securely connected.
- All C-III plus updates are installed.
- **Select Home, and restart the reprogram procedure from the beginning.**
