Reference:

October 24, 2018

VOLUNTARY SERVICE CAMPAIGN 2018 PATHFINDER; ELECTRIC INTAKE VALVE TIMING CONTROL MODULE REPROGRAMMING

CAMPAIGN ID #: PC661 APPLIED VEHICLES: 2018 Pathfinder (R52)

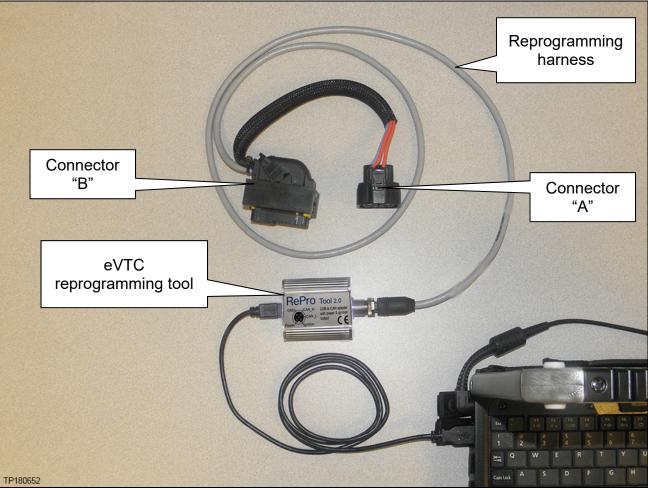
Figure 1

eVTC reprogramming kit (J-52601)

- Each dealer has been shipped one eVTC reprogramming kit (J-52601).
- Tool kit includes:
 - > eVTC reprogramming tool.
 - > Mini USB cable
 - Reprogramming harness
- Additional tools can be obtained from Tech-Mate at 1-800-662-2001.

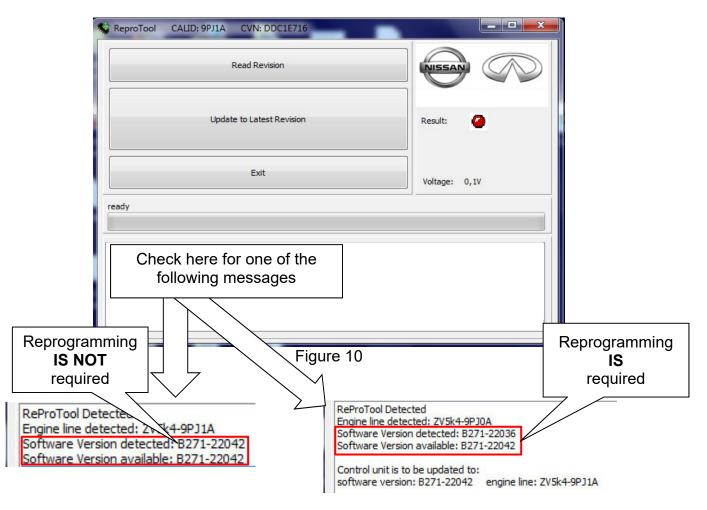
Determine If Reprogramming Is Required

19. Compare the "Software Version detected" to the "Software Version available."

- If the "Software Version detected" is **THE SAME** as the "Software Version available" then reprogramming **IS NOT** required, skip to step 24.
- If the "Software Version detected" is **DIFFERENT** than "Software Version available" then reprogramming **IS** required, continue to the next step (step 20).
