### PIP5603 Possible Check Engine Lamp on With DTC P00C7 and P0106 High Mileage Vehicles

Brand:	Model:	Model Years:	VIN:		Engine:	Transmissions:
			from	to		
Chevrolet	Volt	2016 - 2019	All	All	1.5 L3A	All

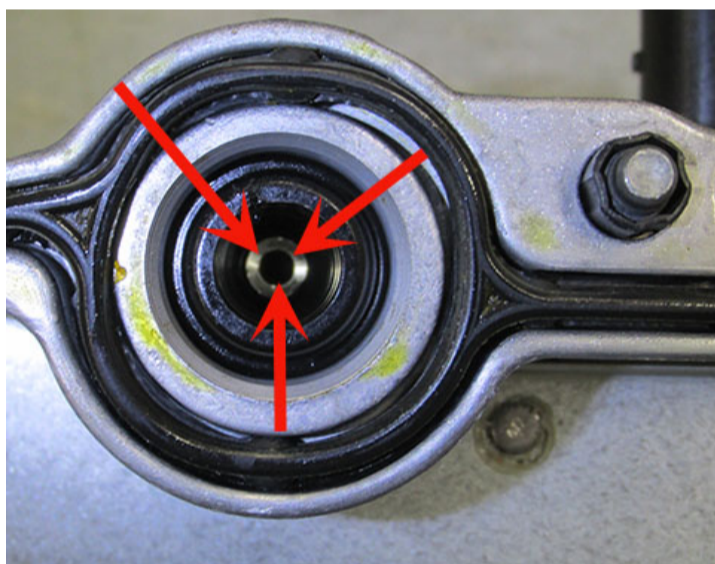
<b>Involved Region or Country:</b>	North America
<b>Additional RPO/s:</b>	None
<b>Condition:</b>	High mileage vehicles may experience a check engine lamp with DTC P00C7 and P0106 set as current or in history
<b>Cause:</b>	Possible plugged PCV orifice

Remove the camshaft cover assembly and inspect the PCV orifice for being restricted. (Photo below is showing actual PCV orifice)

If you find the above PCV orifice is plugged or restricted use a 1.8mm drill bit (hand use only) to clear the orifice.

Reassemble the engine using a new camshaft cover gasket and retest.
