Preliminary Information

PIT5550B Left Side Third Row Seat will not Power Fold/Unfold or Moves One Inch at a Time

Brand:	Model:	Model Years:	VIN:		Engine:	Transmissions:
			from	to		
Cadillac	Escalade	2015 - 2019	All	All	All	All
Chevrolet	Tahoe	2015 - 2019	All	All	All	All
Chevrolet	Suburban	2015 - 2019	All	All	All	All
GMC	Yukon	2015 - 2019	All	All	All	All

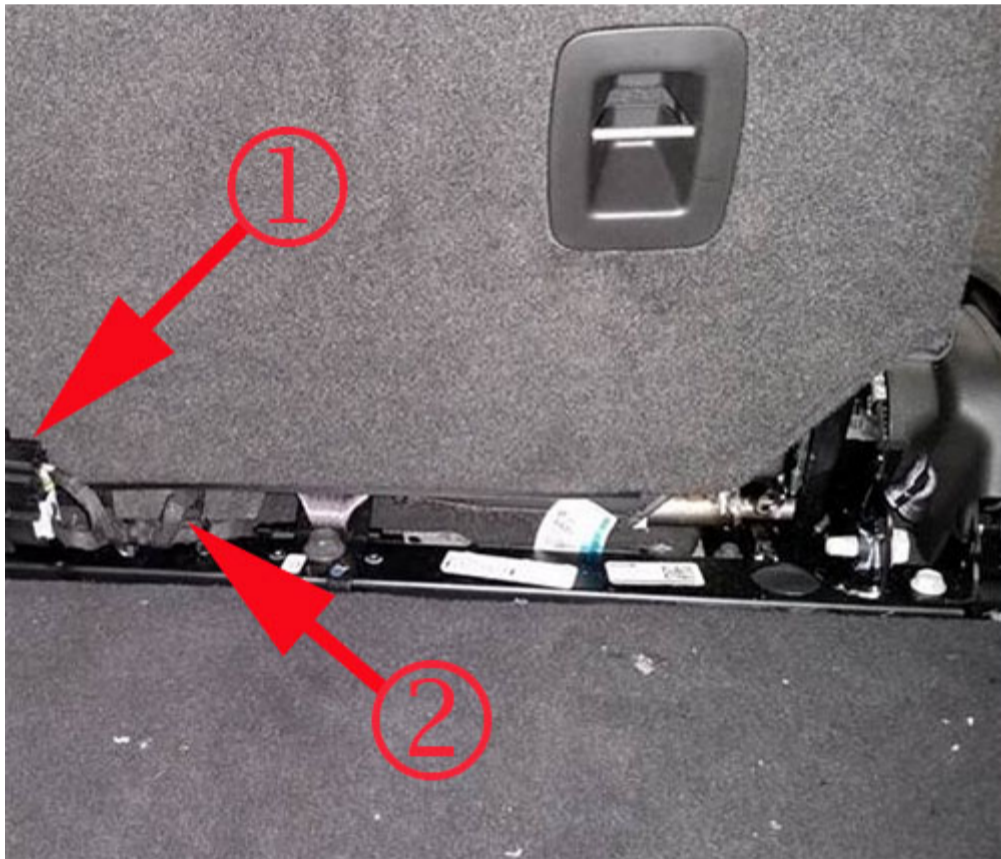
If normal SI diagnostics does not lead to a correction, check for open circuits between the third row folding seat control module and the hall effect sensor which is located within the folding seat drive motor. If open circuits are found, one common area to check for broken wires is about 6 inches away (2) from the third row K169 power folding seat control module (1).

The circuits may be broken internally in the insulation and may not be physically visible.

A pull test on the circuits to see if they stretch may help in diagnosing the location of the open in the circuit.

If a concern is found, repair the circuits as necessary and evaluate operation.
