Preliminary Information

PIP5197J Possible Oil Consumption / Leaks – Blue Smoke Exhaust – Whistle Noise – DTC P0171 and/or P0300 and/or P0299

Models

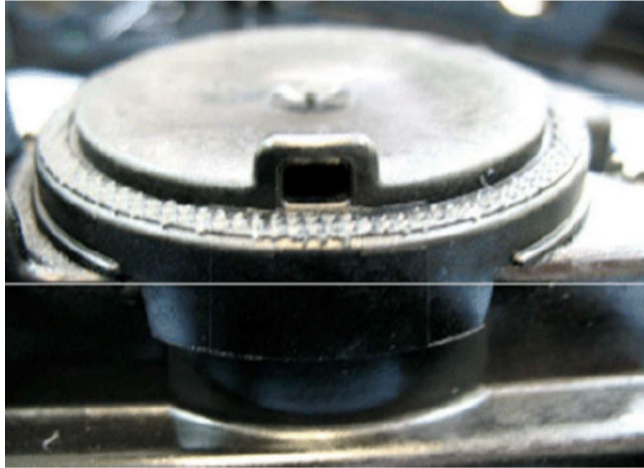
Check the PCV orifice for leaking oil or drawing vacuum at idle thru its external port. (The PCV orifice is an integral part of the camshaft cover). (See picture below).

Please note that a weak or broken piston ring land can cause a P0300.

It may also damage the PCV orifice diaphragm causing a P0171.

If the PCV orifice external port is leaking oil or vacuum, replace the camshaft cover assembly.

Clean oil from all induction system components and retest for oil consumption, leaks or DTCs resetting.

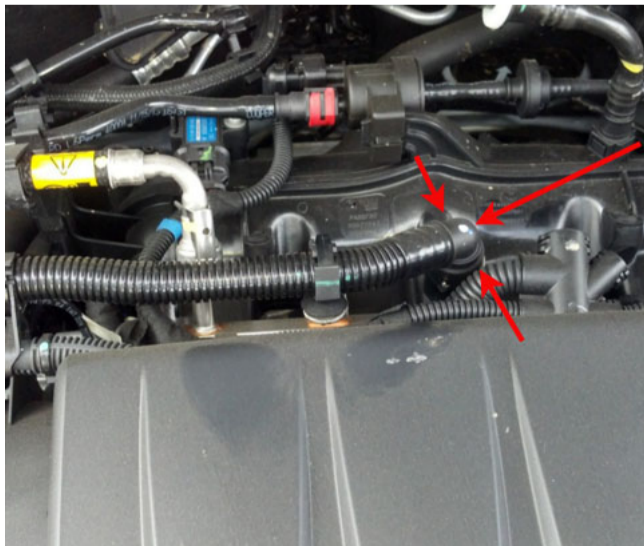
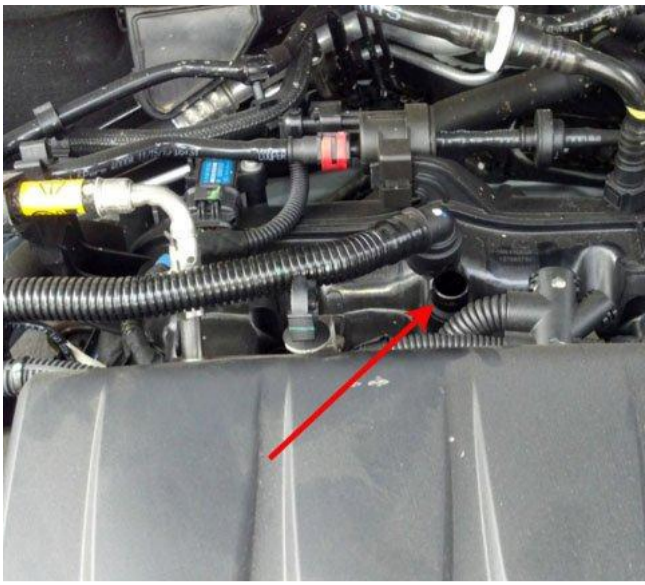
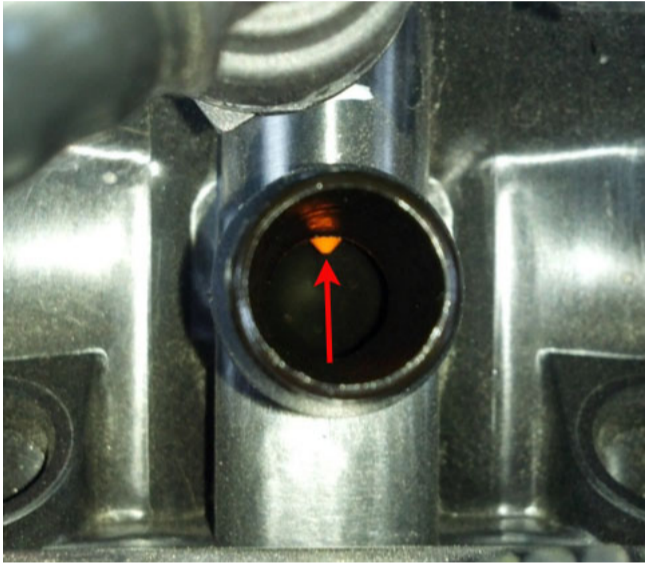
Check for a missing intake manifold Non Return Valve that may have damaged the PCV orifice diaphragm. (See pictures below for inspection procedure).

If the non return valve is not visible as shown in picture, then use a long cotton swab to wipe any excess oil from the valve to validate.

If the non return valve is still not visible, then intake manifold removal for inspection is required to validate.

If the valve is present reinstall the intake manifold. Do not replace.

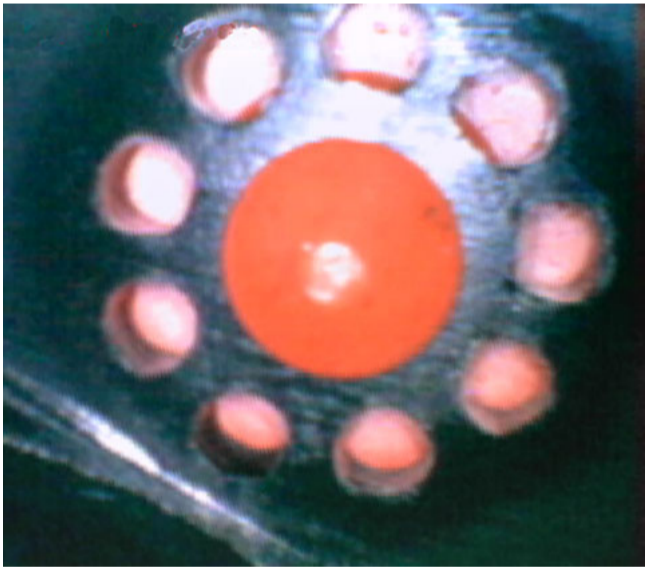
Properly seated Non Return Valve as viewed with the intake manifold removed.

If the intake manifold Non Return Valve is missing, then replace the intake manifold assembly,

Clean oil from all induction system components and retest for oil consumption, leaks or DTCs resetting.

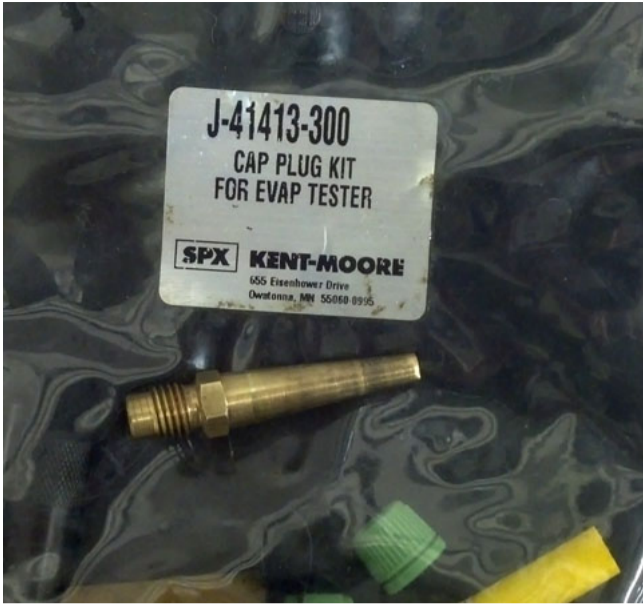
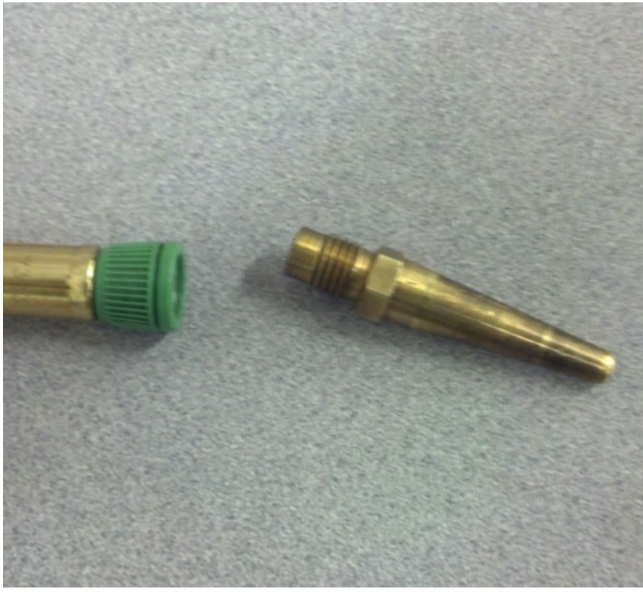
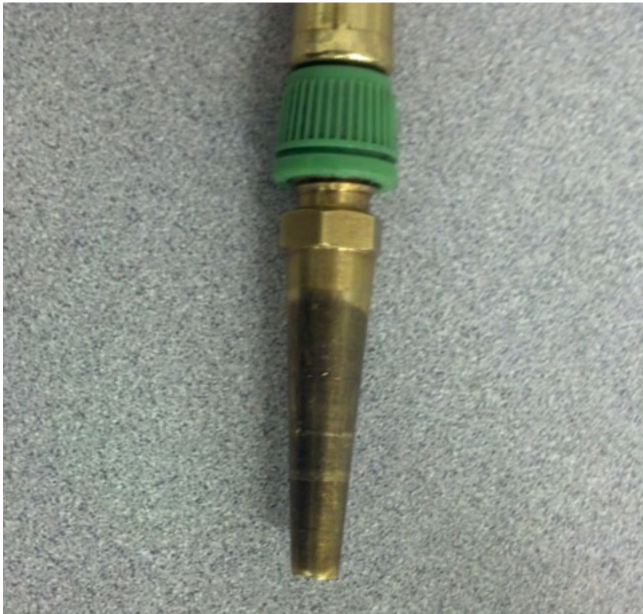
Record the crankcase pressure. (Normal crankcase pressure readings are between -11 & -18 inches of water in park at hot idle) / (ESST gage works best, see pictures below for connection of ESST at the engine oil dipstick hole in the camshaft cover.

If the crankcase pressure is between -10 and 0 inches of water then a cylinder leakage / crankcase pressure concern exists.

This is likely caused by a weak or broken piston ring land.

Replace all four piston assemblies and retest for proper crankcase pressures.

Clean oil from all induction system components and retest for oil consumption, leaks or DTCs resetting.
