N221NAS1

# TECHNICAL BULLETIN

Service Action: Windshield Water Leaks

MODEL:	MODEL YEAR:	VIN:	ASSEMBLY PLANT:
Discovery (LR)	2017	000128-022488	Solihull

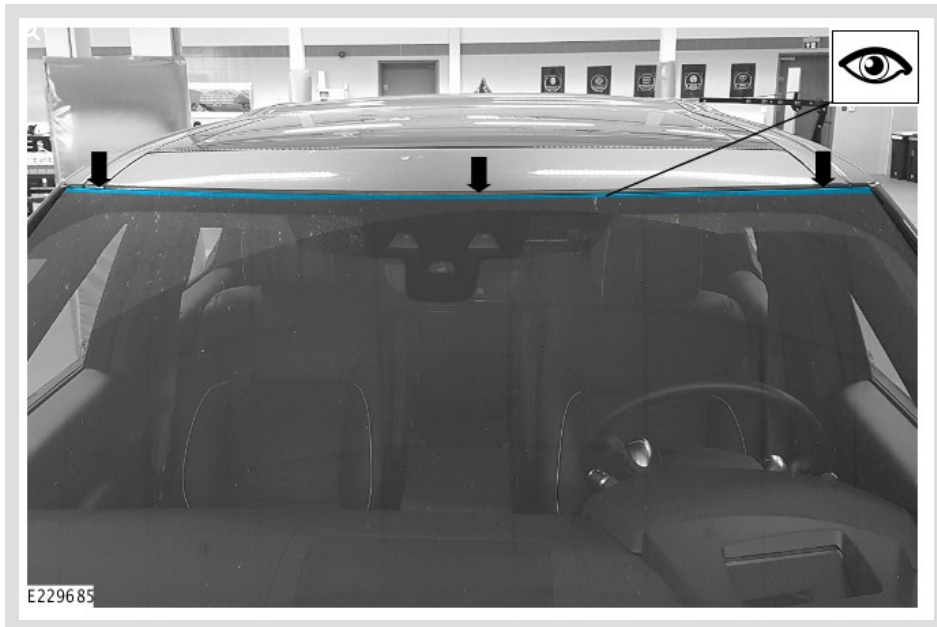
1

Apply soapy water to the affected area as shown and inspect the windshield.

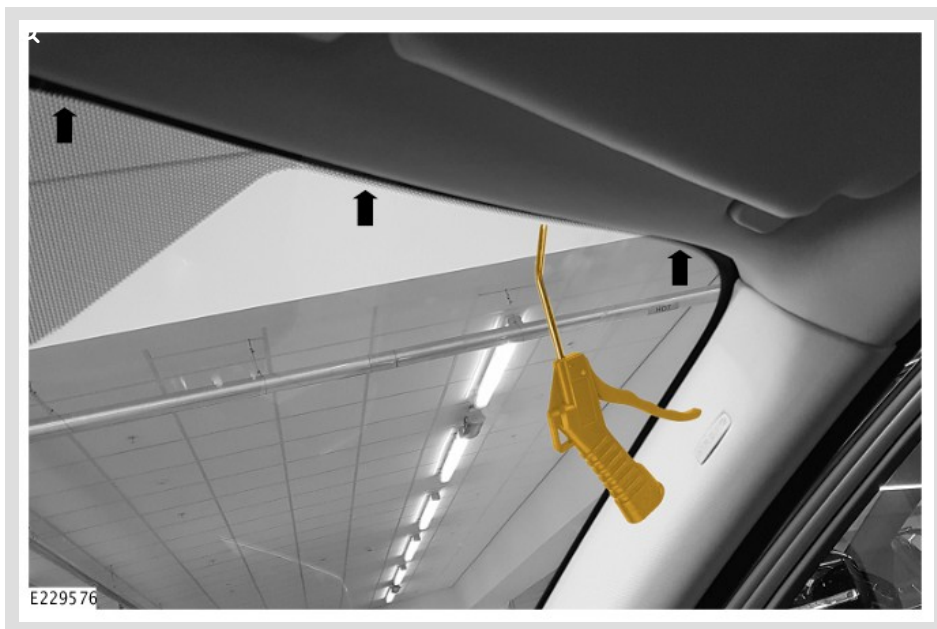
2

Use an air blower to blow compressed air around the edge of the inner side of the windshield as shown.

- 1 While continuing to blow air around the inner edge of the windshield, apply gentle pressure by hand to the top section of the windshield from inside the vehicle.
