N228NAS1

TECHNICAL BULLETIN

Service Action: Engine Serial Number Incorrect

MODEL:	MODEL YEAR:	VIN:	ASSEMBLY PLANT:	APPLICABILITY:
Range Rover Velar (LY)	2018-2019	771213-782400	Solihull	INGENIUM I4 2.0L Petrol

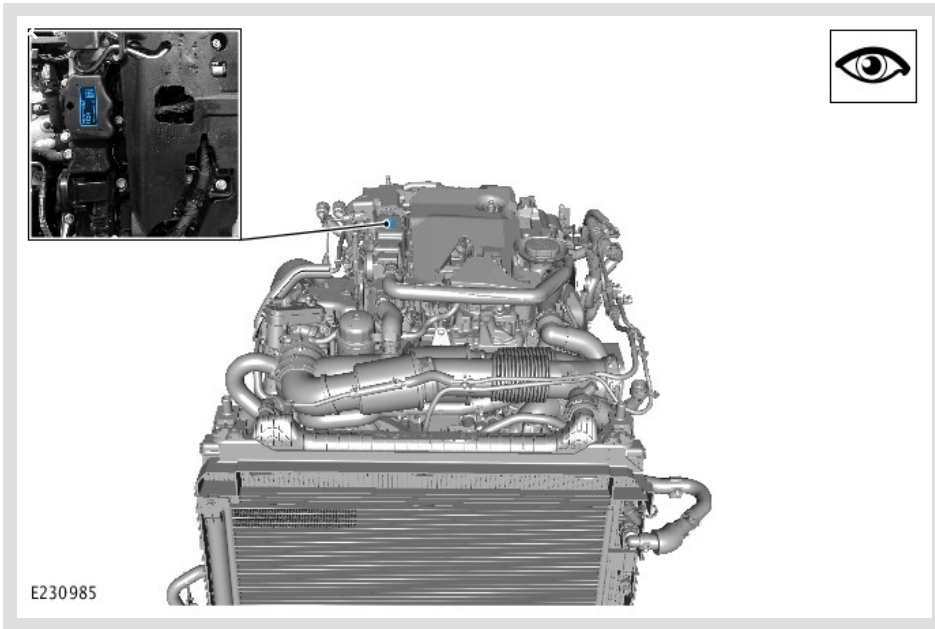
The Engine Serial Number must be entered in the Customer and/or Technician verbatim field.

Record the engine serial number.
