LTB01180NAS2

TECHNICAL BULLETIN

Suspension Fault Message Displayed / Suspension Air Supply Unit Expansion Chamber Broken

MODEL:	MODEL YEAR:	VIN:	APPLICABILITY:
Range Rover Sport (LW)	2018-2019	181320-816885	TDV6 3.0L Diesel /V6 S/C 3.0L Petrol /V8 S/C 5.0L Petrol
Range Rover (LG)	2018-2019	380217-519553	TDV6 3.0L Diesel /V6 S/C 3.0L Petrol /V8 S/C 5.0L Petrol

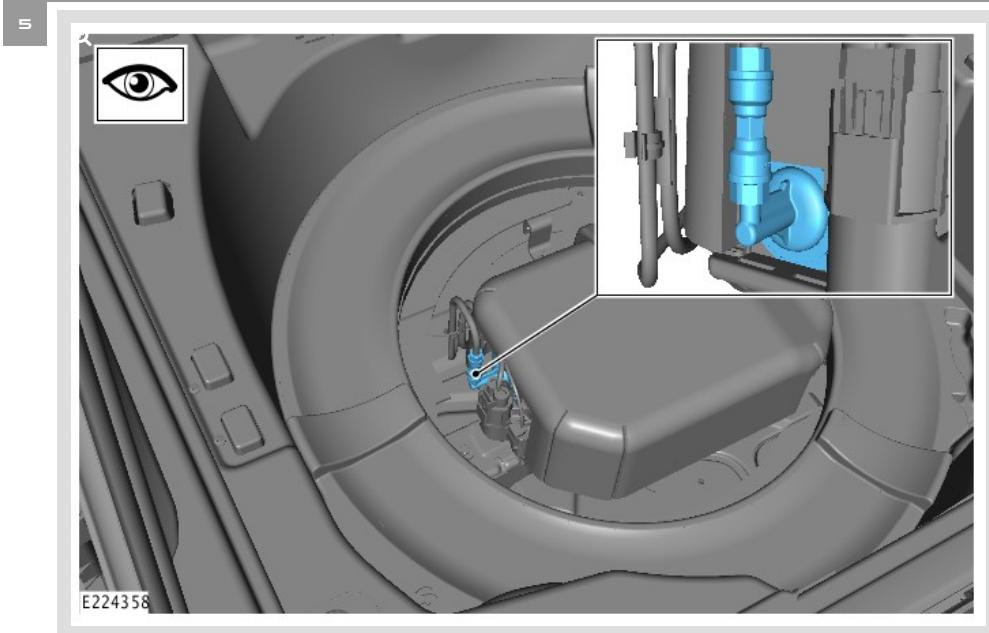
Inspect the suspension air supply unit expansion chamber for damage in the area shown.

- If the suspension air supply unit expansion chamber is not broken, do not continue with this Technical Bulletin.

- See TOPIx Workshop Manual section 204-05: Vehicle Dynamic Suspension - Diagnosis and Testing - Vehicle Dynamic Suspension to continue diagnosis.

- If the suspension air supply unit expansion chamber is broken, go to Step 6.

6 Renew the suspension air supply unit expansion chamber (see TOPIx Workshop Manual section 204-05: Vehicle Dynamic Suspension - Removal and Installation - Suspension Air Supply Unit Expansion Chamber).
