LTB01214NAS1

# TECHNICAL BULLETIN

Rear Lamp Stain, Tarnish, And/Or Contamination

MODEL:	MODEL YEAR:	VIN:
Range Rover (LG)	2018 Onwards	380237 Onwards

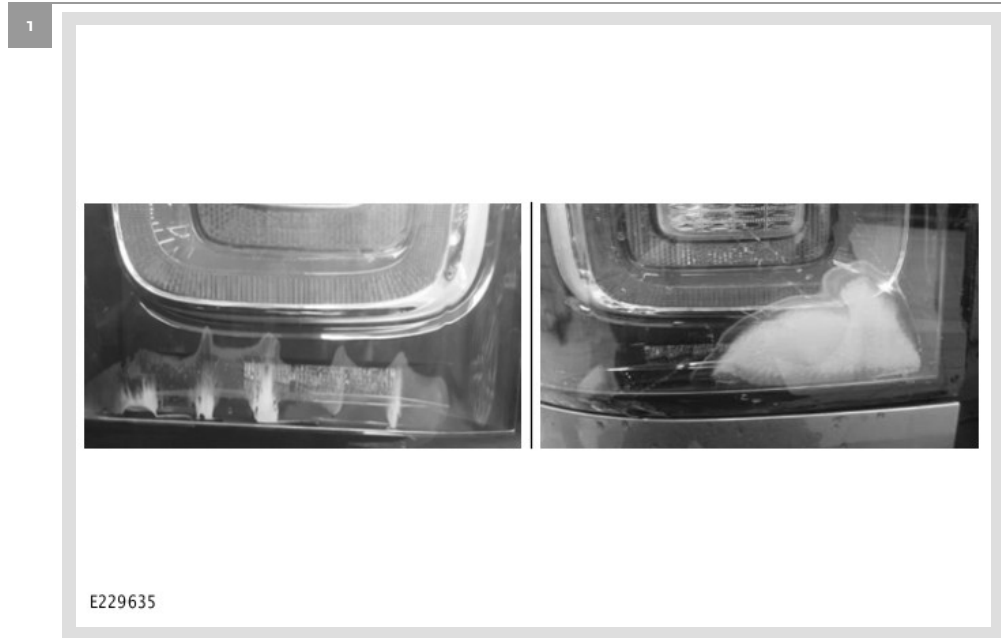
The rear lamp(s) may exhibit signs of staining, tarnishing, and/or contamination on the inner surface of the lens.

This may be caused by moisture freezing on the anti-fog coating applied to the inner surface of the rear lamp lens.

Staining, tarnishing, and/or contamination on the outer lens.

- 1 Inspect the rear lamps.
  - If there are not signs of staining, tarnishing, and/or contamination, continue further diagnosis (see TOPlx Workshop Manual section 417-01: Exterior Lighting - Description and Operation).
    - Do not continue with this Technical Bulletin.
  - If there are signs of staining, tarnishing, and/or contamination, go to Step 2.
- 2 Renew the affected rear lamp(s) (see TOPlx Workshop Manual section 417-01: Exterior Lighting - Removal and Installation - Rear Lamp Assembly).
