Technical Service Bulletin

34 Transmission oil leak from case seam

34 18 37 2052421/1 September 18, 2018.

Model(s)	Year	VIN Range	Vehicle-Specific Equipment
R8	2013 - 2018	All	With S-tronic transmission

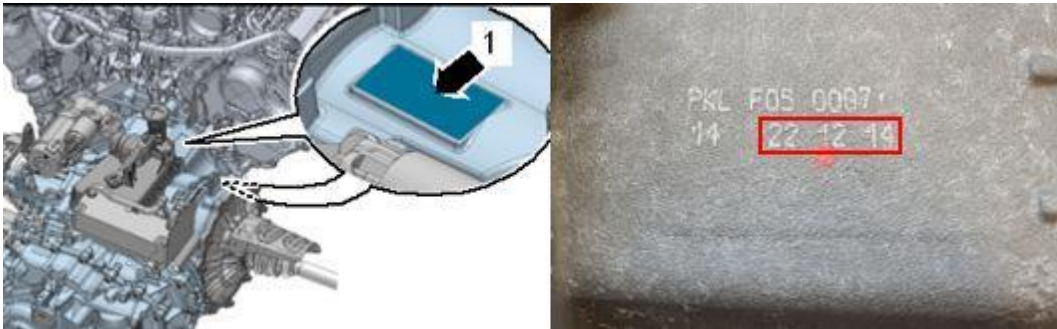
Check and record the transmission build date for your records or possible Audi Technical Assistance Center contact. The build date is located on the top of the transmission bellhousing on the passenger side (Figure 1). The date format is stamped into the bellhousing as Day-Month-Year.

Figure 1. Example of a gearbox production date.

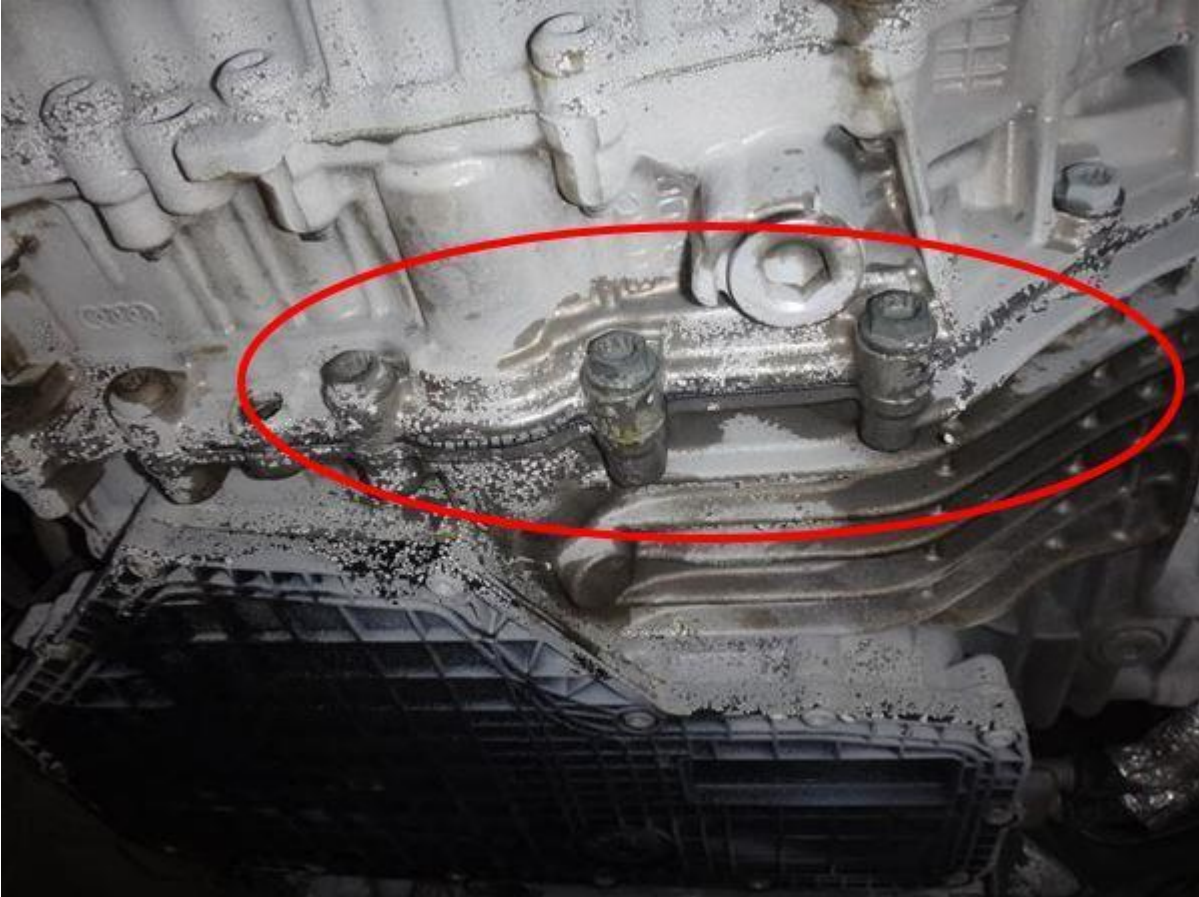
- Transmission oil leaking from case seam at the front of the intermediate housing.

Deviation of tightening torque of case seam bolts.

Figure 2. Oil leak example.

5. If the oil leak is from seam at the front of the intermediate housing shown in Figure 2 proceed to step 7 in this TSB.
6. If the oil leak is not from the location shown in Figure 2 this TSB does not apply and you should complete your diagnosis outside of this bulletin. Take clear pictures of the leak location and open an Audi Technical Assistance Center contact. Attach the pictures of the oil leak to technical inquiry and contact the Audi Technical Assistance Center.
7. Check the seven steel bolts (Figure 3) for a torque of 25 Nm. The seven bolts have a hex head with internal polygon socket (triple square). If one or several bolts do not have the specified torque (25 Nm), document which bolts (1 through 7) were not tightened correctly.

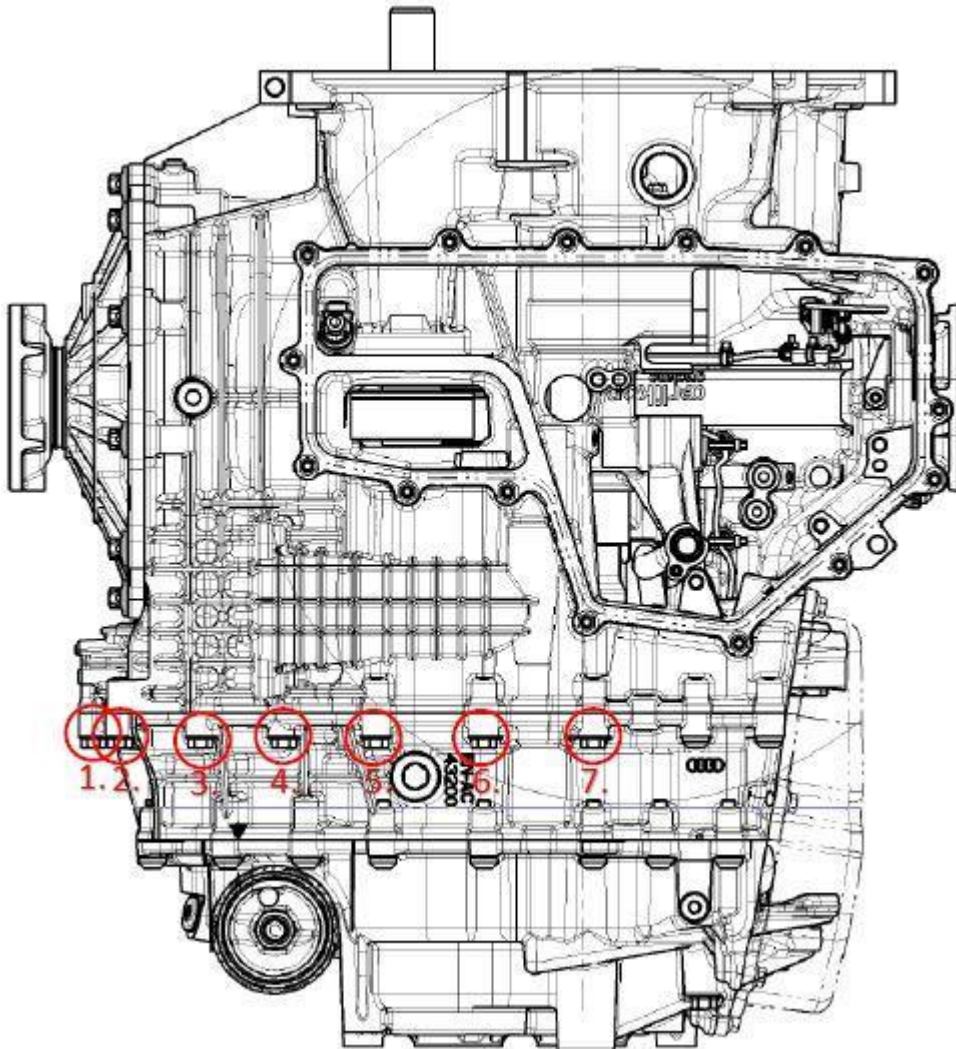
- One or several steel bolts of seam at the front of the intermediate housing are loose.

Figure 3. Bolt locations.

8. Replace the incorrectly tightened bolts individually with a torque of $20\text{Nm} + 90^\circ$. Do not replace any bolts that were not loose.

Never remove two or more bolts at the same time.
