46 Squeal from front brakes

46 18 97 2042182/10 September 19, 2018. Supersedes Technical Service Bulletin Group 46 number 17-80 dated October 23, 2017 for reasons listed below.

Model(s)	Year	VIN Range	Vehicle-Specific Equipment
Q5	2013	047567 - 999999	2.0 and 3.0 engines
Q5	2014 - 2017	All	2.0 and 3.0 engines

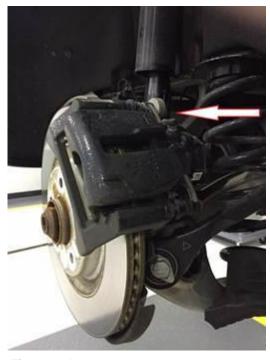
Figure 4. Balance weight position.

The balance weight should be assembled in the upper position near the parking brake electric motor connector (Figure 4).
