Technical Service Bulletin

90 Instrument cluster: trip recorder, short, and long-term memory in on-board computer intermittently resets

90 18 99 2051735/2 September 19, 2018. Supersedes Technical Service Bulletin Group 90 number 18-93 dated July 6, 2018 for reasons listed below.

Model(s)	Year	VIN Range	Vehicle-Specific Equipment
A6, A7	2017 - 2018	All	With multifunction display/trip computer

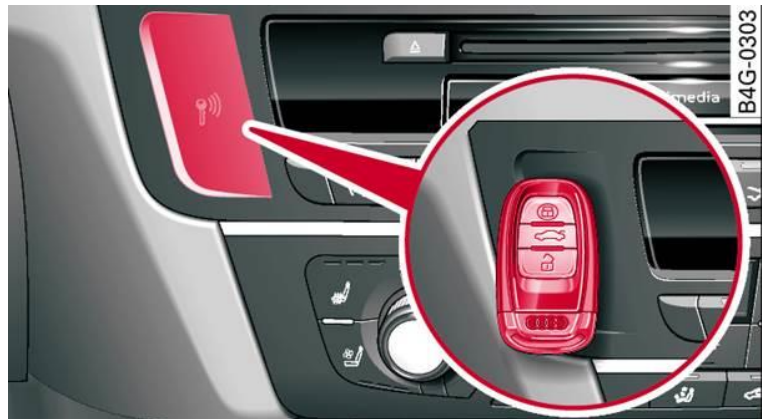
Figure 1. Center console with a location for the vehicle key (example).

2. When the message: "...hold the vehicle key on the transponder..." appears, hold the vehicle key fully on the provided mark of the center console (Figure 1), until the update starts in the instrument cluster and keep the key in this position until the update is completed.

Tip: It is recommended to affix the vehicle key in this position with an adhesive tape that can be removed without leaving any residue.
