# Warranty Communication

**Number: AWC-18-12**

**Subject: SVM Flashing - Slow Installation and Excessive Time Units**

**Date: Sep 25, 2018**

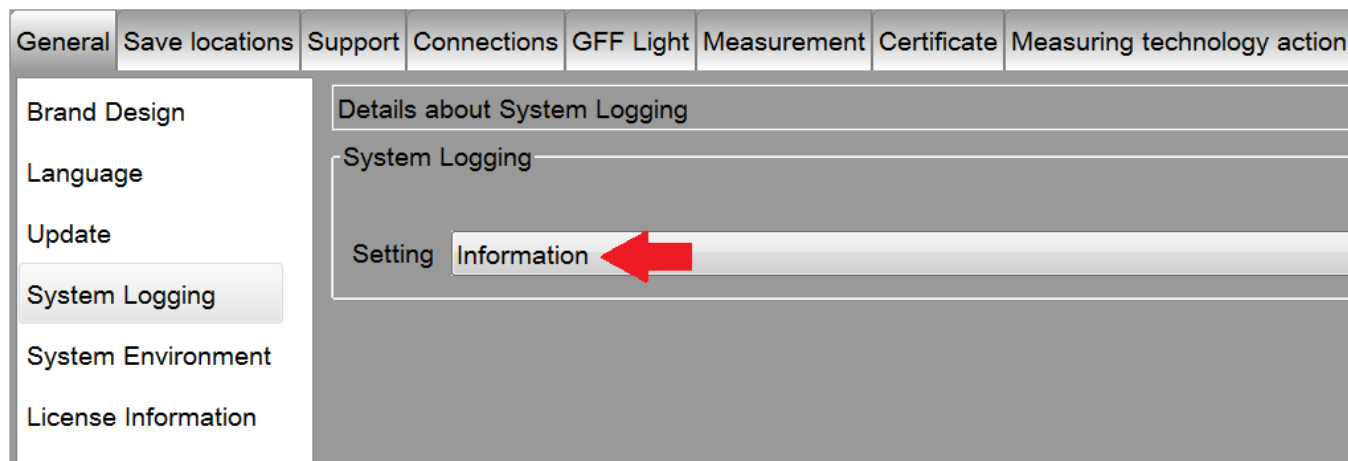
Under the **General** tab, select **System Logging** to view the system logging setting. It should be set at “Information”:

To correct this issue, ensure that the “System Logging” settings on all VAS testers are set to “Information”. If the setting is incorrectly set to “All”, it will cause the tester to run an SVM flash that is longer than expected, which will result in unusually high TUs and can potentially cause the tester to lock up.
