## **TECH TIP**

**TT-18-002 VEHICLE VIBRATION-MISSING  
DRIVESHAFT BALANCE WEIGHTS**

**GROUP: 0-GENERAL  
TECH TIP NO: TT-18-002  
DATE: 10-16-2018**

**SUBJECT VEHICLES:** 11MY-19MY Conventional Trucks equipped with a J08 engine.

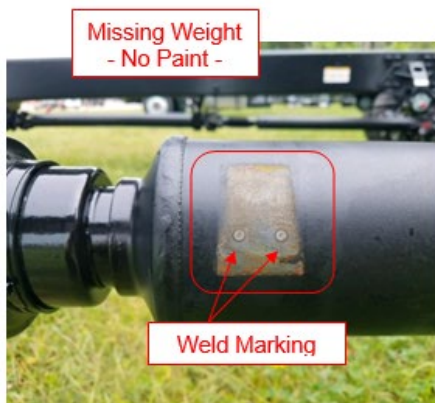
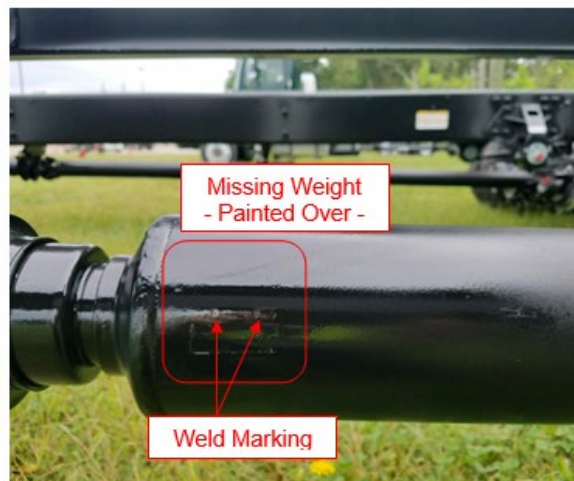
If a low mileage, recently delivered vehicle exhibits a vibration while driving, it is recommended to inspect the driveshaft(s) for missing balance weights. The missing weights may or may not have been painted over. Spot weld marks will remain visible where the weight had been installed. If the vibration is isolated to the driveshaft with the missing weight(s), replacement of the effected driveshaft is necessary.

**NOTE:** During manufacturing and balancing process, not all driveshaft's will require the same number of weights. If a weight is missing, the welding marks will be present.
