MODEL: Karma Revero**DATE:** October 2018**TITLE:** Cabin Temp Sensor Inspection**First Release****PRIORITY:** All**APPLICABILITY:** MY18 Revero vehicles from VIN 50GK41SA1JA000001- 50GK4LSA5JAA0005**MARKET REGION:** North America**PURPOSE:** To ensure proper function of cabin temp sensor motor**Overview:**

TITLE: Cabin Temp Sensor Inspection

CC-18-30-03

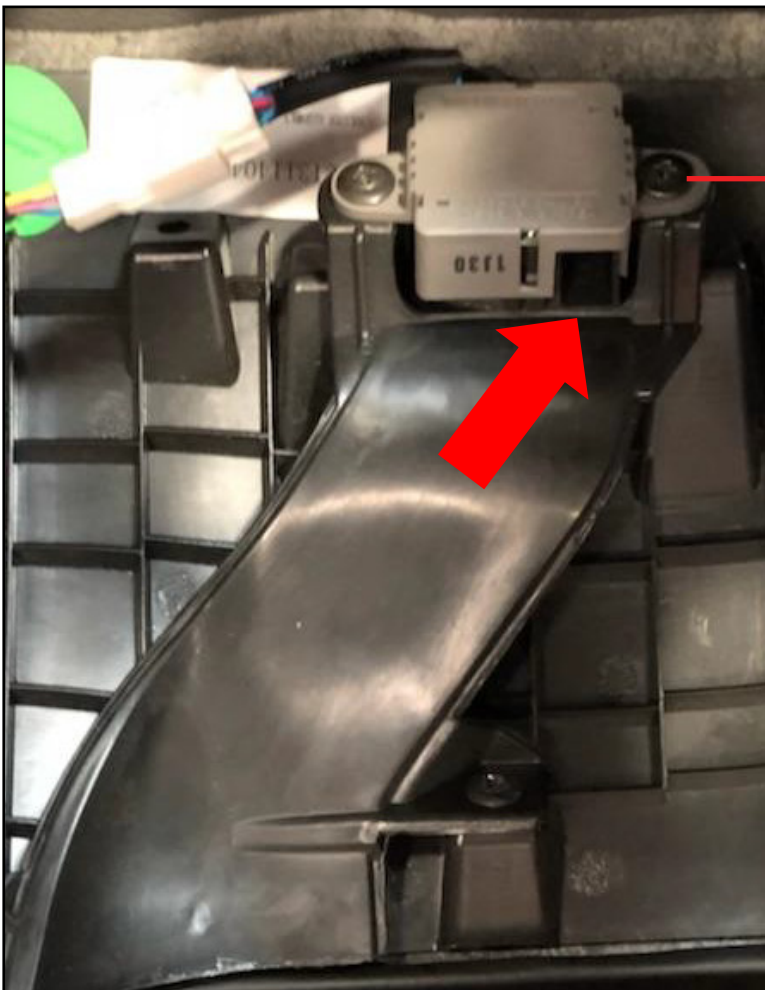
fig.2a

2 Verify the correct temp sensor and motor orientation- (fig. 2 a) is correct with fan visible above the duct. If found as shown in (fig. 2a) proceed to next step.

Correct Installation:
fan opening is visible, connector pigtail is away from the duct.

If it is oriented incorrectly undo the fasteners and reinstall the correct facing direction (install torque 1.5Nm +/-0.3Nm).

1.5Nm +/-0.3Nm

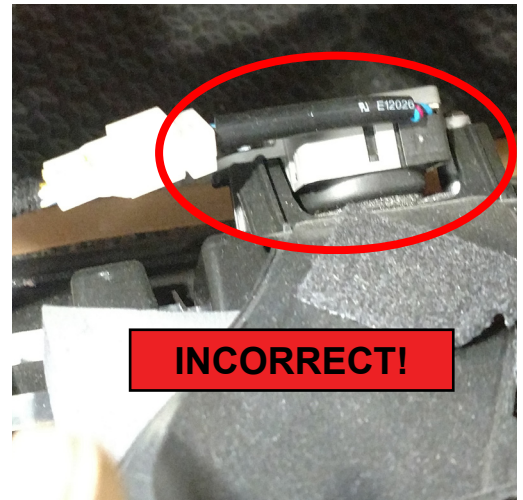
fig.2b

Incorrect installation is seen in (fig. 2b), notice the fan opening is not visible and wire is in front of device.

INCORRECT!

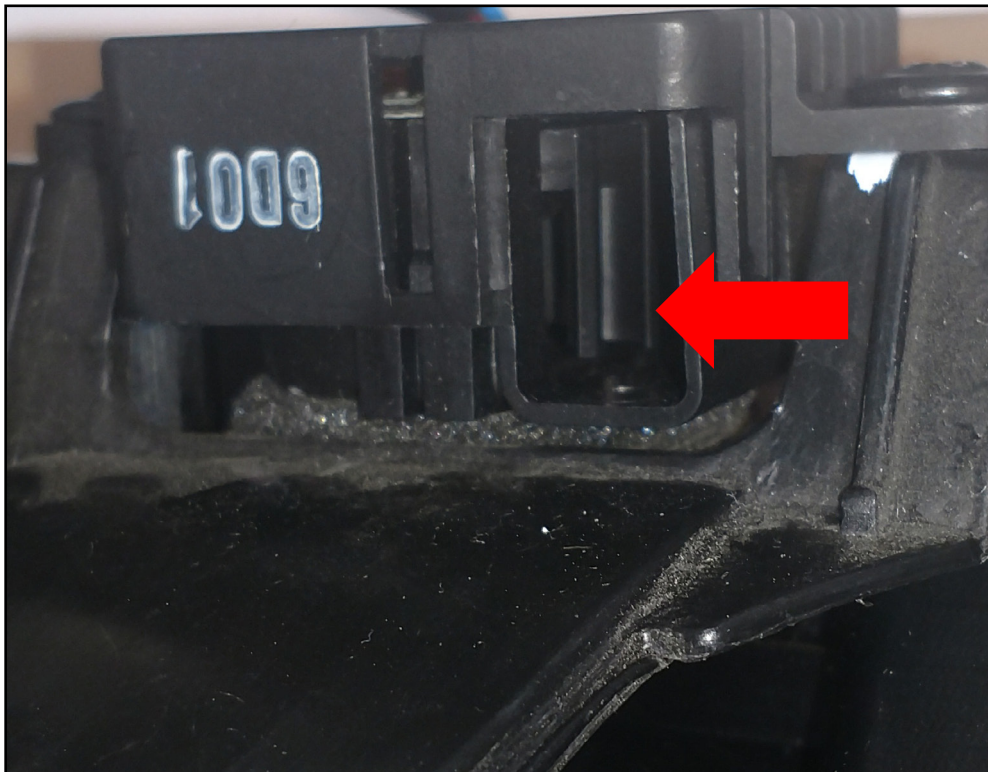
fig.3a

Look into the indicated location, to observe aspiration fan operating (fig. 3a).

If however, the fan is inoperative, proceed with the remainder of this bulletin.

If the fan is operating, please reassemble the vehicle no further action is required.

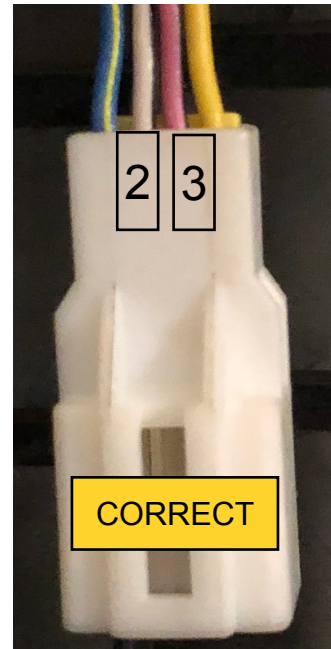
fig. 6b

4. The expose wires can be repositioned now (fig. 6a). The pink/black stripe wire belongs in position 3, the white/black stripe wire is to be inserted to position 2. This is correct in (fig. 6b). For connector pin out see table (fig. 6c)
