RAIN/LIGHT SENSOR (RLS): OIL LEAKAGE FROM GEL PAD

This Service Information bulletin replaces SI B61 30 17 dated July 2017

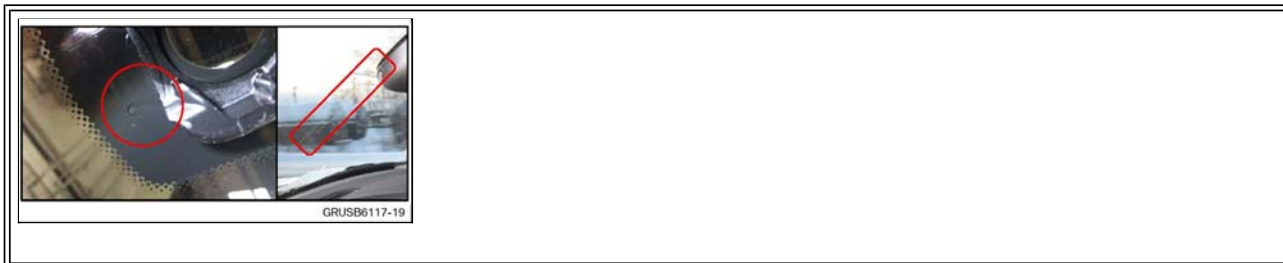
- Oil leaking from the Rain/Light Sensor (RLS).

The oil that serves as the separation medium of the Rain/Light Sensor (RLS) gel pad and the windscreen leaks out.

Expose the Rain/Light Sensor (RLS) and properly clean the area of all oily residue.
